BI-MONTHLY SAFETY AUDIT INSPECTION OF GOOTY STATION OF GUNTAKAL DIVISION FOR THE PERIOD JULY & AUGUST 2015 ON 25.8.2015

**EXECUTIVE SUMMARY ON THE BI-MONTHLY INTERNAL SAFETY AUDIT OF
GY STATION OF GUNTAKAL DIVISION FOR THE PERIOD JULY & AUGUST 2015
ON 25.8.2015**

No. Safety. 195/Bi-MSA/4/2015/GY

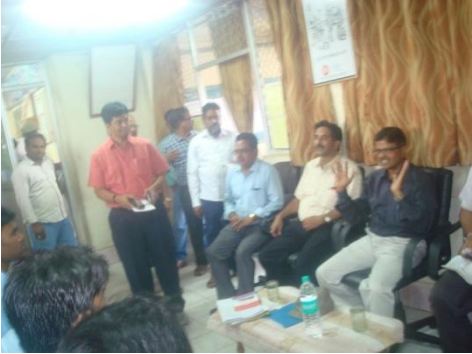
<p>18.0</p>	<p><u>Interactive session with station staff:</u> Interactive session involving LPs, ALPs, Guards, SMs, Guards & Pointsmen was organized at GY Crew Lobby. As many as 60 trainees attended the session. The team of Headquarters and ADRM with Branch Officers of the Division were present in the session. The incidences of accidents and unusual that took place at GY and other locations of SC Railway were discussed and preventive measures were conveyed. Some of the field issues were raised by the staff which is taken care by the Division for early rectification.</p>

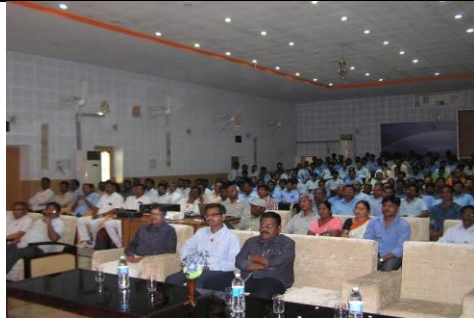
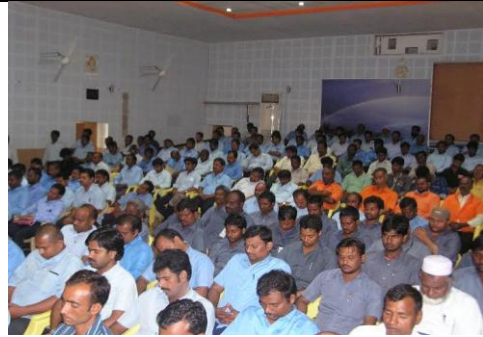
<p>19.0</p>	<p><u>Stress management & relaxation technique programme:</u> Relaxation technique and stress management (meditation) was organized at Railway Club, Guntakal, involving trainees (LPs, ALPs, Pointsmen, SMs, Guards, P.Way Staff). A <u>total of 175 employees have attended</u> the programme. ADRM with Branch Officers apart from Headquarters Safety Audit Team have participated in the said programme.</p>
