## **South Central Railway**

# **Inspection of FOB at Lingampally Station**

**Preliminary Report  
September 2019**

**Name of the Project** : VISUAL INSPECTION OF FOB/ PF-1 - PF-6 AT LINGAMPALLY RAILWAY STATION

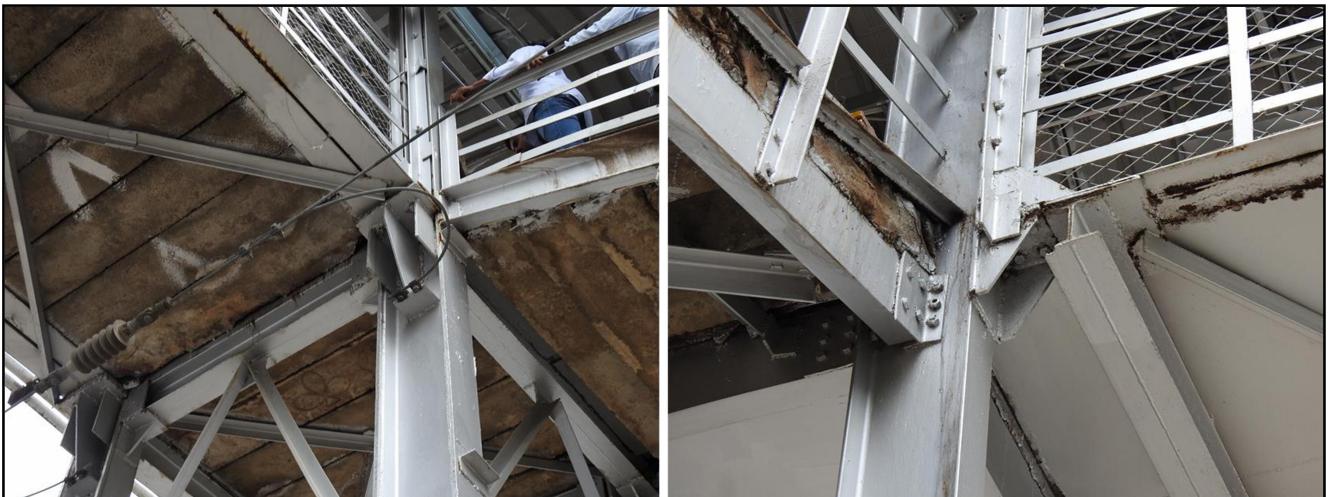
**Fig 9:** Cleat angles

| | Number of staircases | 4 No's | Staircase steps are observed as Precast RCC slab panels of size 300 x 100 mm used. Steps are supported on ISMC 300 channel using cleat angles. Staircase landing of 2 m wide is supported on vertical and horizontal channels members. |
