| <b>Name of the Project</b> | : | VISUAL INSPECTION OF FOB/ PF-1 - PF-2 AT WIRUR RAILWAY STATION |
| <b>Location</b> | : | WIRUR RAILWAY STATION |
| <b>Date of Inspection</b> | : | 23 <sup>rd</sup> September 2019 |

## FORMAT FOR VISUAL INSPECTION OF STEEL FOOT OVER BRIDGE

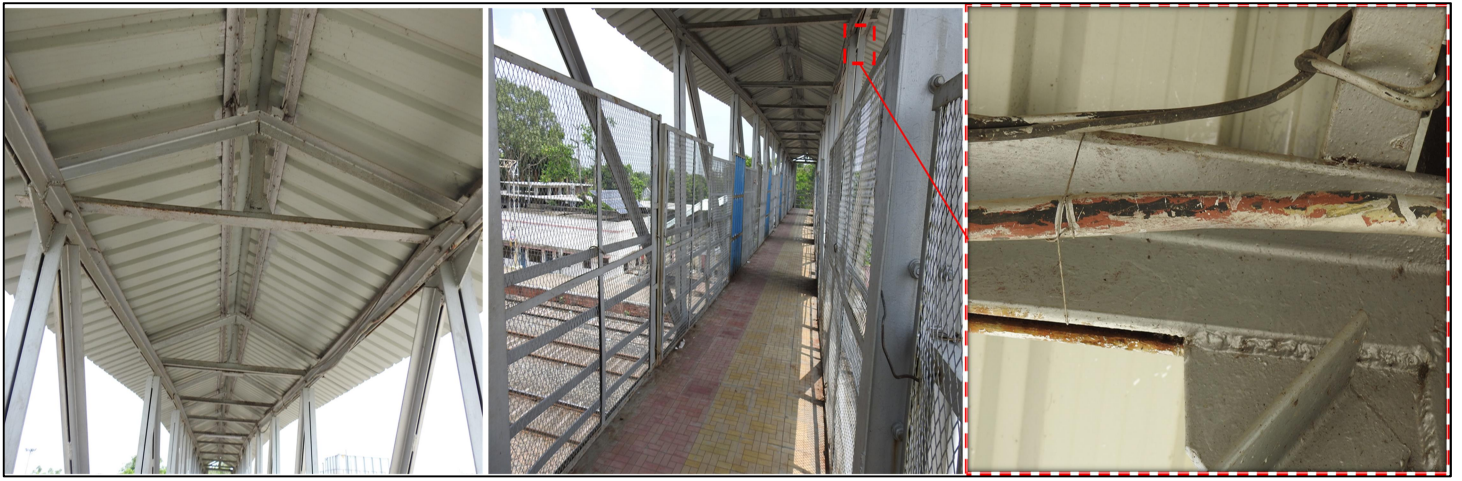
***Fig 1:*** Cables, Roof truss, Flooring and Protective screen

| PART 2 IDENTIFICATION OF LOADS ON BRIDGE | | | |
|---|---|---|---|
| | b) Cables | Yes | Cables are protected with 1-inch HDPE pipe. (Refer <i>fig :1</i> ) |
| | c) Roof Truss | Yes | King post truss with 65 x 65 x 6 mm angles are used (Refer <i>fig: 1</i> ). |
| | d) Roof Sheet | Yes | Metal sheet is used for roof (Refer <i>fig: 1</i> ). |
| | b) Provision of protective screen for passengers | Yes | Chain link fence made of galvanized wire of 2 mm gauge and 2mm galvanized sheet is used above OHE line on both side of pathway is used for protection. (Refer <i>fig :1</i> ) |

| PART 3 STRUCTURAL SYSTEM OF THE BRIDGE | | | |
|---|---|---|---|
| 3.3 | Element of roof truss section | Angular sections | Roof truss is made with 65 x 65 x 6 mm angles and supported on 75 x 75 x 10 mm angles main top chord members.<br>(Refer <i>fig :1</i> ) |

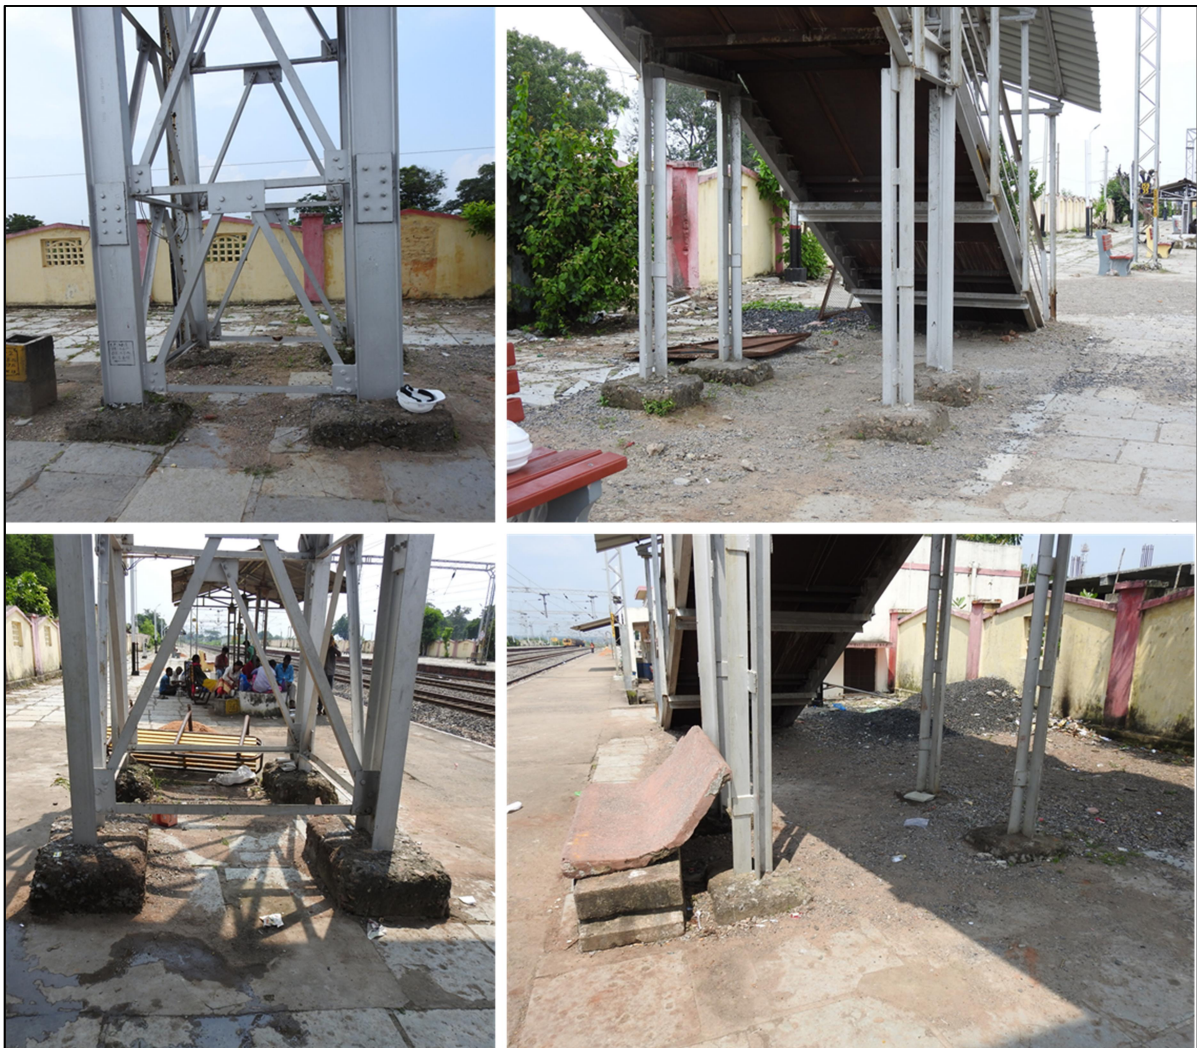
***Fig 2:*** Trestles details

| PART 3 STRUCTURAL SYSTEM OF THE BRIDGE | | | |
|---|---|---|---|
| | Trestles Connection Details | | Concrete encasement on platforms is observed<br>(Refer <i>fig :2</i> ) |

| 3.5 | Type/Shape of Column section | I – Section | FOB is supported on vertical column of Four - ISMB 300. (Refer <b>fig :2</b> ) |

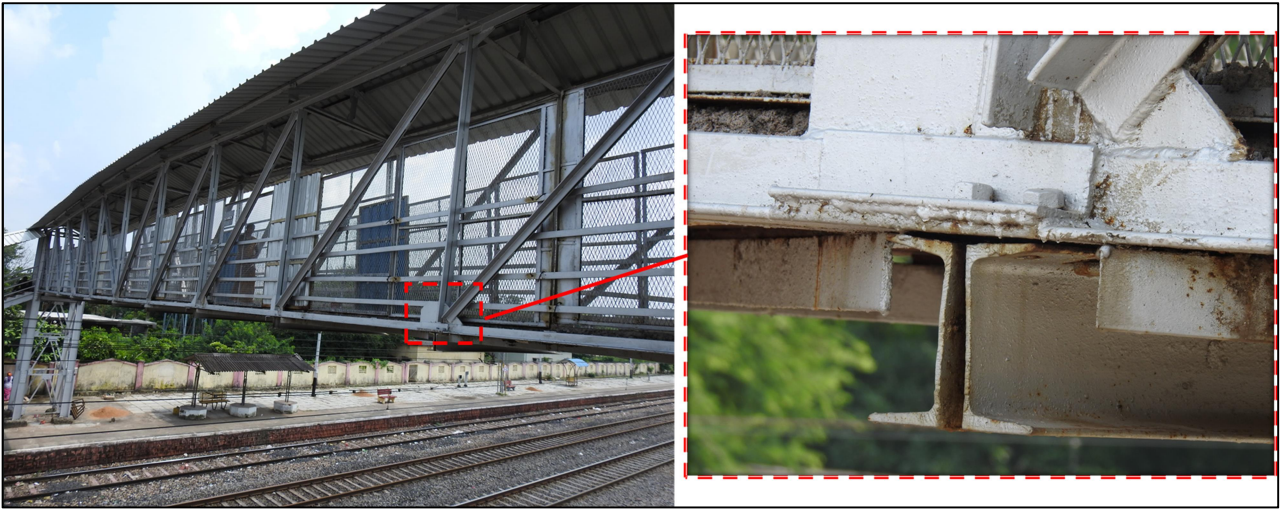
**Fig 3:** Top and bottom chord members, bracings and Floor beams

| | /Bracings | sections and angular section | joint.<br>d. ISMC 150 Double Channel are used as Floor Beams supported with 65 x 65 x 8 mm angular section to transfer load from slab to roof truss.(Refer <b>fig :3</b> ) |

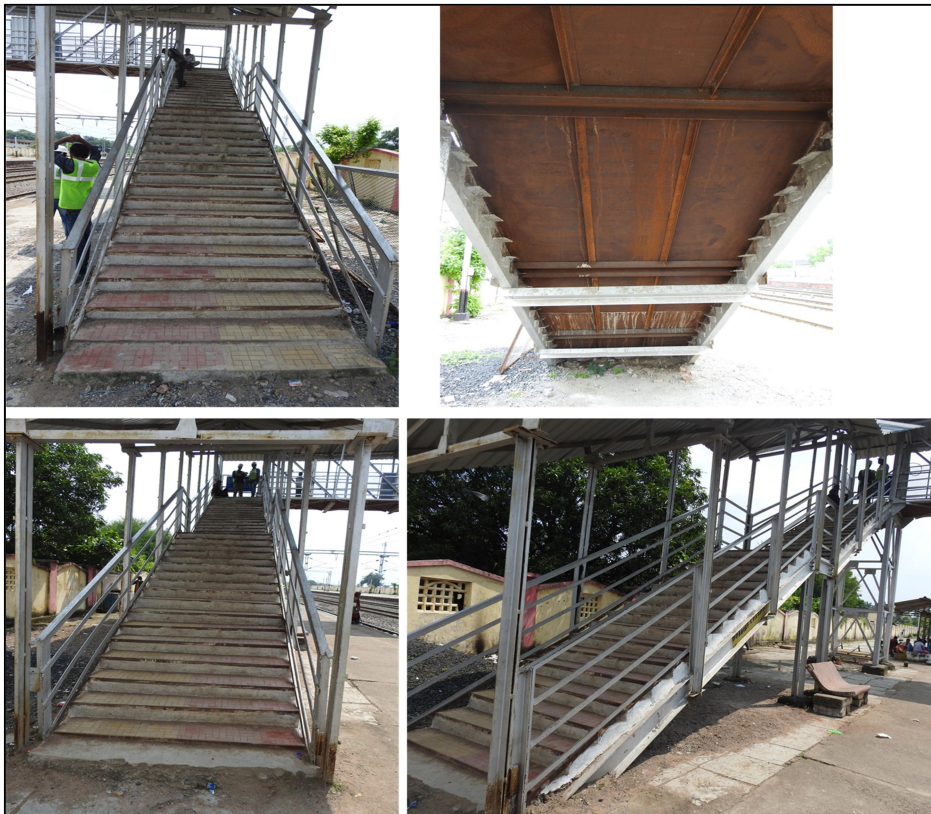
**Fig 5:** Staircase details and bottom view

| 3.7 | Number of staircases | 2 No's | Staircase steps is also cast in site slab of size 300 x 100 mm used. Steps are supported on ISMC 250 channel using sacrificial plate. Staircase landing of 1.6 m wide is supported on vertical and horizontal channels members. Roof of staircase is supported with 65 x 65x 6 mm double angular section. (Refer <b>fig :5</b> ) |
| 3.8 | Type of Parapet Railing | Steel railing | Staircase is provided with railing on both sides of one-meter height using 65 x 65 x 6 mm angles and 50 x 6 mm M.S flats are used. (Refer <b>fig :5</b> ) |
