| Name of the Project | : | VISUAL INSPECTION OF FOB/ PF-1 - PF-2 AT MAHABUBABAD RAILWAY STATION |
| Location | : | MAHABUBABAD RAILWAY STATION |
| Date of Inspection | : | 24 <sup>th</sup> SEPTEMBER, 2019 |

## FORMAT FOR VISUAL INSPECTION OF STEEL FOOT OVER BRIDGE

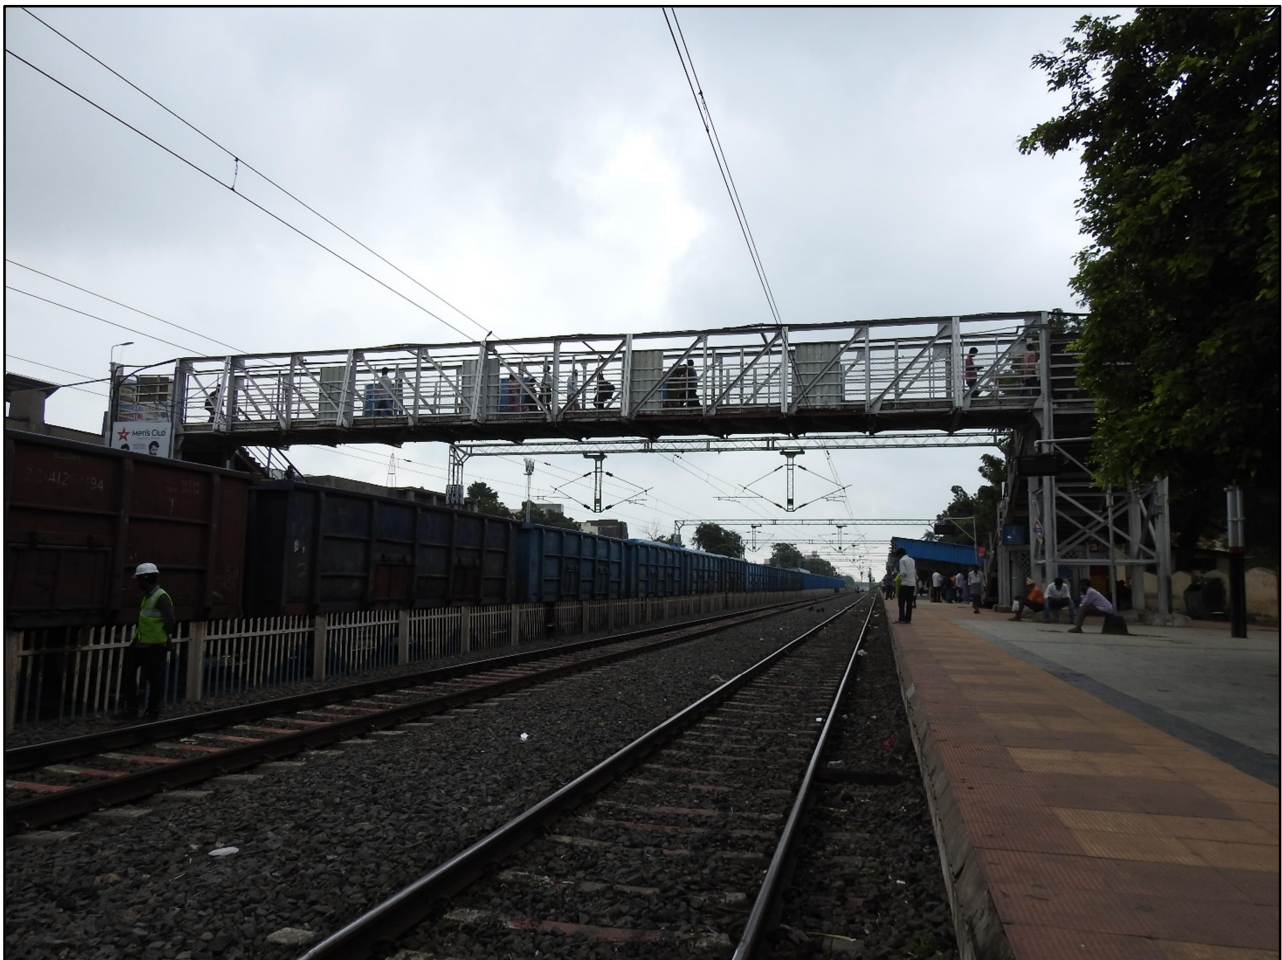
*Fig 1:* Front view of FOB towards Khammam

| PART 3 STRUCTURAL SYSTEM OF THE BRIDGE | | | |
|---|---|---|---|
| | Type /Shape of Truss Section | N- type, Double Angle | a) Main Chord members 2/150 x 150 x 14 mm Double Angle section.<br>b) 100 x 100 x 12 mm are used as Vertical and inclined bracing Members<br>c) 10 mm thick, gusset plate used for welded joint. (Refer <b>fig : 1</b> ) |

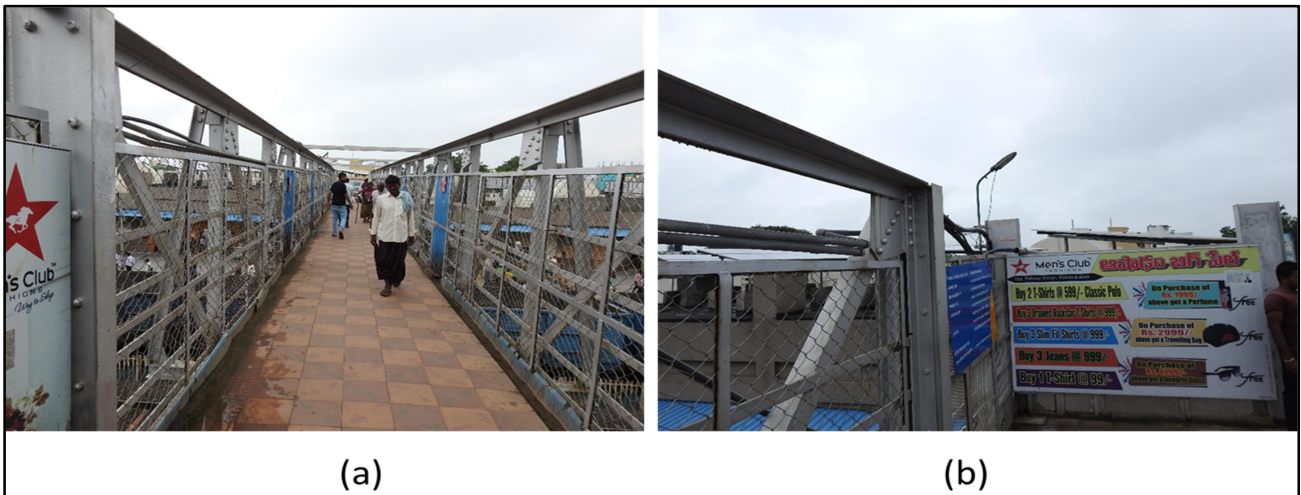
**Fig 3:** Advertising boards

| PART 2 IDENTIFICATION OF LOADS ON BRIDGE | | | |
|---|---|---|---|
| | b) Cables | Yes | Cables are protected are supported to Main truss (Refer <b>fig: 3</b> ) |
| | a) Additional wearing coat on Floor | No | Chequered tiles used for Flooring (Refer <b>fig :3</b> ) |
| | b) Provision of protective screen for passengers | Yes | Chain link fence made of Galvanized wire of 2 mm gauge and 2 mm Galvanized sheet is used above OHE Line on both side of Gangway is used for passengers Protection. (Refer <b>fig :3</b> ) |

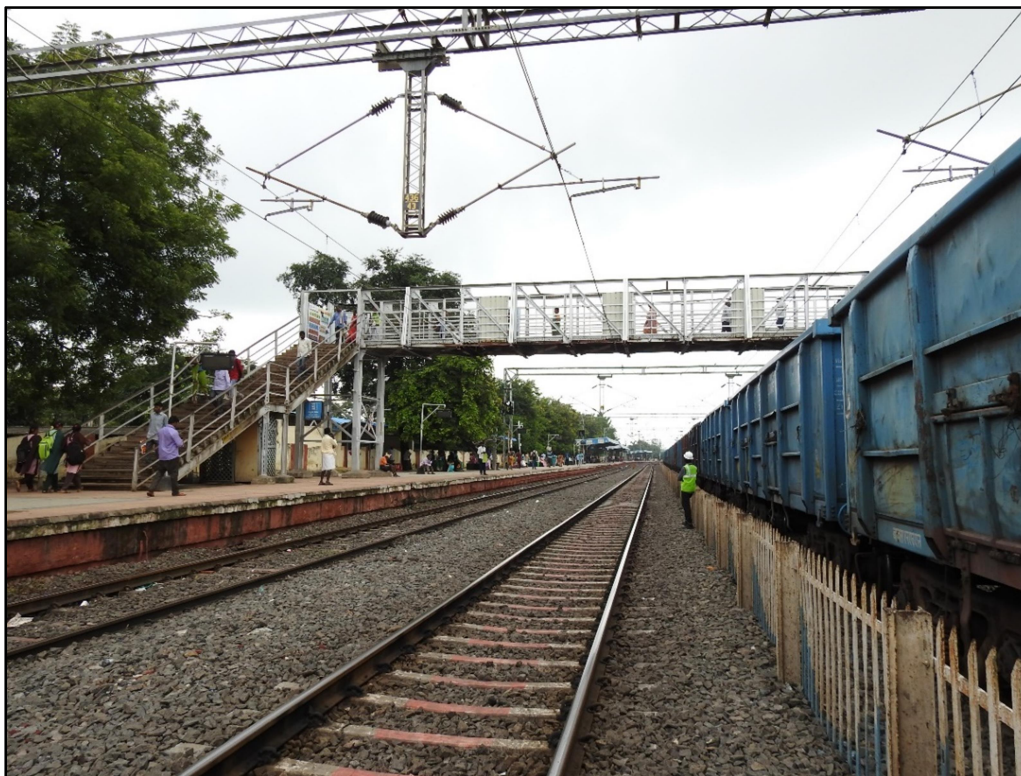
**Fig 5:** FOB view from platform 2 with staircase

| | Shape of Column section | I – Section | FOB is Supported on Vertical Built up Column of 4 - ISMB 350 and 2 of 200 x 10 mm plates are welded to both flanges upto bottom of Truss, 75 x 75 x 8 mm Angle Lacing members connected using Gusset plates and bolts. (Refer <b>fig : 5</b> ) |
