| <b>Name of the Project</b> | <b>:</b> | <b>VISUAL INSPECTION OF FOB/ PF-1 – CIRCULATING AREA AT MANCHIRYAL RAILWAY STATION</b> |
| <b>Location</b> | <b>:</b> | <b>MANCHIRYAL RAILWAY STATION</b> |
| <b>Date of Inspection</b> | <b>:</b> | <b>24<sup>th</sup> September 2019</b> |

## FORMAT FOR VISUAL INSPECTION OF STEEL FOOT OVER BRIDGE

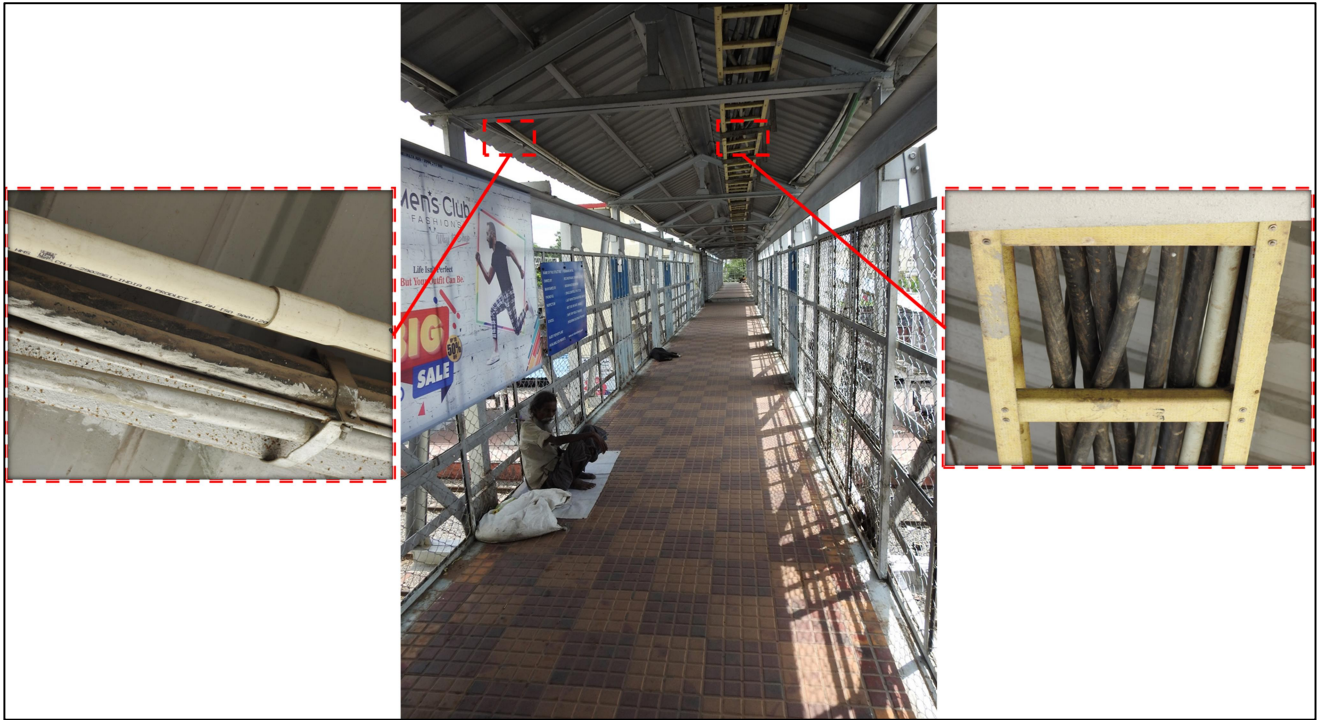
| PART 2 IDENTIFICATION OF LOADS ON BRIDGE | | | |
|---|---|---|---|
| | b) Cables | Yes | a. Cables run in 1-inch pipe and 1-inch CPVC pipe.<br>b. King post truss of 65 x 65 x 6 mm angles<br>c. Metal sheet is used for roof<br>d. Advertising boards are provided. (Refer <b>fig :1</b> ) |
| | a) Additional wearing coat on Floor | No | Chequered tiles are used for flooring (Refer <b>fig :1</b> ) |
| | b) Provision of protective screen for passengers | Yes | Chain link fence made of galvanized wire of 2 mm gauge and 2mm galvanized sheet is used above OHE line on both side of gangway is used for protection (Refer <b>fig :1</b> ) |

| PART 3 STRUCTURAL SYSTEM OF THE BRIDGE | | | |
|---|---|---|---|
| | Element of roof truss section | Angle sections | 1 <sup>st</sup> span and 2 <sup>nd</sup> span roof truss is made with 65 x 65 x 6 mm angle section and supported on 150 x 150 x 12 mm Double angle Top chord of truss (Refer <b>fig :1</b> ) |

**Fig 1:** Cables, Roof truss, load of advertising hoarding, Flooring and protective screen

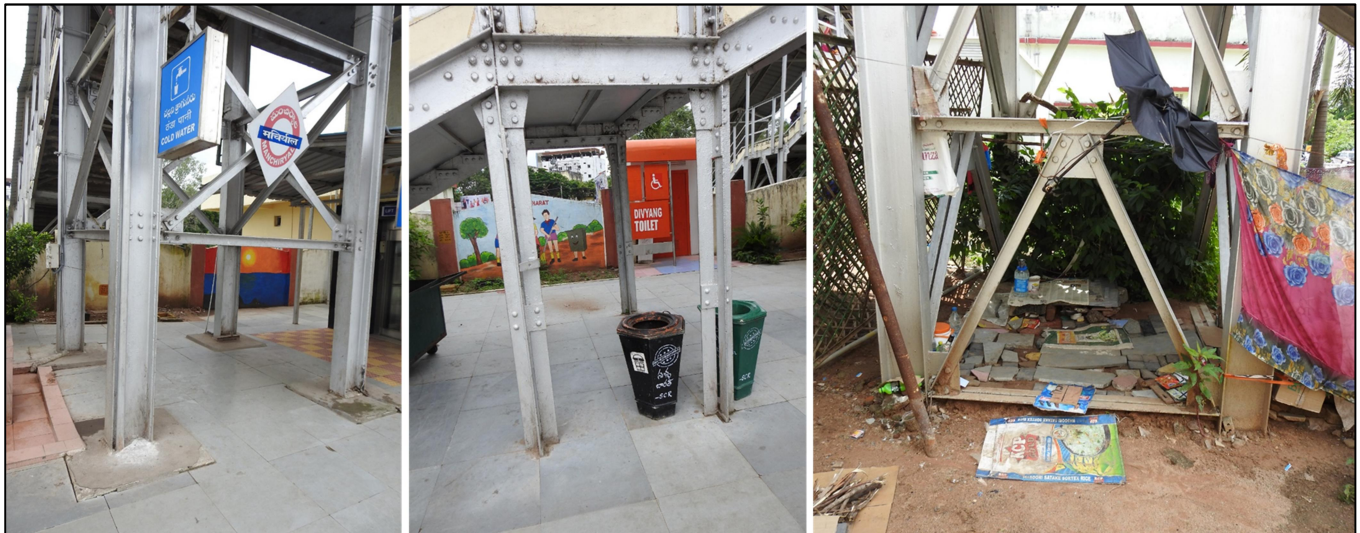
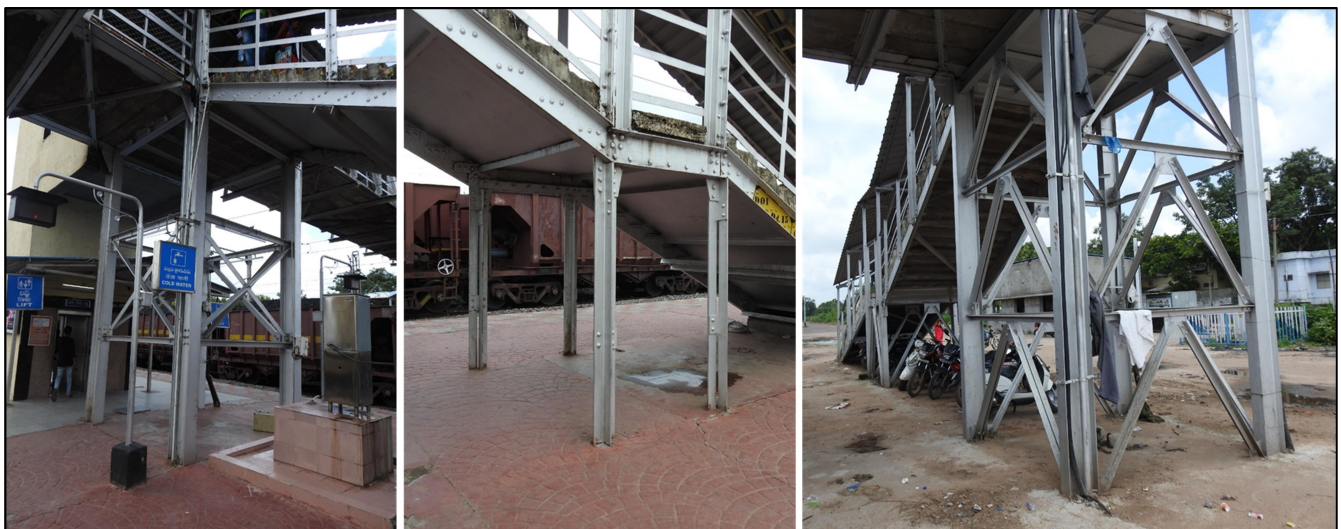
| PART 3 STRUCTURAL SYSTEM OF THE BRIDGE | | | |
|---|---|---|---|
| | Column – Trestles Connection Details | | a. Concrete encasement is observed at bottom of vertical supports.<br>b. Elevator Roof truss is supported on trestles on PF-1 and PF-2. (Refer <b>fig :2 and 3</b> ) |

| | BEAM-Column joint (bolted, welded, riveted) | Bolted | c. Staircase landing is supported ISMB 300 at 2 <sup>nd</sup> span circulating area. (Refer <b>fig :2</b> ) |

**Fig 2:** Trestles details

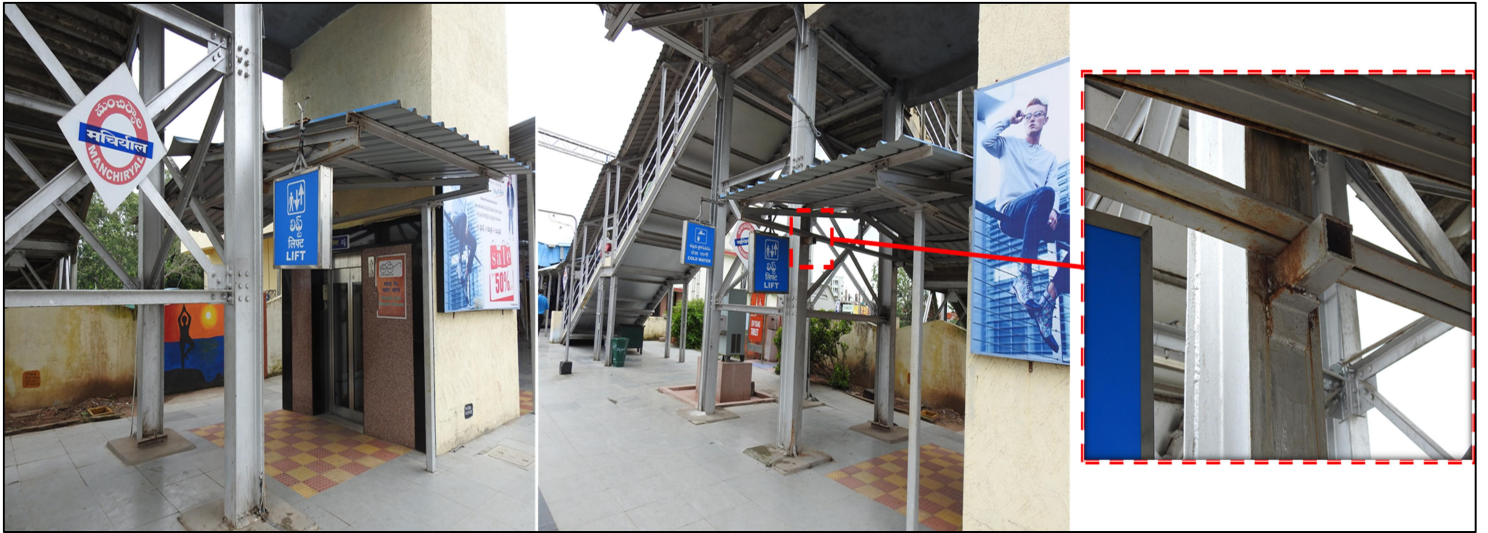
**Fig 3:** Elevator Roof truss supported on trestles on PF-1 and PF-2 & RCC slab resting on trestles

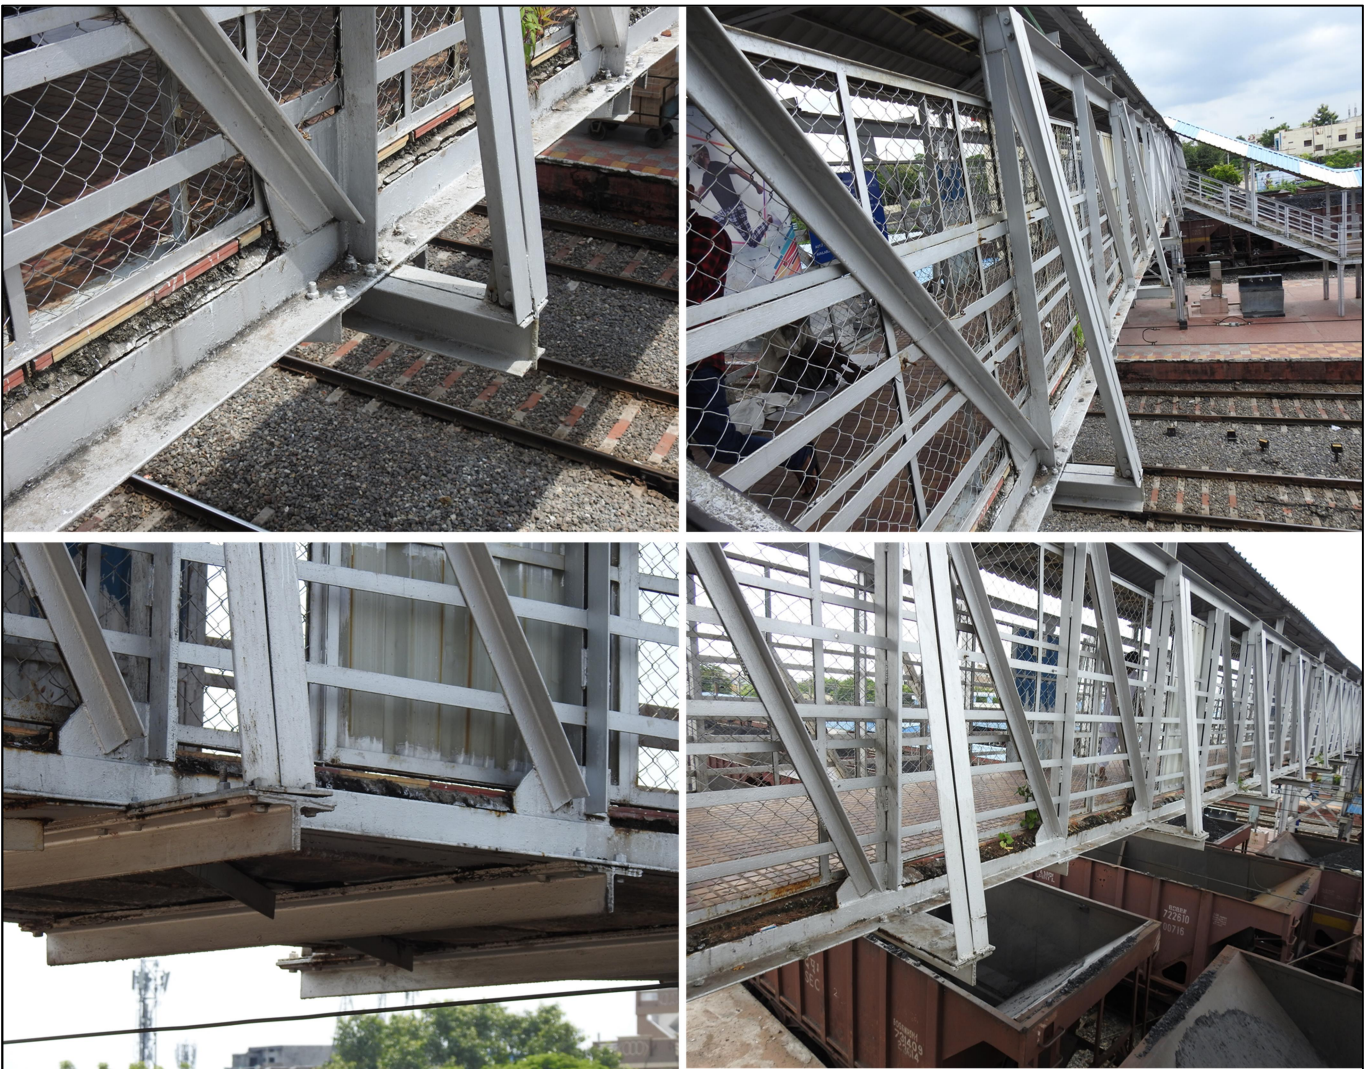
| | No of Floor beams/bracings for span | 1 <sup>st</sup> span :9 no's<br>2 <sup>nd</sup> span: 17 no's | 100x 10 mm angle section bottom chord.<br>e. For 2 <sup>nd</sup> span 100x100x12 mm Double angle section are used for floor beams supported by 100x 100 x10 mm angle section bottom chord member connected by bolts (Refer <b>fig :4</b> ) |

**Fig 4:** Chord members, Floor beams, vertical and diagonal bracings for 1<sup>st</sup> span and 2<sup>nd</sup> span
