| <b>Name of the Project</b> | : | VISUAL INSPECTION OF FOB/ PF-1 – CIRCULATING AREA AT BELLAMPALLI RAILWAY STATION |
| <b>Location</b> | : | BELLAMPALLI RAILWAY STATION |
| <b>Date of Inspection</b> | : | 25 <sup>th</sup> September 2019 |

## FORMAT FOR VISUAL INSPECTION OF STEEL FOOT OVER BRIDGE

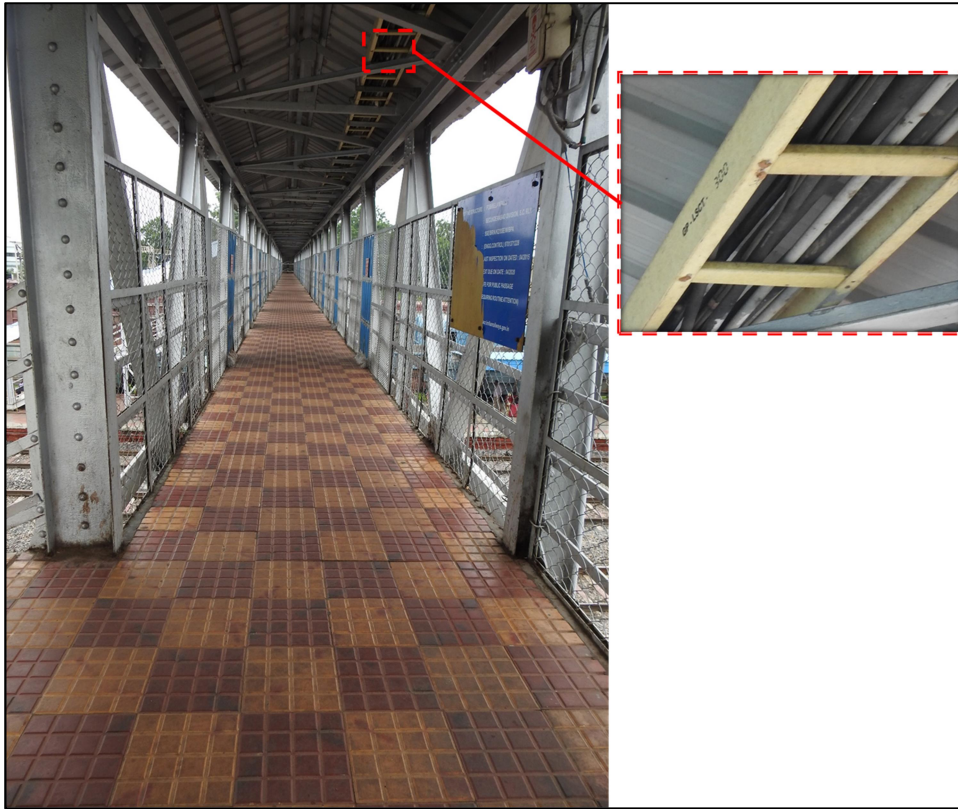
**Fig 1:** Cables, Roof truss, Flooring and protective screen

| PART 2 IDENTIFICATION OF LOADS ON BRIDGE | | | |
|---|---|---|---|
| | b) Cables | Yes | a. Cables 1-inch pipe running in cable tray<br>b. King post of ISA 65 x 65 x 6 mm are used<br>c. Metal sheet is used for roof<br>d. No advertising boards are provided. (Refer <b>fig :1</b> ) |
| | a) Additional wearing coat on Floor | No | Chequered tiles are used for flooring (Refer <b>fig :1</b> ) |
| | b) Provision of protective screen for passengers | Yes | Chain link fence made of galvanized wire of 2 mm gauge and 2mm galvanized sheet is used above OHE line on both side of pathway is used for protection (Refer <b>fig :1</b> ) |

| PART 3 STRUCTURAL SYSTEM OF THE BRIDGE | | | |
|---|---|---|---|
| | Element of roof truss section | ISA | Span roof truss is made with ISA 65 x 65 x 6 mm and supported on ISMC 150 Double channel section top chord member. (Refer <b>fig :1</b> ) |

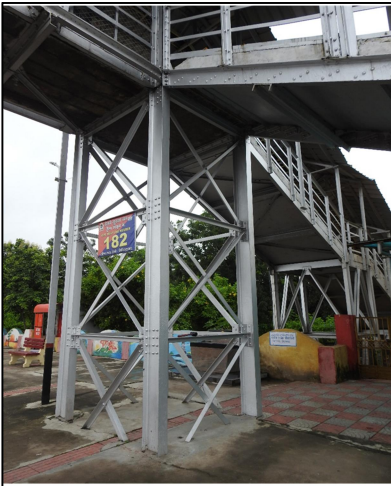
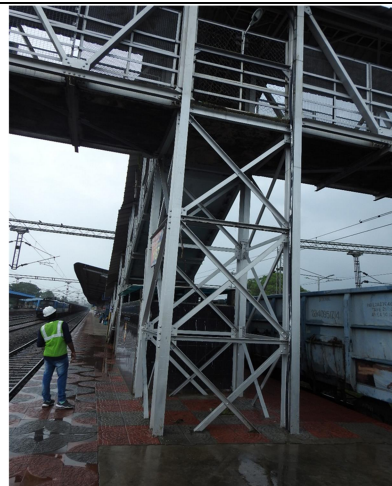
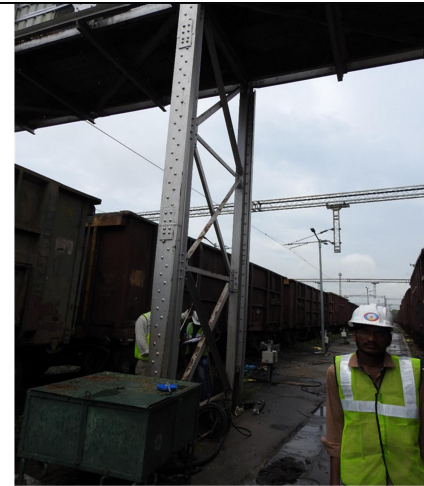
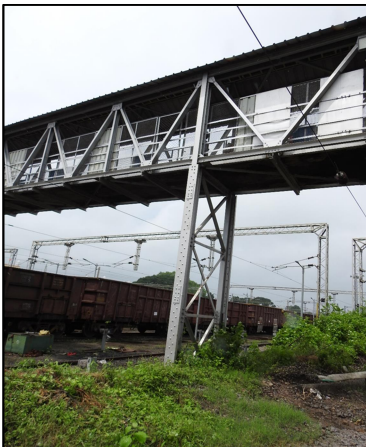
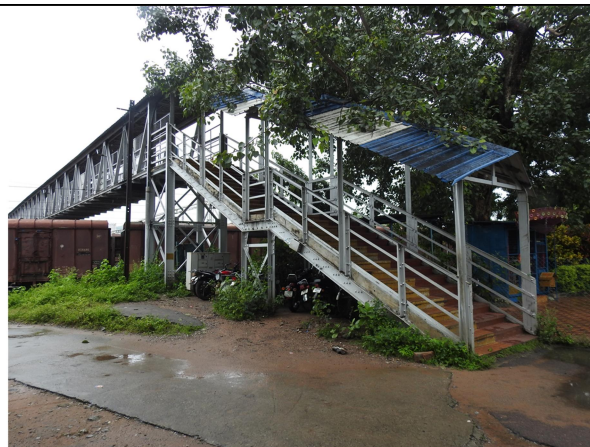
**Fig 2:** Trestles details

| PART 3 STRUCTURAL SYSTEM OF THE BRIDGE | | | |
|---|---|---|---|
| | No of HD Bolts and size | Not visible, filled with concrete | Concrete encasement is observed in vertical supports at platform level. (Refer <b>fig :2</b> ) |

| | BEAM-Column joint (bolted, welded, riveted) | Bolted and riveted | d. Stanchion-1 and Stanchion-2 are built up section of ISMC 250 and ISMB 300. (Refer <b>fig :2</b> ) |

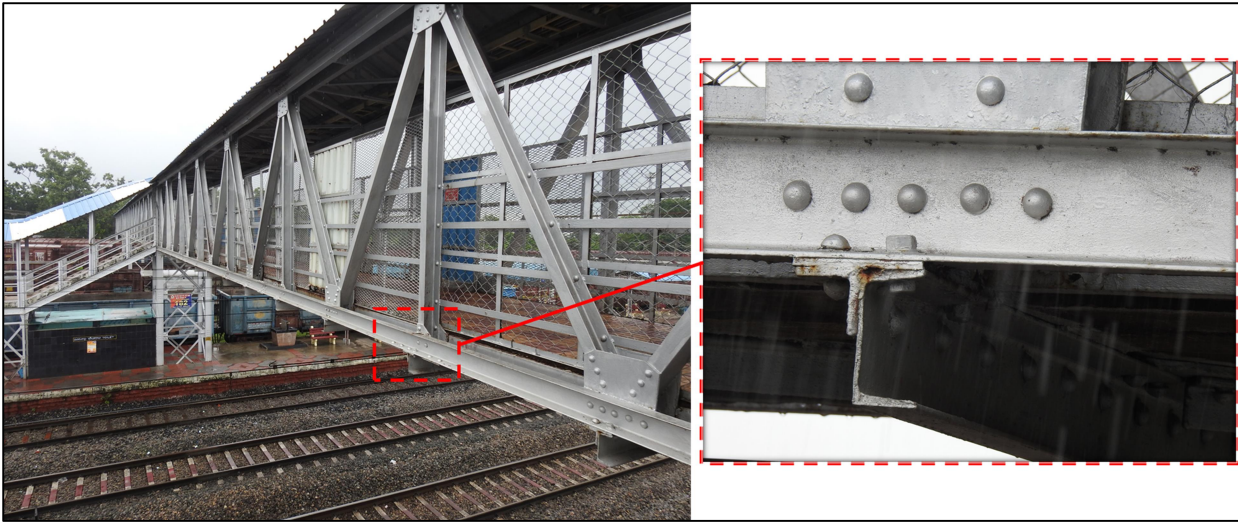
**Fig 3:** Chord members, verticals, diagonal bracings and Floor beams

| | for span | 2 <sup>nd</sup> span: 13 no's<br>3 <sup>rd</sup> span :9 no's<br>4 <sup>th</sup> span: 15 no's | riveted gusset plate. (Refer <b>fig :3</b> ) |

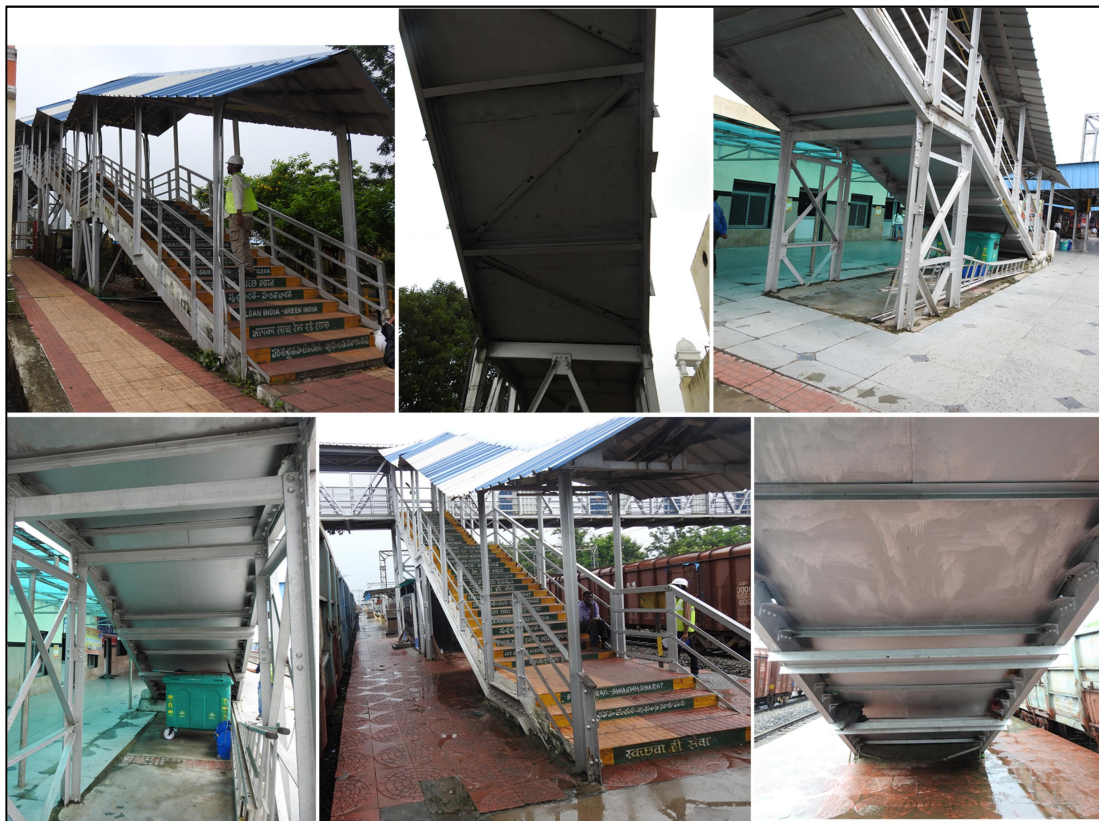
**Fig 5:** Staircase details

| | Number of staircases | 4 No's | Staircase steps are observed as cast in situ slab. Steps size of 300 x 100 mm are supported on ISMC 250 channel stringer beam. Staircase landing of 1.82 m wide is supported on ISMC 250. (Refer <b>fig :5</b> ) |
| | Height of Railing | 1 m | b. Staircase roof is supported with ISA 75 x75 x6 mm double angle section which is supported on ISMC 250. (Refer <b>fig :5</b> ) |
