| <b>Name of the Project</b> | <b>:</b> | <b>VISUAL INSPECTION OF FOB/ PF-1 - PF-2 AT MADHIRA RAILWAY STATION</b> |
| <b>Location</b> | <b>:</b> | <b>MADHIRA RAILWAY STATION</b> |
| <b>Date of Inspection</b> | <b>:</b> | <b>23<sup>rd</sup> SEPTEMBER, 2019</b> |

**FORMAT FOR VISUAL INSPECTION OF STEEL FOOT OVER BRIDGE**

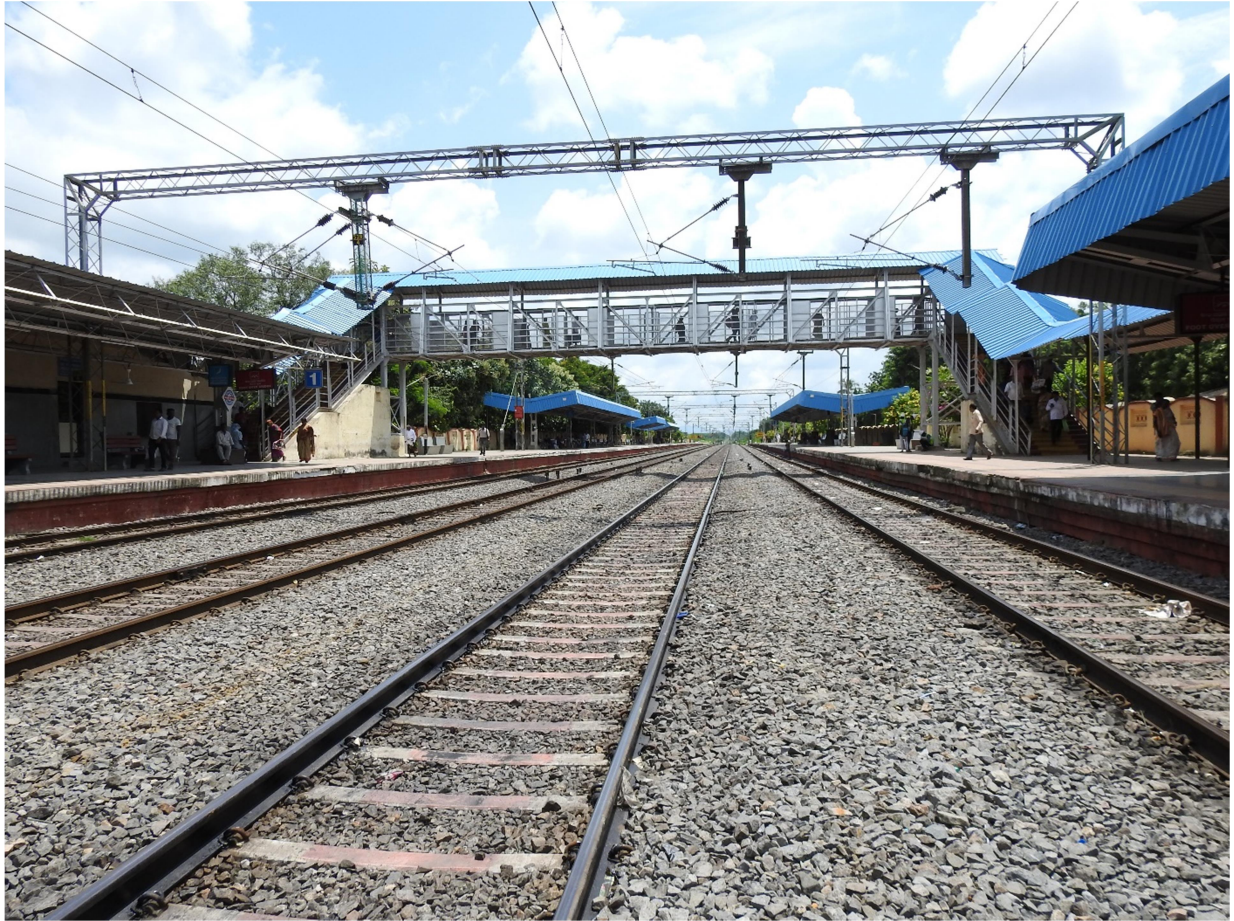
| | Type /Shape of Truss Section | Pratt (N- type) | a) Main Chord members 2/150 x 100 x 12 mm<br>Double Angle section.<br>b) 100 x 100 x 12 mm angles are used vertical<br>posts and inclined bracings.<br>c) 10 mm thick, gusset plate used for welded<br>joint. (Refer <b>fig :1</b> ) |

***Fig 1:*** Front view of FOB towards Vijayawada Junction

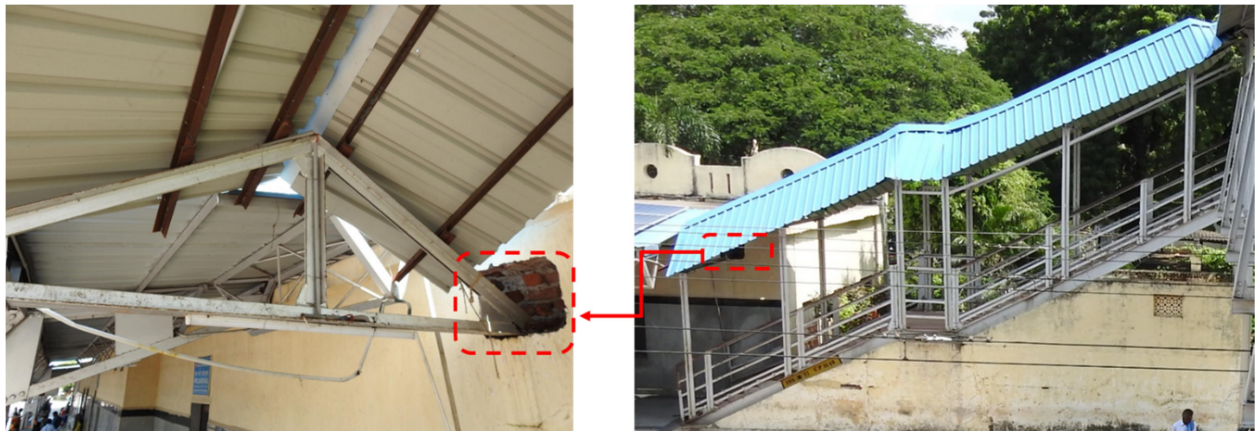
| | Type of Parapet Railing | Steel Railing | Staircase is provided with Railing on both sides of one-meter height using 65 x 65 x 8 mm Angle and 50 x 12 mm Flat. (Refer <b>fig : 2</b> ) |

***Fig 2:*** Staircase Roof truss on platform 1

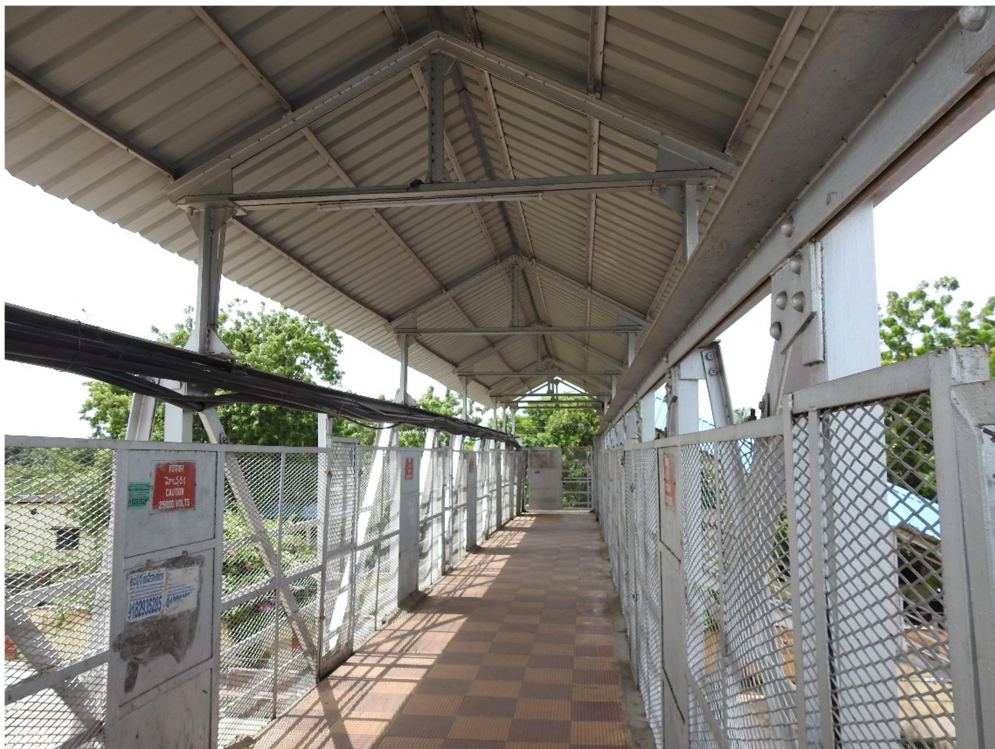
| | | Yes/No | Notes |
|---|---|---|---|
| | c) Roof Truss | Yes | 2/65 x 65 x 8 mm Angles are used (Refer <b>fig : 4</b> ) |
| | d) Roof Sheet | Yes | Corrugated Galvanized Sheet is used for Roof n(Refer <b>fig : 4</b> ) |
| | a) Additional wearing coat on Floor | No | Chequered tiles used for Flooring (Refer <b>fig : 4</b> ) |
| | c) Type of Material used for mesh | GI wire mesh | (Refer <b>fig : 4</b> ) |

| | Element of roof truss section | King post Angle | 2/65 x 65 x 8 mm King post Angle sections are<br>used for roof truss supported on 2/150 x 100 x<br>12mm Top Chord Members using welded<br>joints.<br>(Refer <b>fig :4</b> ) |

**Fig 4:** Pathway of FOB

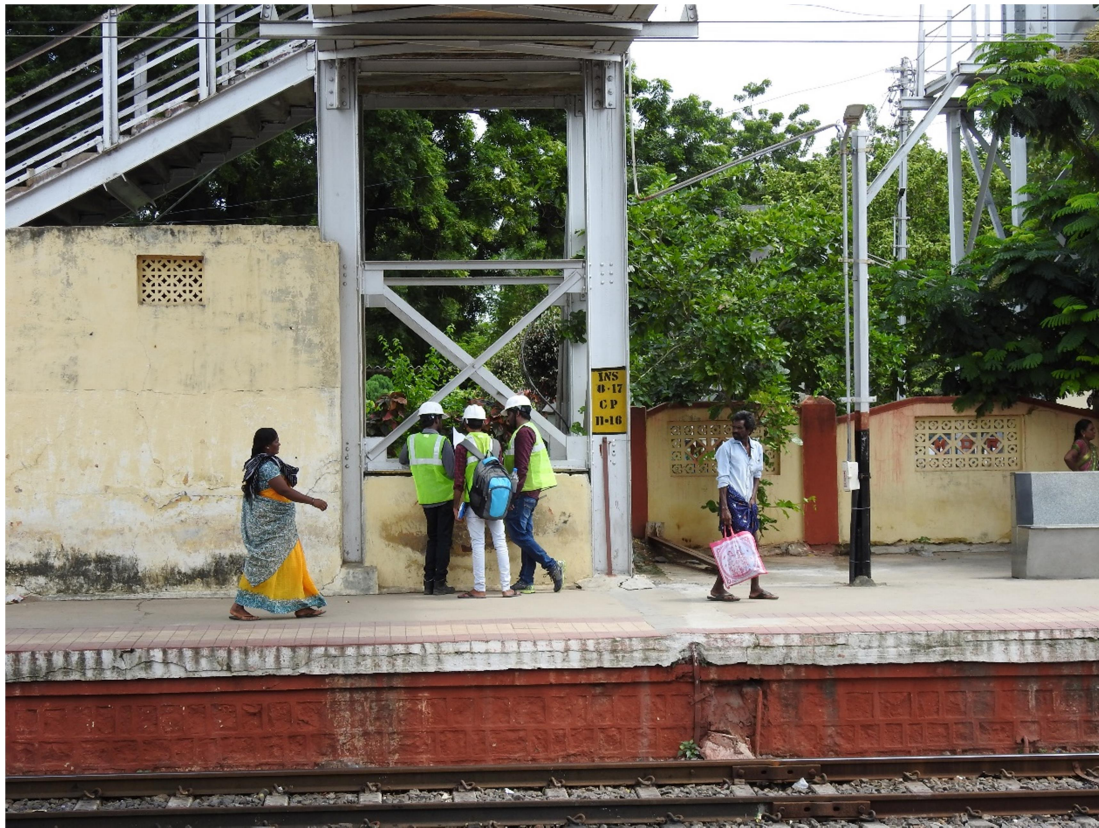
| | | | Notes |
|---|---|---|---|
| | Type of Material for Bottom Encasement | Concrete | Concrete encasement is used for protecting trestles from the corrosion on the platform |

| | | | (Refer <b>fig :5</b> ) |
| | Shape of Column section | I – Section | FOB is Supported on Vertical built-up Column<br>of 4 - ISMB 350 and 2/200 x 10 mm plates<br>welded to both flanges upto bottom of truss with<br>2/80 x 80 x 10 mm horizontal and 80 x 80x 10<br>mm inclined members connected using Gusset<br>plates and rivets. (Refer <b>fig :5</b> ) |

**Fig 5:** FOB is supported on four column Trestles on either side
