| <b>Name of the Project</b> | <b>:</b> | <b>VISUAL INSPECTION OF FOB/ PF-1 - PF-2 AT KHAMMAM RAILWAY STATION</b> |
| <b>Location</b> | <b>:</b> | <b>KHAMMAM RAILWAY STATION</b> |
| <b>Date of Inspection</b> | <b>:</b> | <b>22<sup>th</sup> SEPTEMBER, 2019</b> |

## **FORMAT FOR VISUAL INSPECTION OF STEEL FOOT OVER BRIDGE**

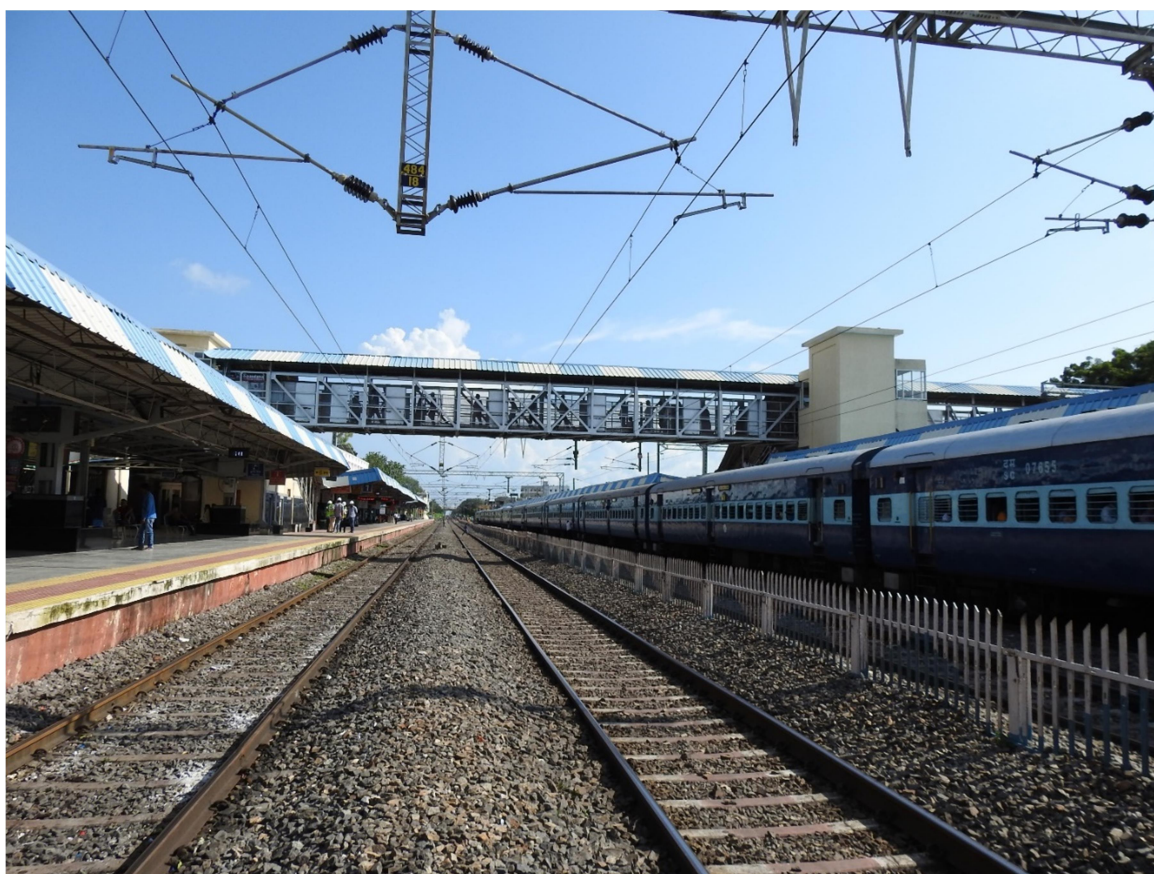
**Fig 1(a):** Front view of FOB span 1 towards Madira

| | Type /Shape of Truss Section | N- type,<br>Double Angle | <b>Span 1:</b><br>a) Main Chord members 2/125 x 125 x 14 mm Double Angle section @ 200 mm spacing between angles.<br>b) ISMB 175 are used as verticals and bracing members<br>c) 10 mm thick, gusset plate used for welded joint. (Refer <b>fig : 1(a)</b> )<br><b>Span 2:</b><br>a) Main Chord members 100 x 100 x 12 mm Double Angle section<br>b) 75 x 75 x 8 mm angles are used as verticals and bracing members<br>c) 10 mm thick, gusset plate used for welded joint. (Refer <b>fig : 1(b)</b> ) |

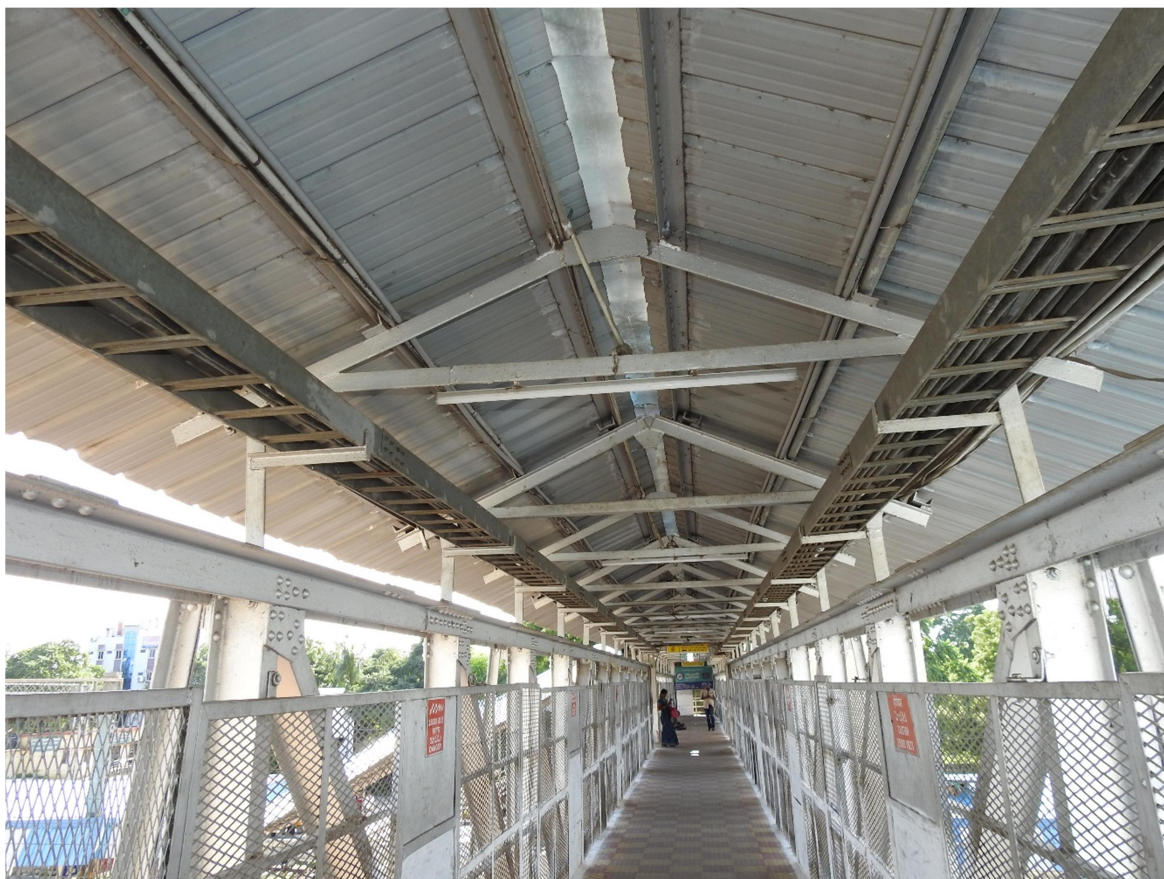
***Fig 2(a):*** FOB span 1 pathway

| | | Yes/No | Notes |
|---|---|---|---|
| | b) Cables | Yes | Set of Cables running on the both sides along the length of FOB. (Refer <b>fig :2</b> ) |
| | c) Roof Truss | Yes | 65 x 65 x 8 mm Angles are used (Refer <b>fig :2</b> ) |
| | d) Roof Sheet | Yes | Metal Sheet is used for Roof (Refer <b>fig :2</b> ) |
| | a) Additional wearing coat on Floor | No | Chequered tiles used for Flooring (Refer <b>fig :2</b> ) |
| | b) Provision of protective screen for passengers | Yes | Galvanized XPM mesh of 2 mm gauge and 2 mm galvanized sheet is used above OHE Line on both side of pathway is used for passengers Protection. (Refer <b>fig :2</b> ) |

| | Condition of Slab from Top | Covered with Chequered tiles | In span 2 Pre-cast RCC slab panels are resting on Floor beams.<br>Chequered tile (25 mm thick) flooring is laid on the top of the Pre-cast slab panels.(Refer <b>fig : 2</b> ) |

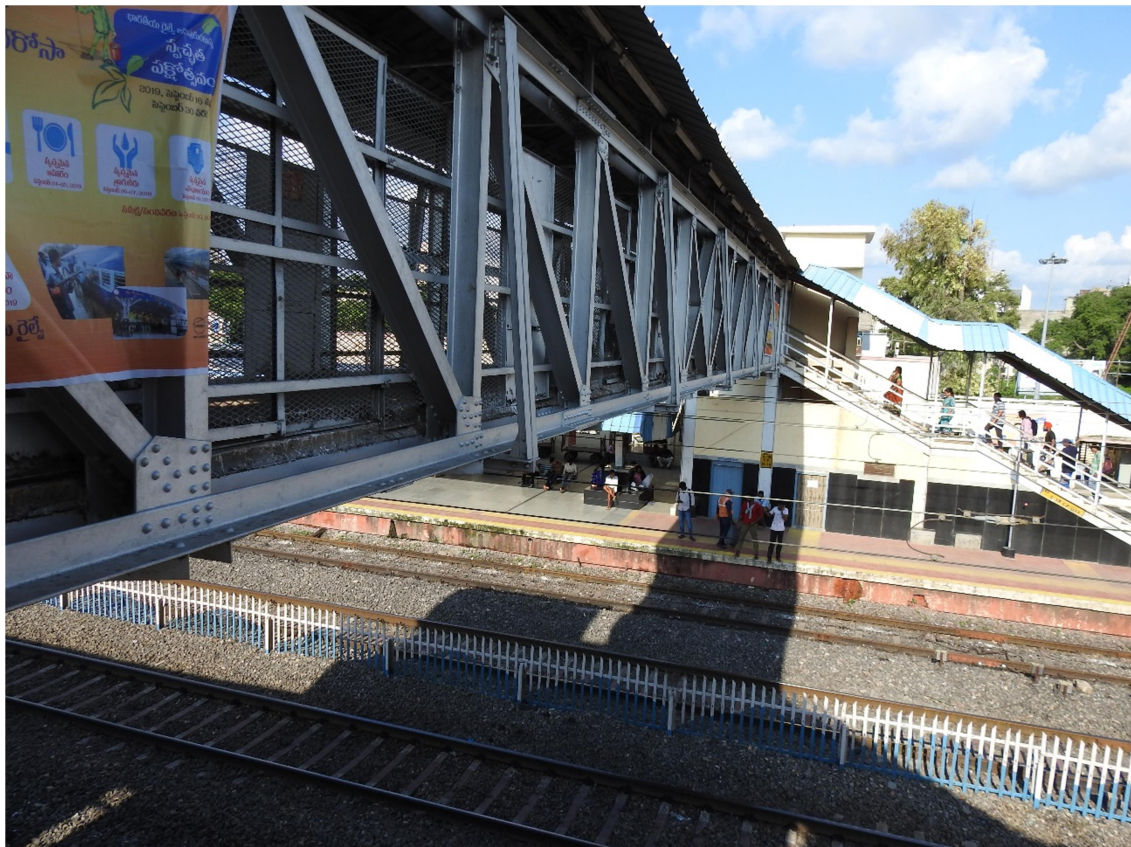
**Fig 3:** FOB span 2 pathway

| | Number of Staircase | 3 No's | Staircase steps are observed as Pre-cast RCC slab panels of size 300 x 100 are used. Steps are supported on ISMC 250 Channel Stringer beam using cleat Angles. Staircase Landing of 2 m wide is supported on Vertical and Horizontal Angle Members. (Refer <b>fig : 3,8</b> ) |

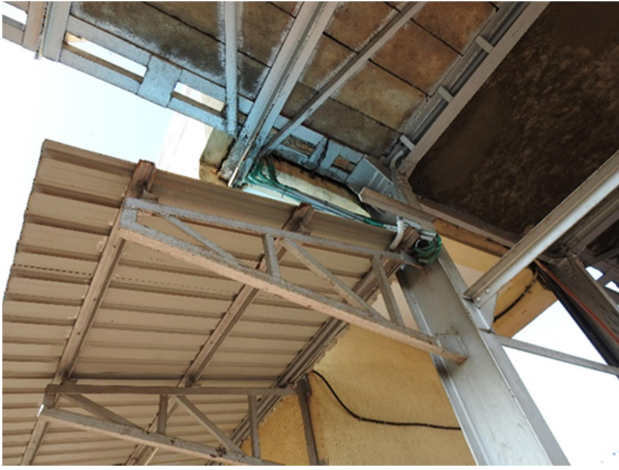
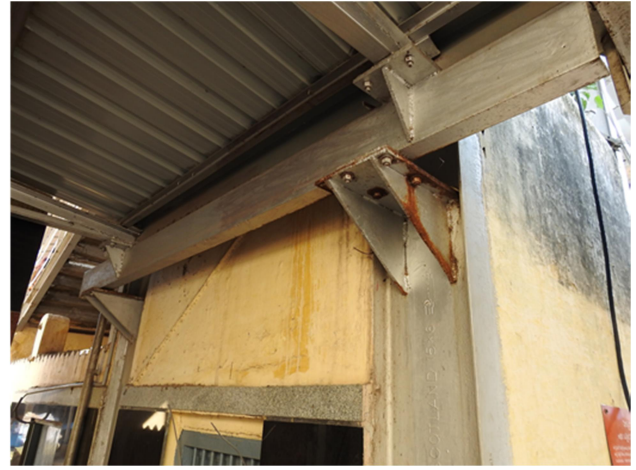
**Fig 6:** shed for lift is supported on Trestles

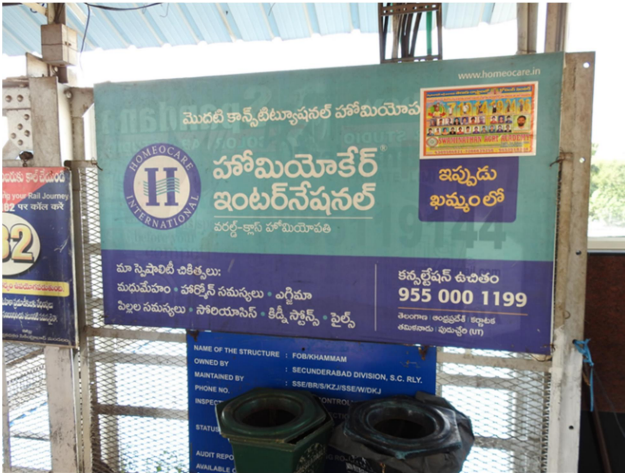
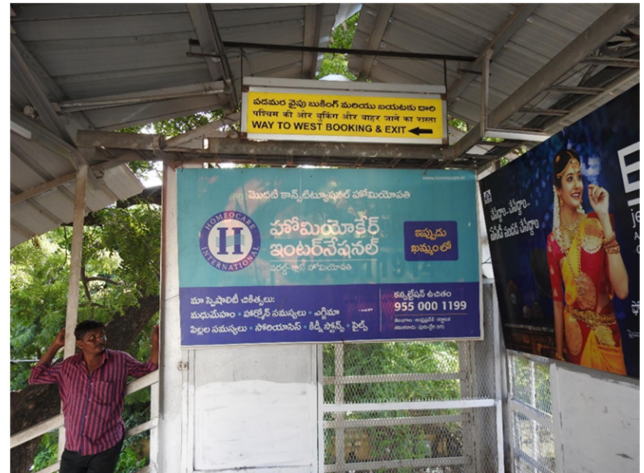
| | | Yes/No | Notes |
|---|---|---|---|
| | e) load of advertising hoarding | Yes | Advertising boards are provided (Refer <b>fig :7</b> ) |

**Fig 7:** Advertisement boards on landing

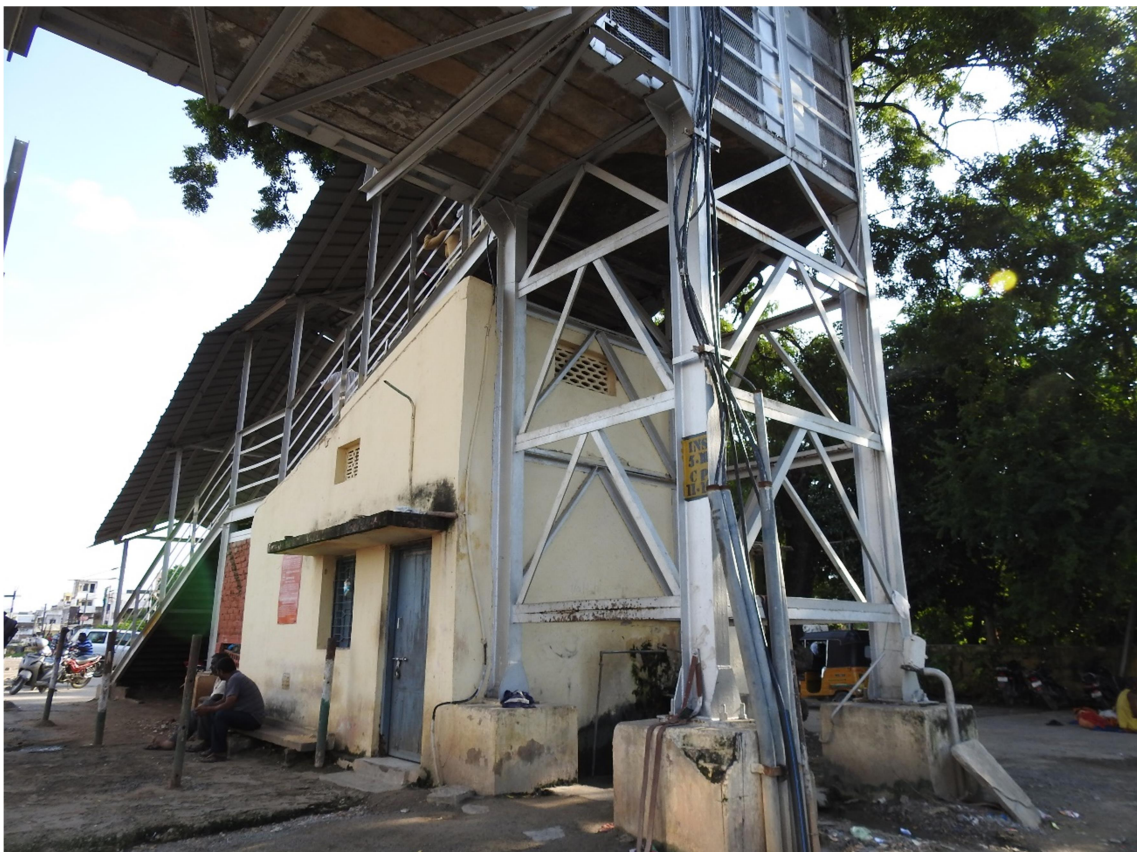
| | Dimensions<br>(L x W x D) | a : 940 x 850 x 900<br>mm | 600 x 300 base plate (Refer <b>fig :8</b> )<br><br>** 'a' dimensions of Concrete pedestal are observed in site below staircase 3. |
| | Shape of Column section | I – Section | FOB is Supported on Vertical Columns of ISMB 400 with 75 x 75 x 8 mm Angle Lacing members connected using Gusset plates and bolts. (Refer <b>fig : 8</b> ) |

| | Type of Parapet Railing | Steel Railing | Stair case is provided with Railing on both sides of one-meter height using Angle 65 x 65 x 8 mm and 50 x 10 mm Flat plate sections(Refer <b>fig :8</b> ) |

***Fig 8:*** Trestles supporting staircase

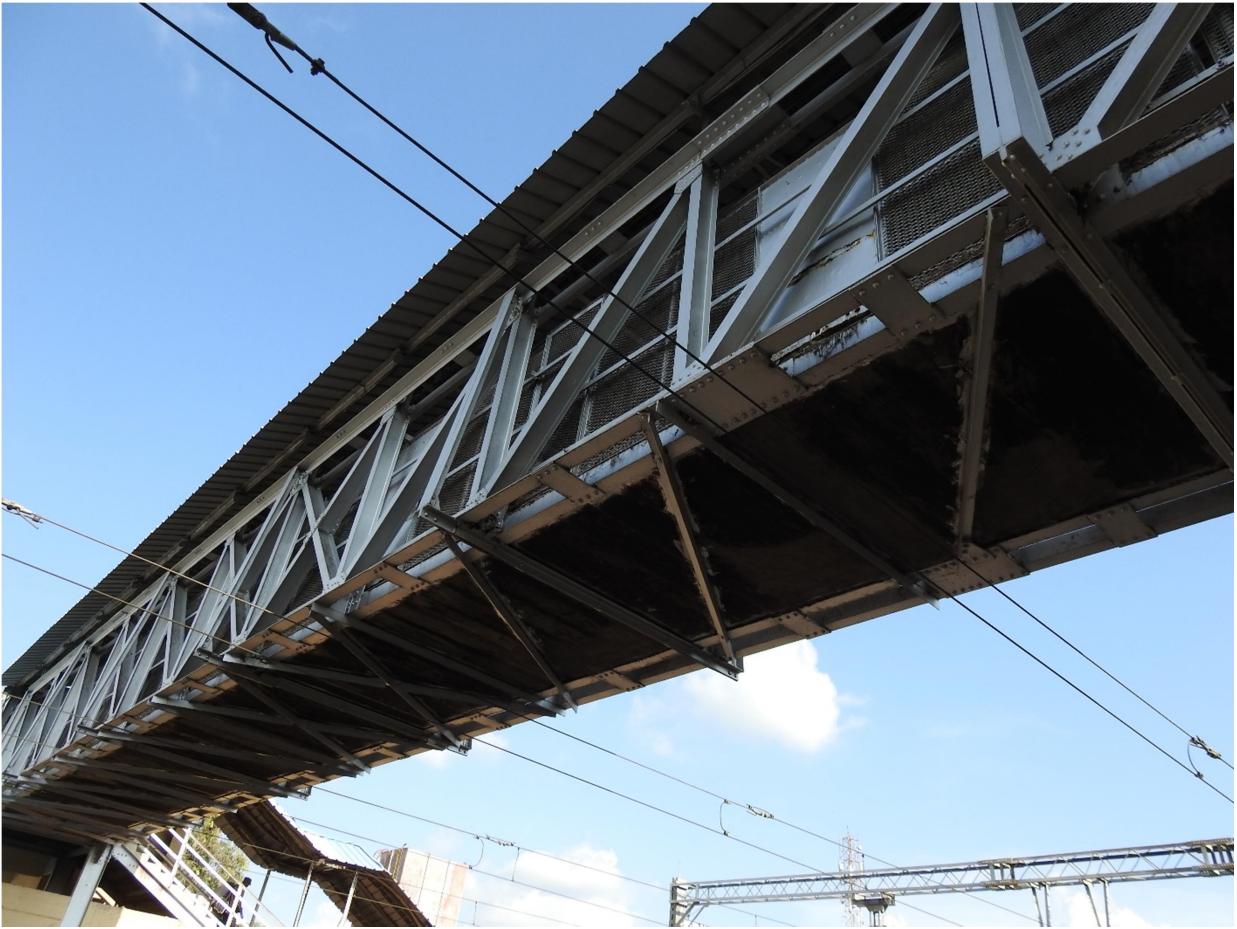
***Fig 9:*** span 1 bottom view

| | No of Floor beams/bracings | Span 1 = 11 nos<br>Span 2 = 13 nos | 2/90 x 90 x 8 mm Double Angle Sections are used as Floor beams. 65 x 65 x 8 mm angle sections are used for bottom bracings of pathway. Floor beams are connected to bottom chord Member using Bolts and Bracing are connected by welding. (Refer <b>fig : 9</b> ) |
