| <b>Name of the Project</b> | <b>:</b> | <b>VISUAL INSPECTION OF FOB AT CHIRALA RAILWAY STATION</b> |
| <b>Location</b> | <b>:</b> | <b>CHIRALA RAILWAY STATION</b> |
| <b>Date of Inspection</b> | <b>:</b> | <b>25<sup>th</sup> OCTOBER, 2019</b> |

### **VISUAL INSPECTION OF STEEL FOOT OVER BRIDGE**

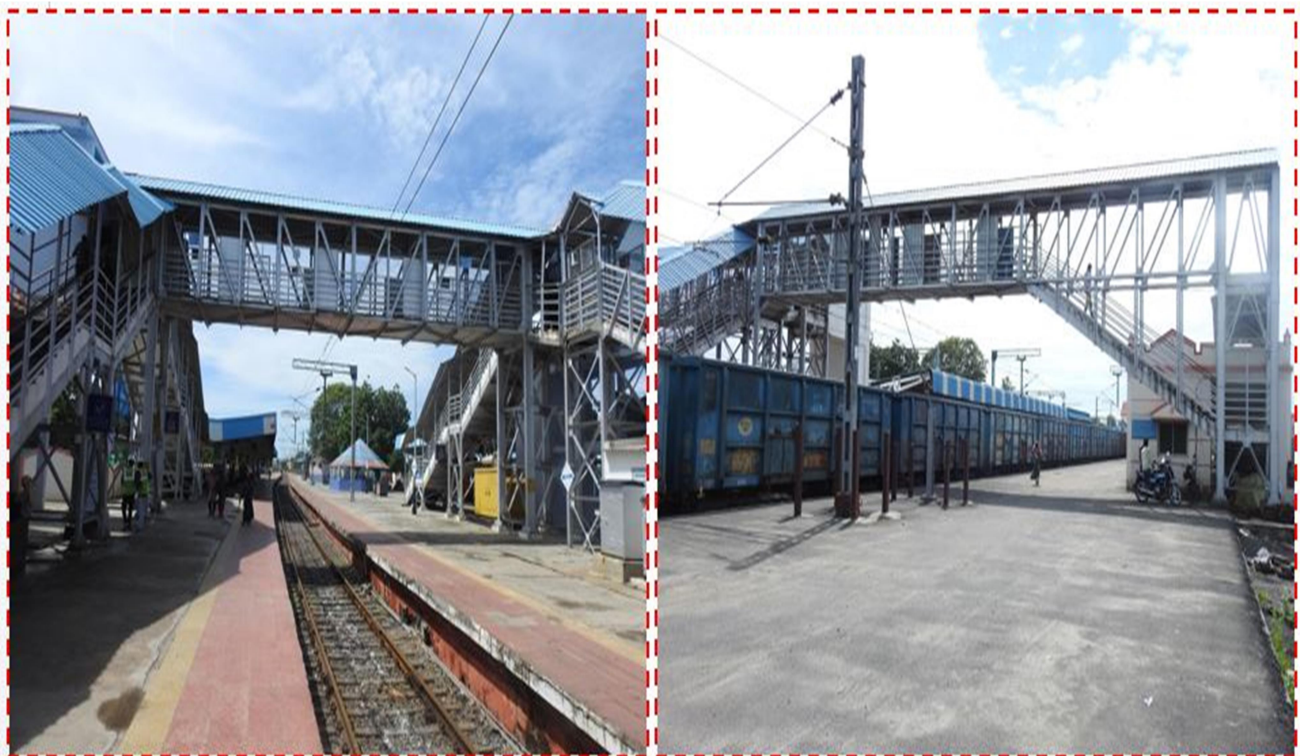
**Fig 1:** Front view of FOB span 1&3

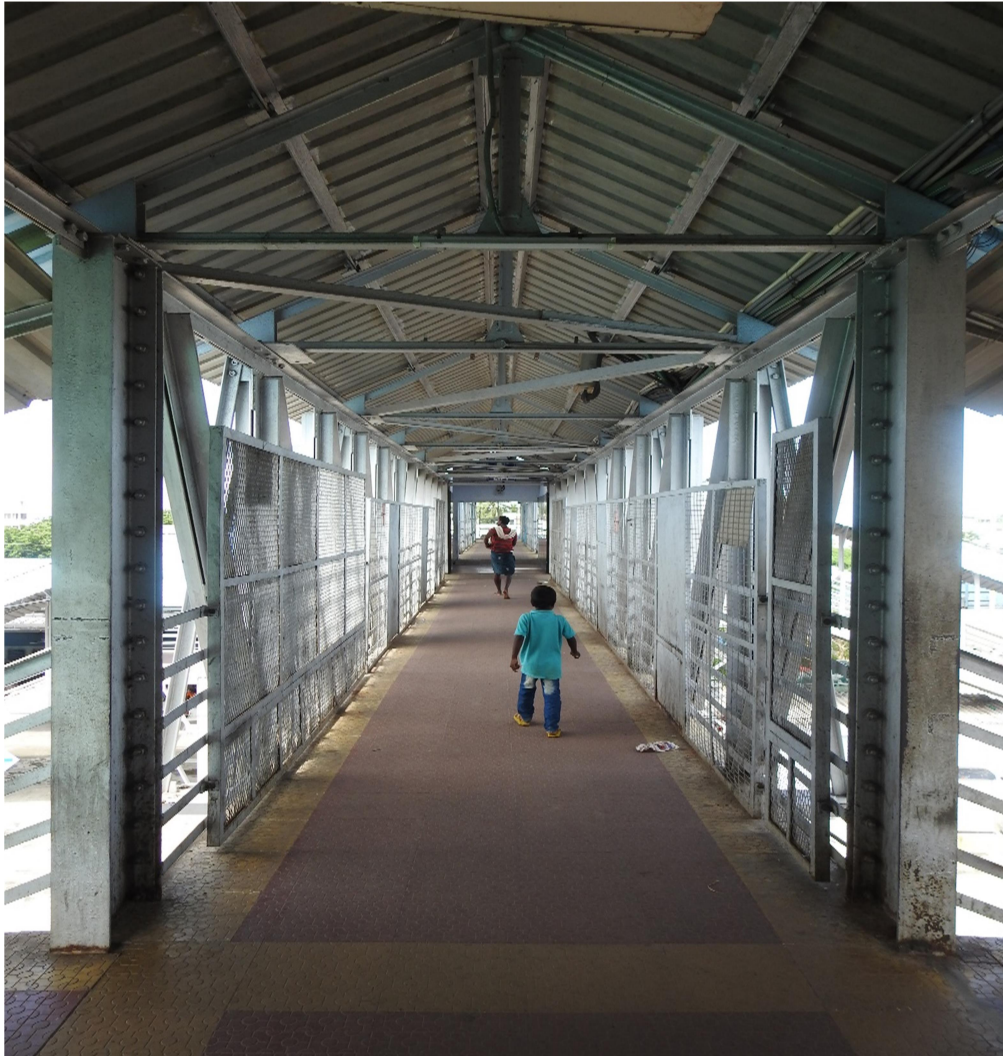
| | | Yes/No | Notes |
|---|---|---|---|
| | a) Additional wearing coat on Floor | Yes | Chequered tiles used for Flooring (Refer <b>fig :2</b> ) |
| | b) Provision of protective screen for passengers | Yes | Fence made of galvanized wire of 2 mm gauge and 2 mm galvanized sheet is used above OHE Line on both side of pathway is used for passengers Protection.<br>(Refer <b>fig :2</b> ) |

| PART 3 STRUCTURAL SYSTEM OF THE BRIDGE | | | |
|---|---|---|---|
| | Element of roof truss section | | King post of 65 x 65 x 6 mm Angle sections are used for roof truss supported on Vertical members of 100 x 100 x 10 mm Double Angle section (Refer <b>fig : 2</b> ) |

**Fig 2:** FOB pathway, protective screen

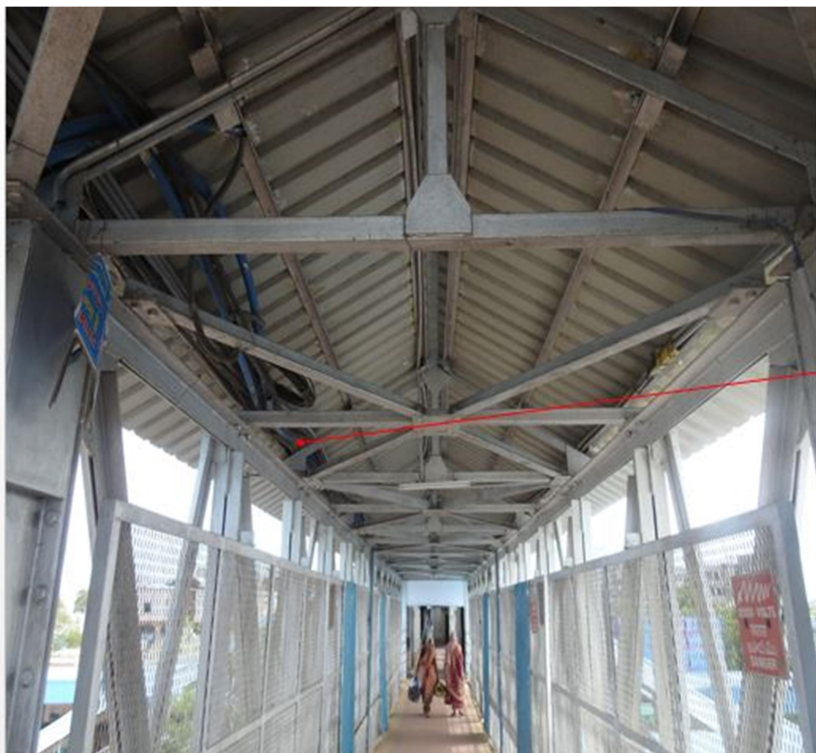
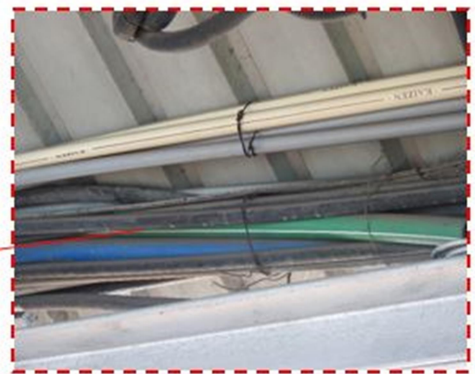
| | | Yes/No | Notes |
|---|---|---|---|
| | b) Cables | Yes | a. Cables are in 1-inch HDPE pipe of 5 Nos., 1-inch PVC pipe of 5 Nos. & 1.5-inch CPVC pipe of 2 Nos. supported on Roof Truss.<br>(Refer <b>fig :3</b> )<br>b. King post of 65 x 65 x 8 mm Angles are used as Roof truss (Refer <b>fig :2</b> )<br>c. Metal Sheet is used for Roof (Refer <b>fig :2</b> ) |

**Fig 3:** Additional loads of PVC pipes

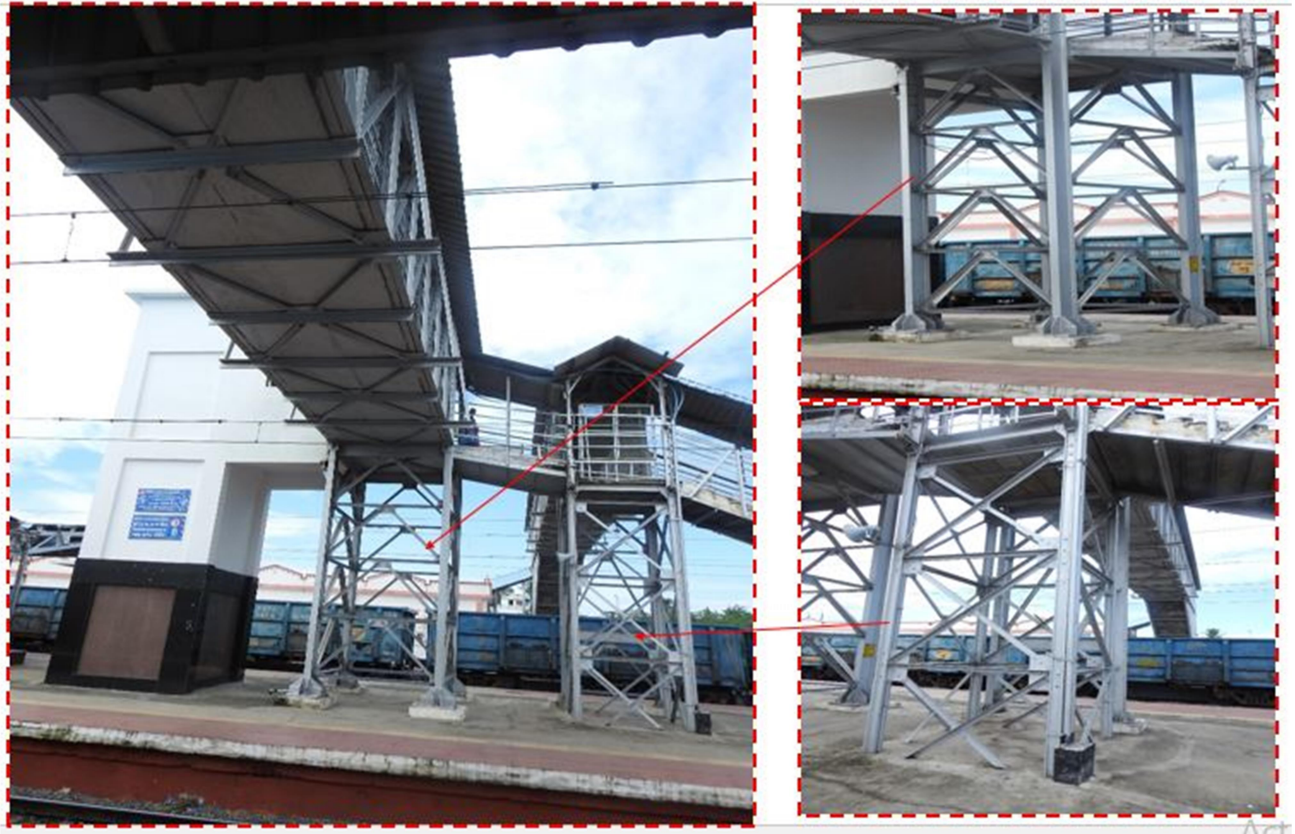
| PART 3 STRUCTURAL SYSTEM OF THE BRIDGE | | | |
|---|---|---|---|
| | Type/Shape of Column section | ISMB-300 & ISMB-350 | a. Spans 1 is supported on trestles whereas Span-2 & 3 is supported on trestles and Stanchion.<br>b. Trestles Columns are ISMB-350 sections. (Refer <b>fig : 4</b> )<br>c. Stanchion-column are ISMB-350 & ISMB-300 Sections (Refer <b>fig : 4</b> ) |

**Fig 4:** Stanchion column sections details

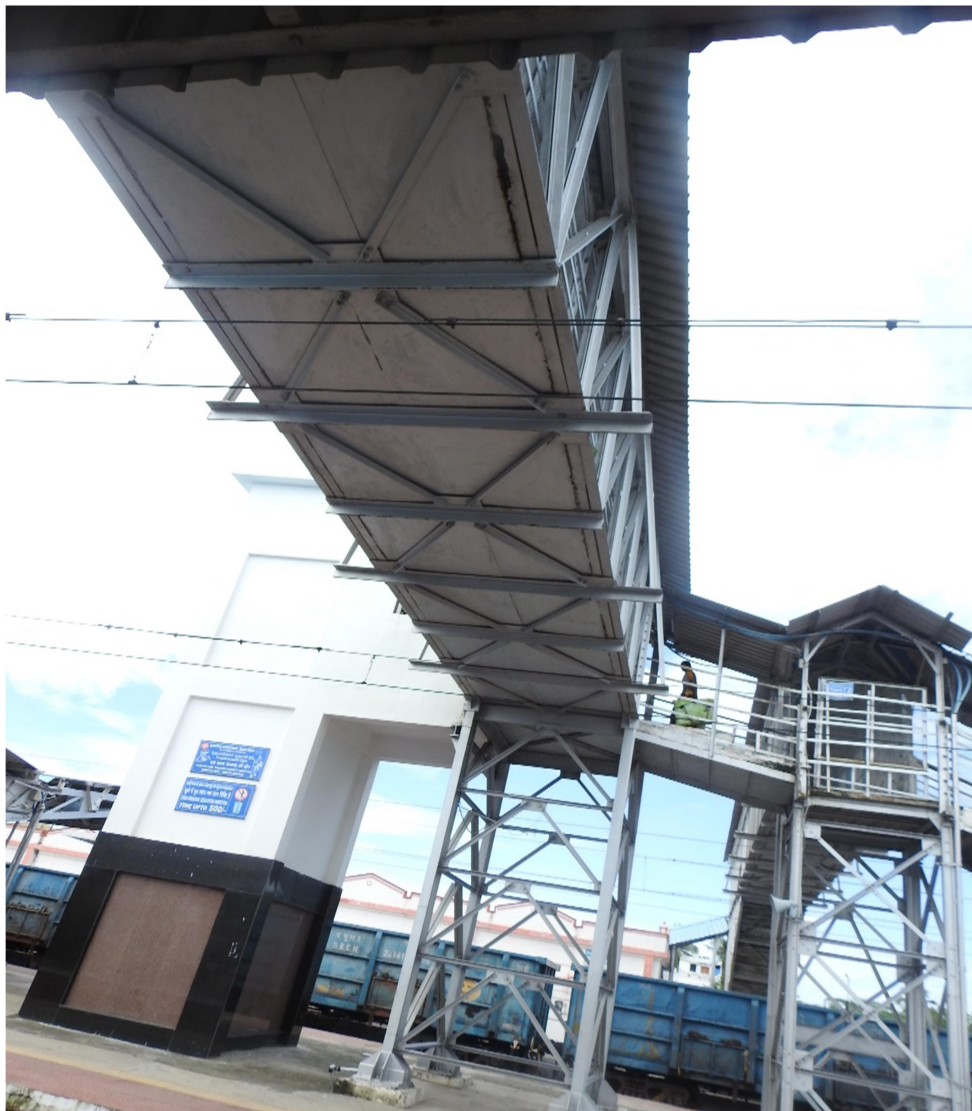
| PART 3 STRUCTURAL SYSTEM OF THE BRIDGE | | | |
|---|---|---|---|
| | Type /Shape of Truss Section | Rail & Double Angle section | <b>Span 1 &amp; 2</b><br>a) Top & Bottom Chord members are 100 x 100 x 10 mm Double Angle Sections. (Refer <b>fig : 5</b> )<br>b) 100 x 100 x 10 mm Double Angle sections are used as vertical and diagonal members.<br>c) 130 x 130 x 10 mm Double Angle sections and 100 x 100 x 10 mm Double Angle sections are used as Floor beams.<br>d) Bottom Lateral Bracings 100 x 100 x 10 mm Angle sections in Zigzag and cross pattern are used<br><br><b>Span 3</b><br>e) Top and bottom Chord members are 130 x 130 x 10 mm Double Angle sections (Refer <b>fig : 5</b> )<br>f) 70 x 70 x 10 mm double Angle sections are used as vertical and diagonal members.<br>g) 130 x 130 x 10 mm double Angle sections are used as Floor beams.<br>h) Bottom Lateral Bracings 65 x 65 x 6 mm Angle sections in Zigzag pattern are used |

**Fig 5:** Bottom view of FOB

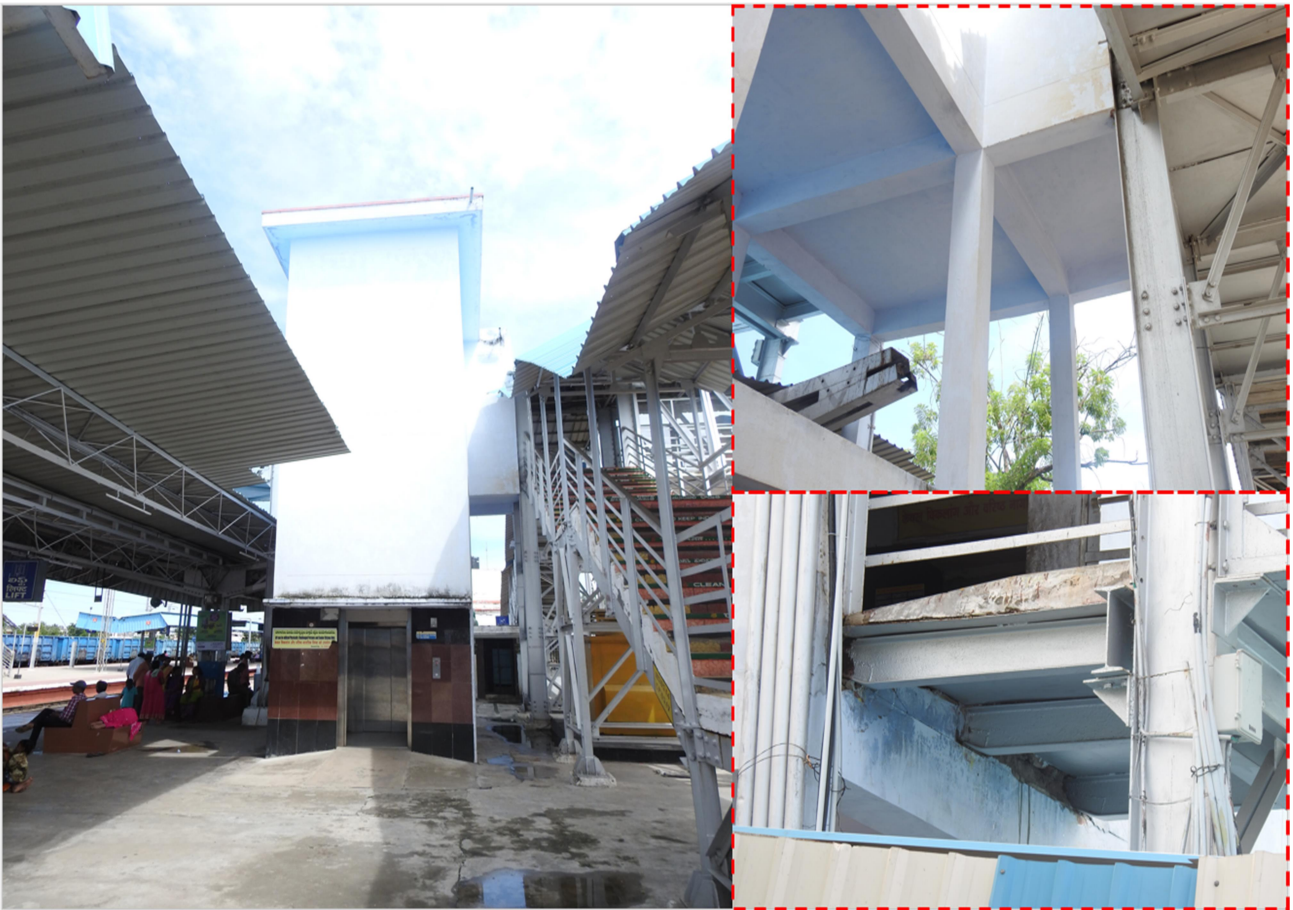
**Fig 7:** Lift connected to Trestle at Plat form 2

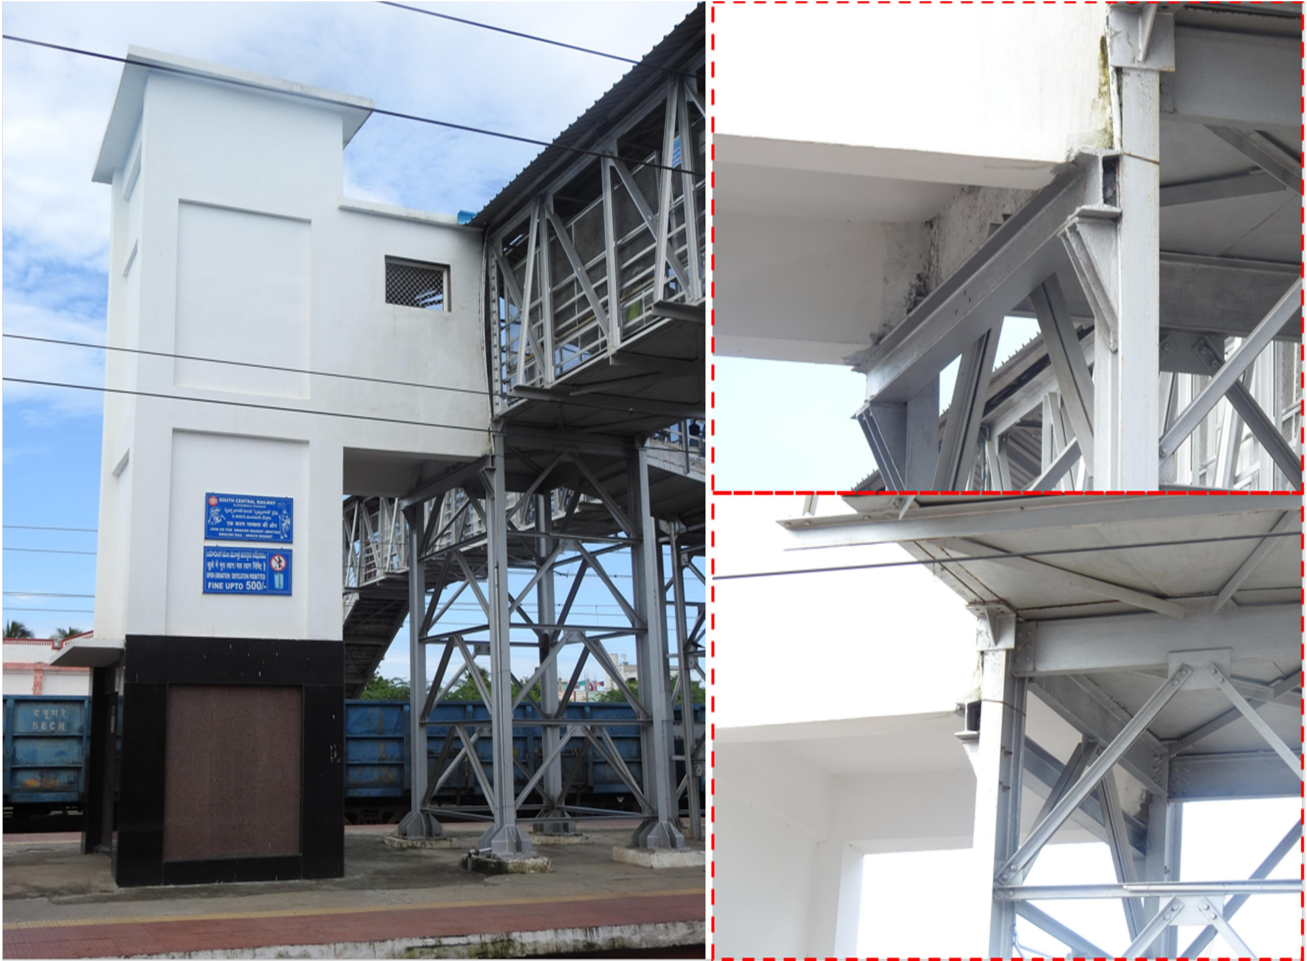
***Fig 8:*** Lift connected to Trestle at Plat form 4
