| <b>Name of the Project</b> | <b>:</b> | <b>VISUAL INSPECTION OF FOB/ PF-1 - PF-2 AT ELURU RAILWAY STATION</b> |
| <b>Location</b> | <b>:</b> | <b>ELURU RAILWAY STATION</b> |
| <b>Date of Inspection</b> | <b>:</b> | <b>19<sup>th</sup> OCTOBER, 2019</b> |

### **VISUAL INSPECTION OF STEEL FOOT OVER BRIDGE**

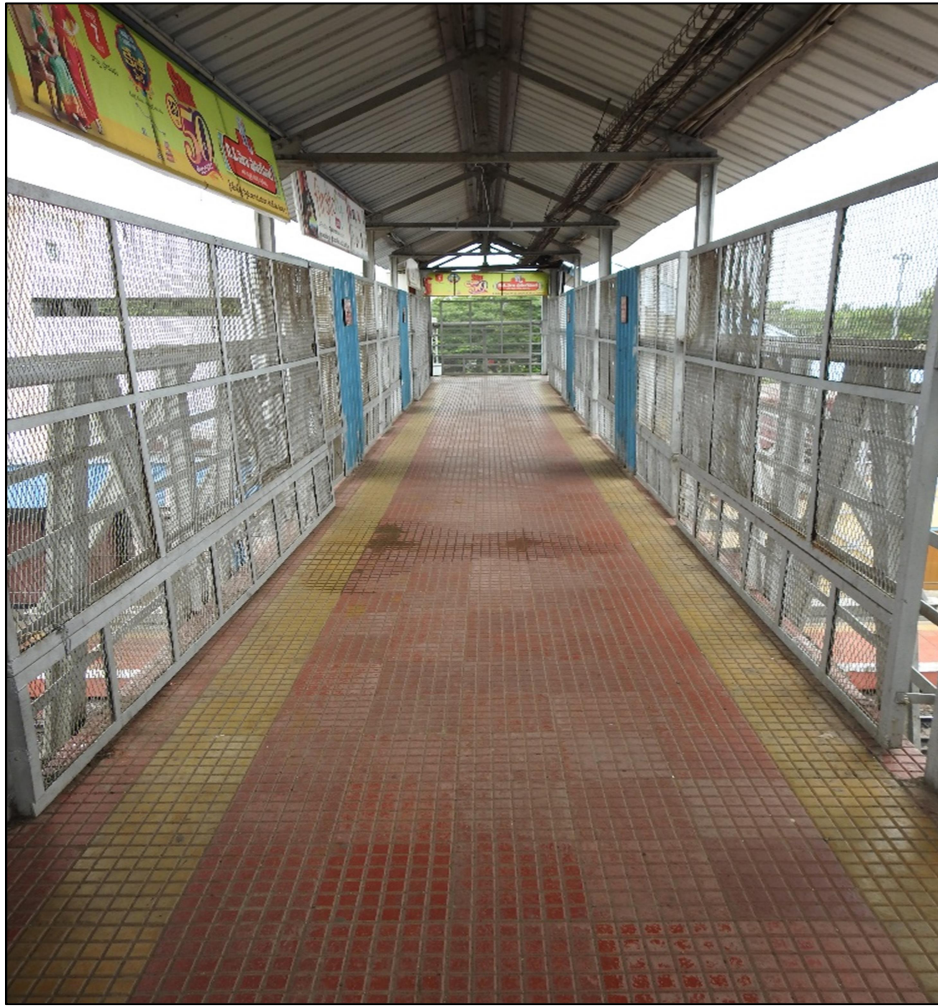
**Fig 2:** FOB span 1 & 2 pathway, Roof Truss, Chequered tiles, protective screen and Hoardings

| | | Yes/No | Notes |
|---|---|---|---|
| | a) Additional wearing coat on Floor | Yes | Chequered tiles used for Flooring (Refer <b>fig :2</b> ) |
| | b) Provision of protective screen for passengers | Yes | Fence made of galvanized wire of 2 mm gauge and 2 mm galvanized sheet is used above OHE Line on both side of pathway is used for passengers Protection.(Refer <b>fig :2</b> ) |

| | Element of roof truss section | Angle section | King post of 65 x 65 x 10 mm Angle sections are used for roof truss supported on Vertical members of 65 x 110 x 110 mm top chord Rail section (Refer <b>fig : 2</b> ) |

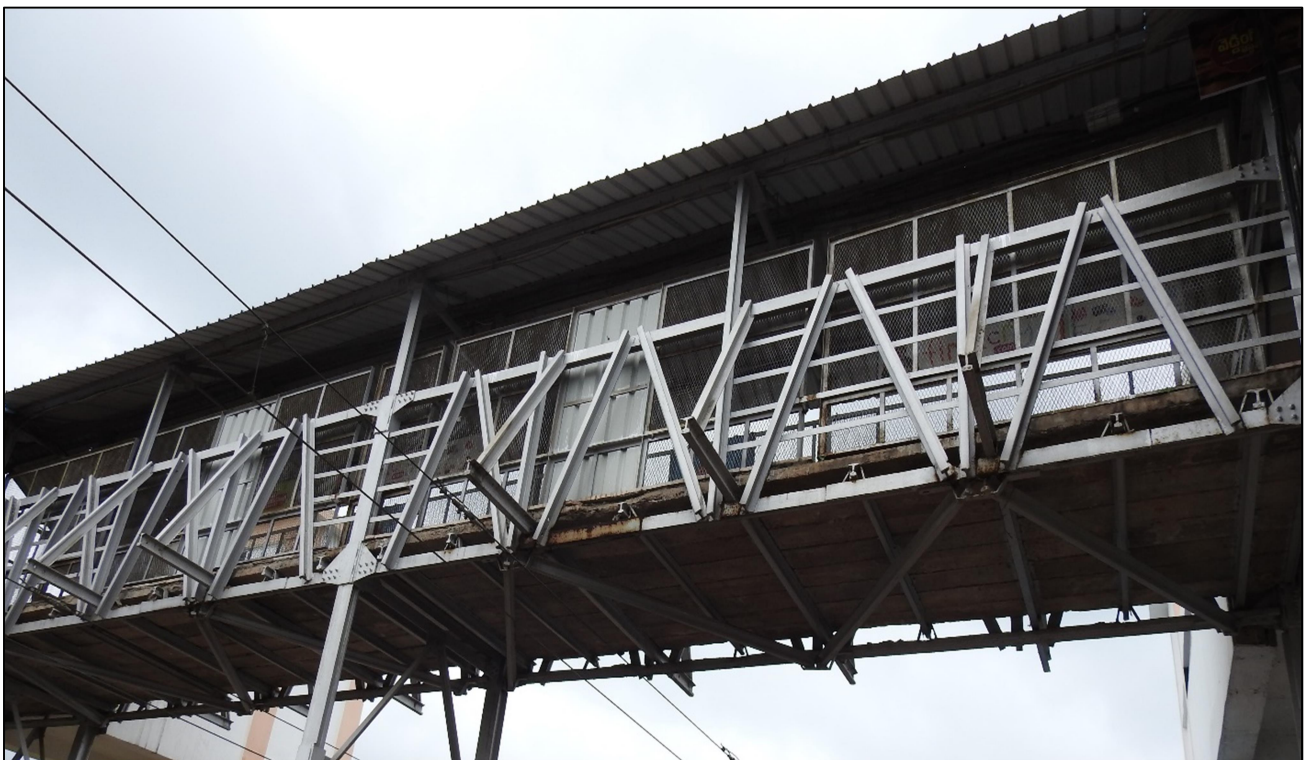
**Fig 7:** Bottom view of FOB

| | Type /Shape of Truss Section | Warren Truss (with NG Rails) | a) Top and bottom Chord members are 60 x 110 x 110 (Head x Web x Foot) Flat-bottom Rail section (Refer <b>fig : 7</b> )<br>b) 60 x 110 x 110 mm Rail section are used as vertical and diagonal bracing members.<br>c) 60 x 110 x 110 mm Rail sections are used as Floor beams supported with Knee bracings 60 x 110 x 110 mm rail section.<br>d) Bottom Lateral Bracings 60 x 110 x 110 Rail sections connected to bottom chord member using MS flat. |
