| <b>Name of the Project</b> | <b>:</b> VISUAL INSPECTION OF FOB/ PF-1 - PF-4 AT KRISHNA CANAL RAILWAY STATION |
| <b>Location</b> | <b>:</b> KRISHNA CANAL RAILWAY STATION |
| <b>Date of Inspection</b> | <b>:</b> 21 <sup>st</sup> OCTOBER, 2019 |

### **VISUAL INSPECTION OF STEEL FOOT OVER BRIDGE**

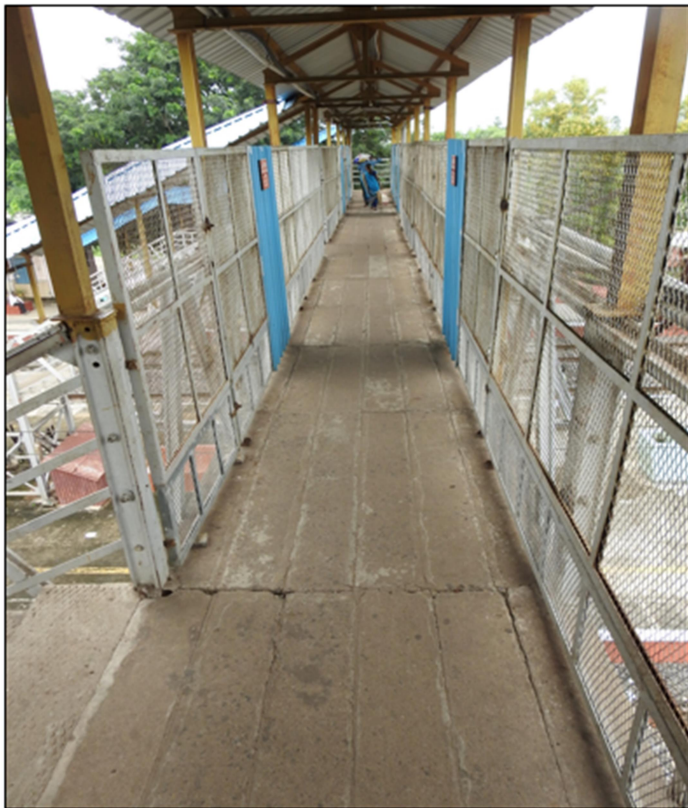
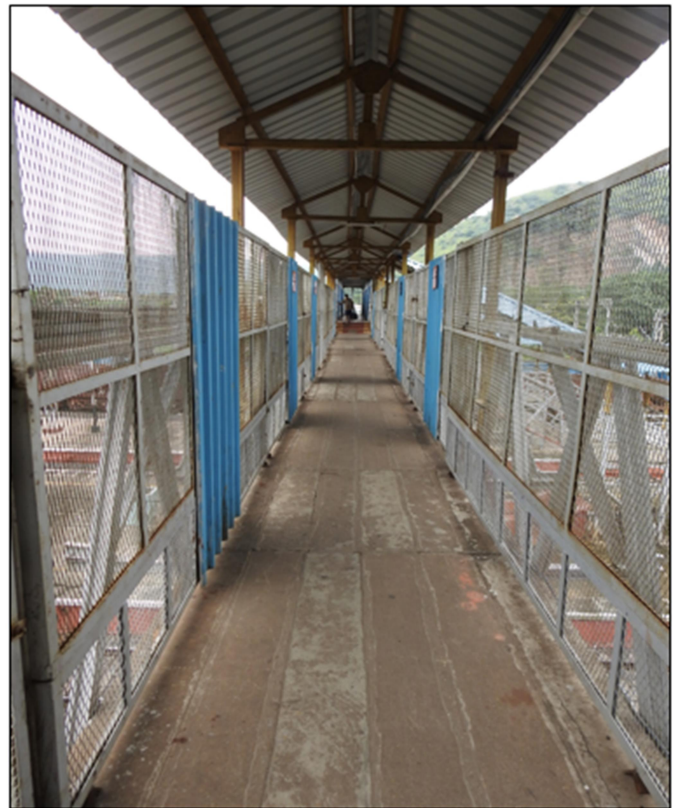
**Fig 2:** FOB span 1, 2 & 3 pathway & protective screen

| | | Yes/No | Notes |
|---|---|---|---|
| | b) Provision of protective screen for passengers | Yes | Fence made of galvanized wire of 2 mm gauge and 2 mm galvanized sheet is used above OHE Line on both side of pathway is used for passengers Protection. (Refer <b>fig :2</b> ) |

Span -1 & 2 Pathway

Span-3 Pathway

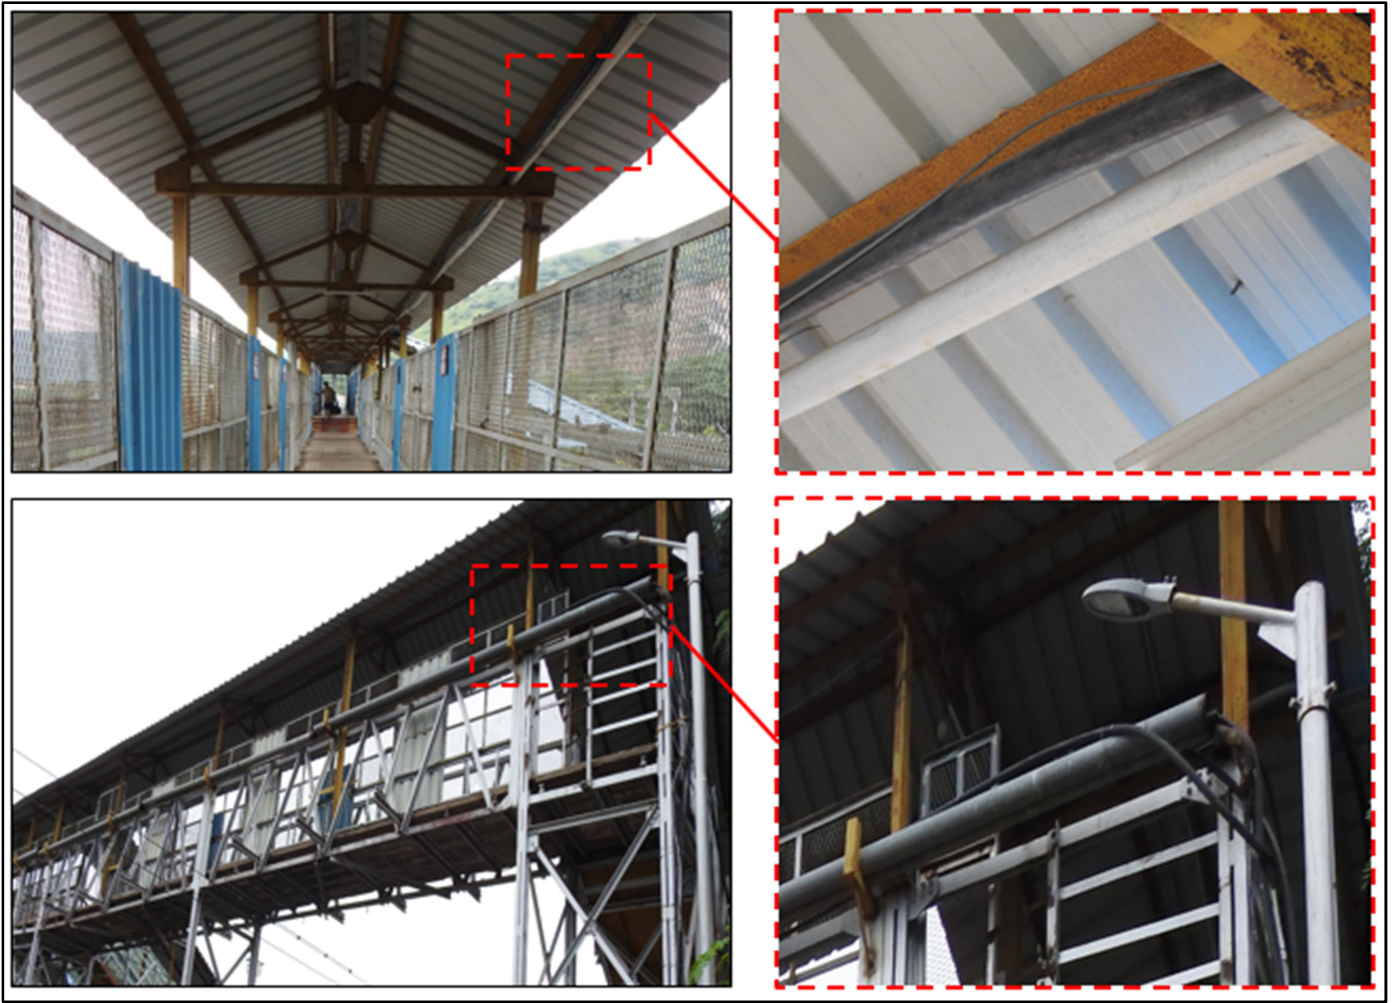
**Fig 3:** Additional loads of GI, HDPE, PVC pipes

| | | Yes/No | Notes |
|---|---|---|---|
| | b) Cables | Yes | a. Cables in 1-inch HDPE pipe of 2 No's, 1.5-inch HDPE pipe of 2 No's, 0.7-inch HDPE pipe of 2 No's, 2-inch PVC pipe of 1 No's, 2.5-inch GI pipe of 1 No's and 4 inch GI pipe of 1 No's supported on Roof Truss. (Refer <b>fig :2</b> )<br>b. 2 inch GI Pipe supported on Truss<br>c. King post of 65 x 65 x 12 mm Angles are used as Roof truss (Refer <b>fig :2</b> )<br>d. Steel Metal Sheet is used for Roof (Refer <b>fig : 2</b> ) |

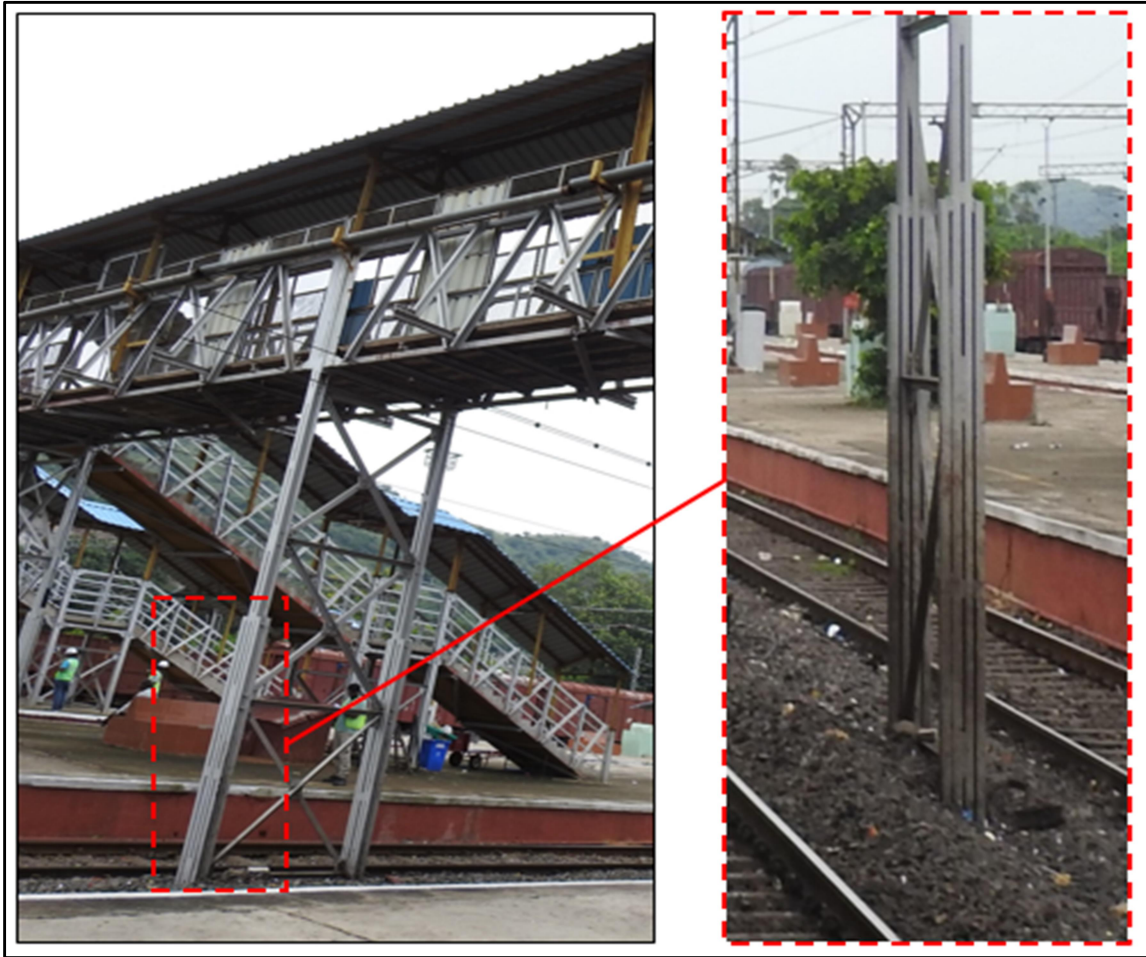
**Fig 4:** Stanchion column Rail sections details

| PART 3 STRUCTURAL SYSTEM OF THE BRIDGE | | | |
|---|---|---|---|
| | Type/Shape of Column section | Bull headed Rail Section | a. FOB is supported on vertical column of 2 Rail section 65 x 130 x 65, with bracings of 65 x 65 x 10 mm angle section.<br>b. Trestles 1, 3 and 4 have 4 columns whereas Trestles 2 (Stanchion) have only 2 columns.<br>c. Trestle 2 (Stanchion column) and Trestle 3 has built up section of 4 rail sections 65 x 130 x 65mm up to a height of 2.94 and 2.25 m respectively and continued with 2 rails (Refer <b>fig : 4, 5</b> ).<br>d. Staircase landing is supported by 2 Rail section of 65 x 130 x 65mm. |

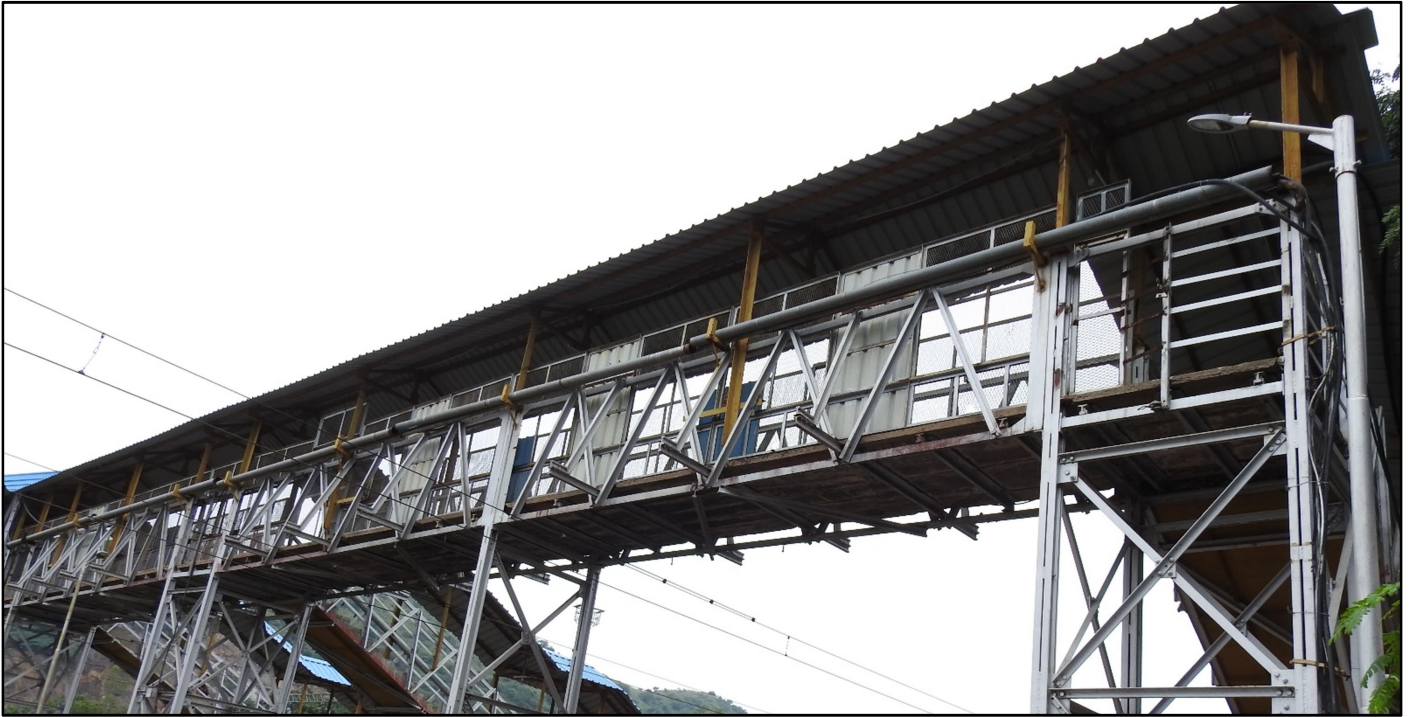
**Fig 6:** Bottom view of FOB

| PART 3 STRUCTURAL SYSTEM OF THE BRIDGE | | | |
|---|---|---|---|
| | Type /Shape of Truss Section | Warren Truss (NG Rail section) | a) Top and bottom Chord members are 45 x 100 x 100 (Head x Height x Base) Rail section(Refer <b>fig : 6</b> )<br>b) 50 x80 x 80 mm Rail section are used as diagonal bracing members.<br>c) 50 x80 x 80 mm Rail sections are used as Floor beams supported with Knee bracings 50 x 80x 80 mm rail section.<br>d) Bottom Lateral Bracings 50 x 80 x 80 Rail section in Zig-zag pattern are used. |

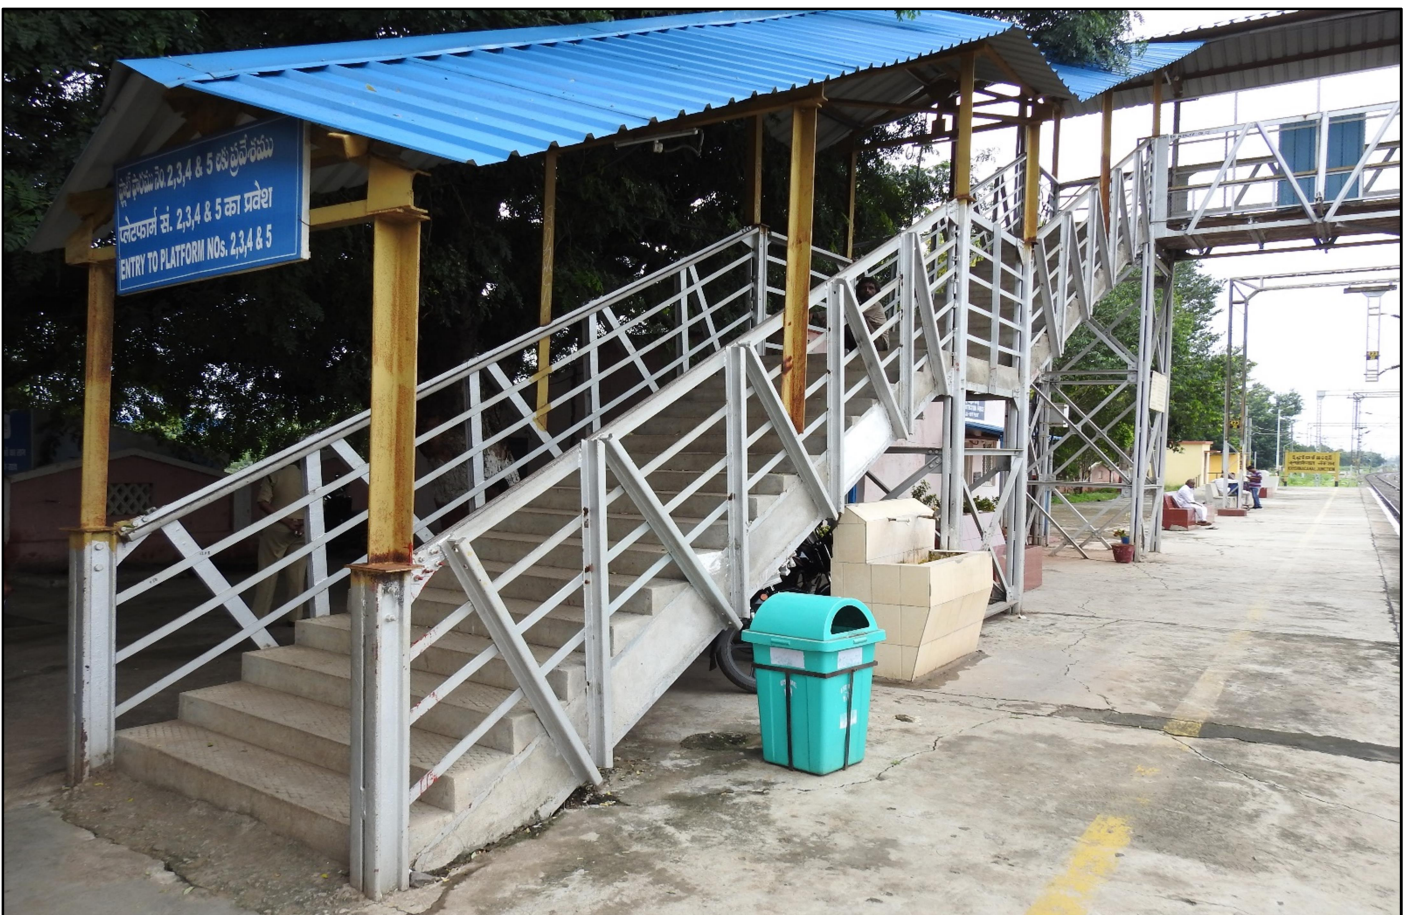
**Fig 7:** Staircase side view of FOB

| | Number of Staircase | 3 No's | Staircase is observed as In-situ RCC Slab supported on 50 x 90 x 90mm Rail Stringer beam. (Refer <b>fig : 7</b> ) |
