| <b>Name of the Project</b> | <b>: VISUAL INSPECTION OF FOB/ PF-1 – PF-2 AT TSUNDURU RAILWAY STATION+</b> |
| <b>Location</b> | <b>: TSUNDURU RAILWAY STATION</b> |
| <b>Date of Inspection</b> | <b>: 24<sup>th</sup> October 2019</b> |

## VISUAL INSPECTION OF STEEL FOOT OVER BRIDGE

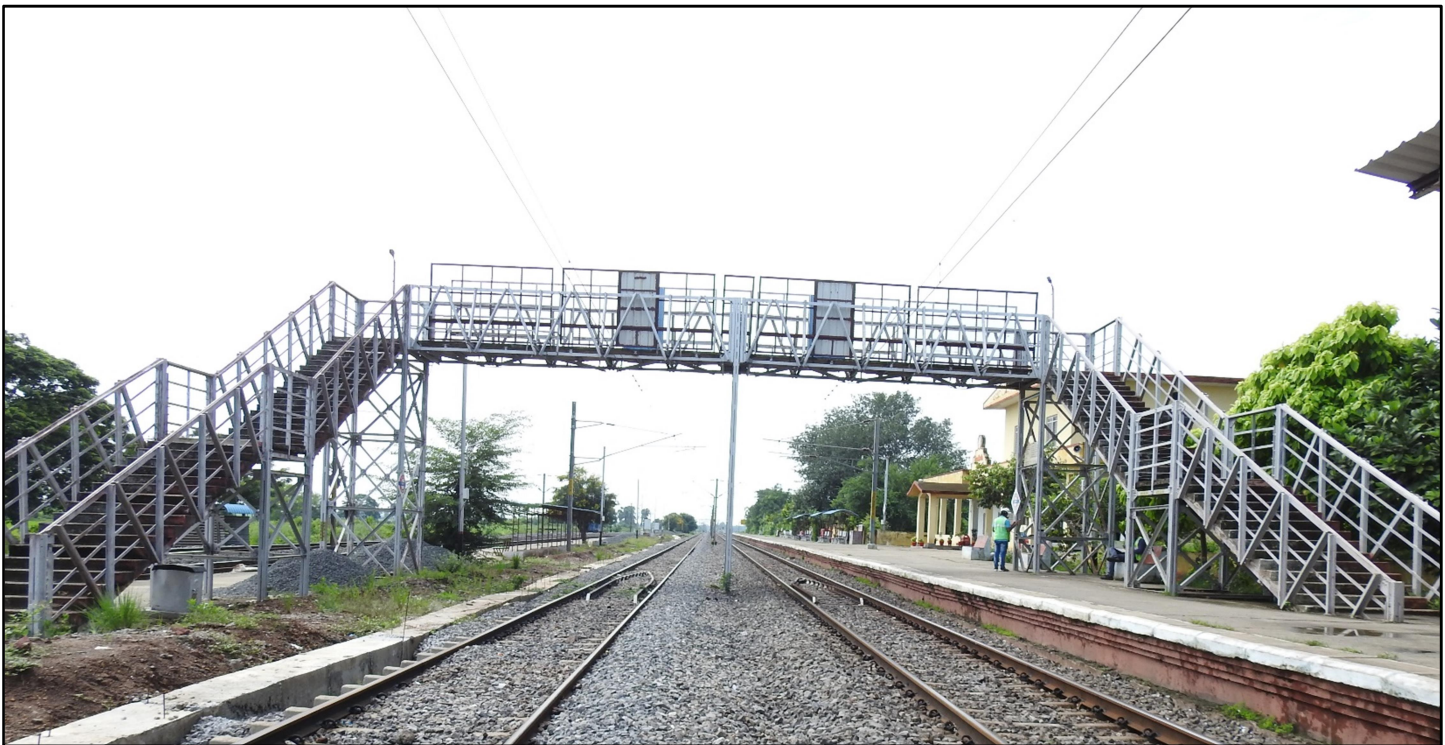
***Fig 2:*** FOB Front view

| PART 3 STRUCTURAL SYSTEM OF THE BRIDGE | | | |
|---|---|---|---|
| | Type/Shape of Girder Section | Warren truss fabricated with NG Rail | a) Top and bottom Chord members are 50 x 80 x 80 (Head x Height x Base) NG Rail section. (Refer <b>fig :2</b> ) |

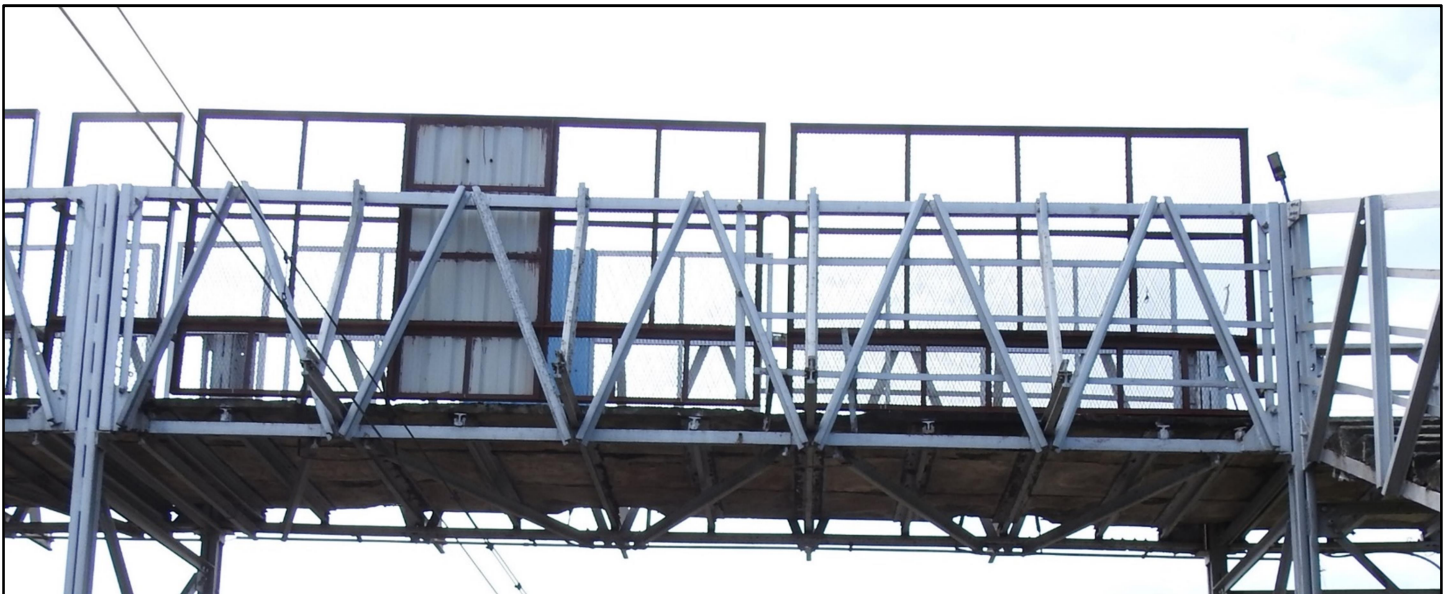
**Fig 5:** Span 1 Side view and Bottom View

a) Corrosion of Floor beams is observed in 1<sup>st</sup> span

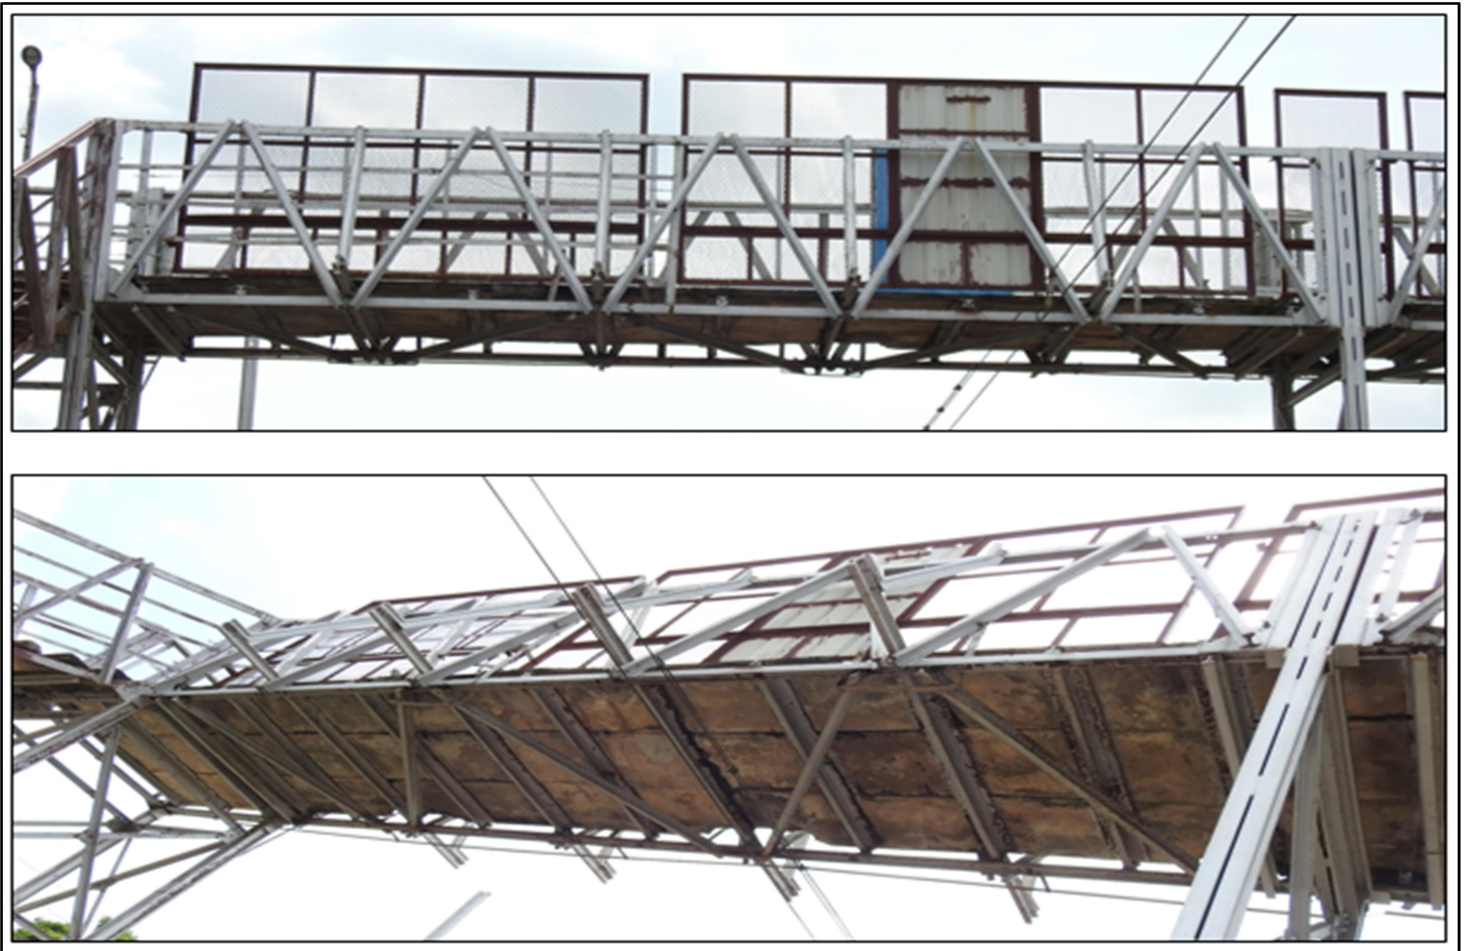
**Fig 6:** Span 2 Side view and Bottom View

b) Corrosion of Floor beams is observed in 2<sup>nd</sup> span

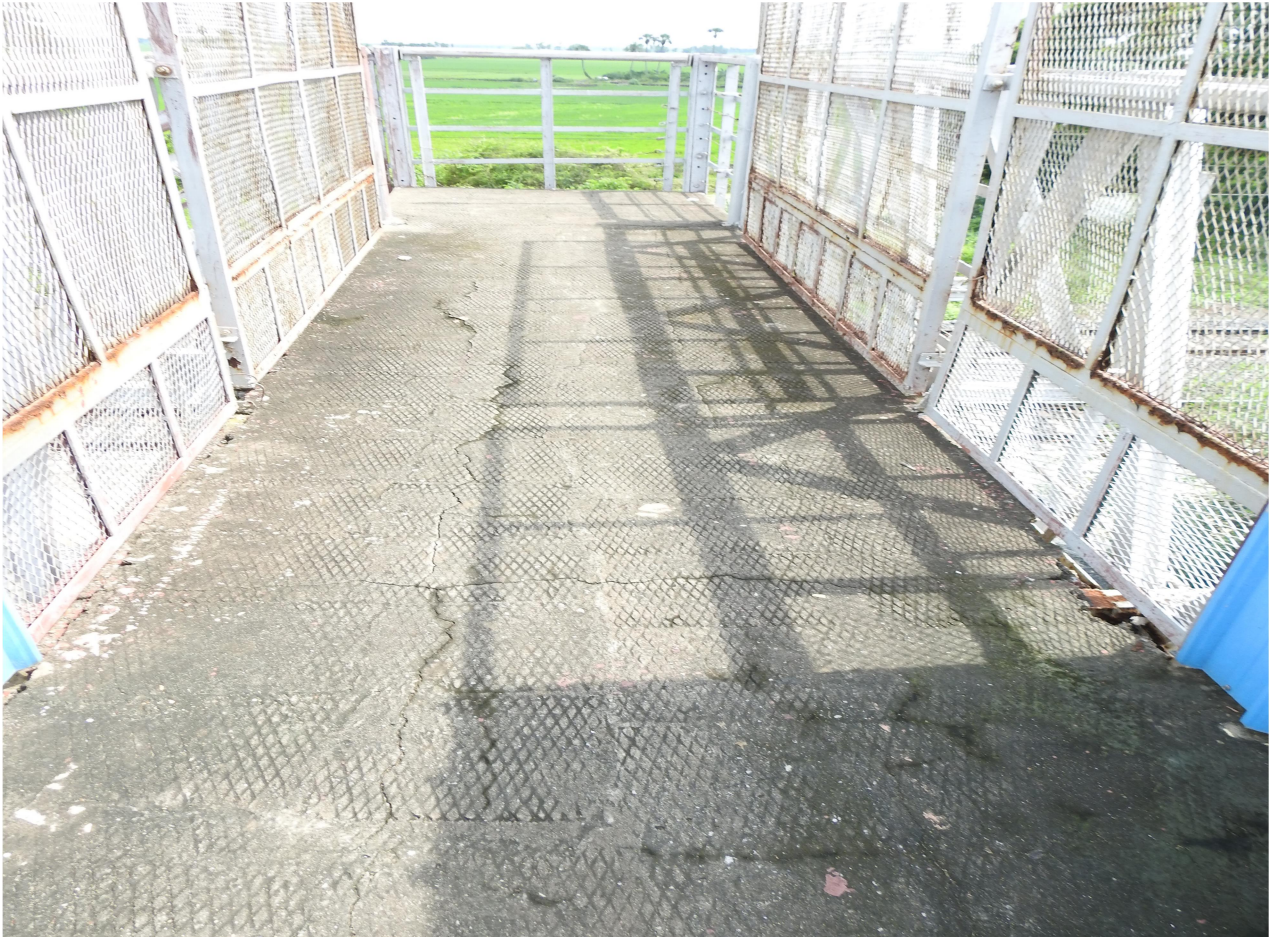
***Fig 8:*** path way, Protective screen

| | | Yes/No | Photo ID |
|---|---|---|---|
| | a) Additional wearing coat on Floor | Yes | Cement concrete layer is used for flooring (Refer <b>fig :8</b> ). GI Pipe of 25 mm dia. connected to bottom chord. |
| | b) Provision of protective screen for passengers | Yes | Chain link fence made of galvanized wire of 2 mm gauge and 2mm galvanized sheet is used above OHE line on both side of gangway is used for protection (Refer <b>fig :8</b> ) |

| | Condition of Slab from Top | RCC slab is not visible, Covered with CC flooring | b. Cement concrete flooring is laid on the top of the slab panels (Refer <b>fig : 8</b> ) |

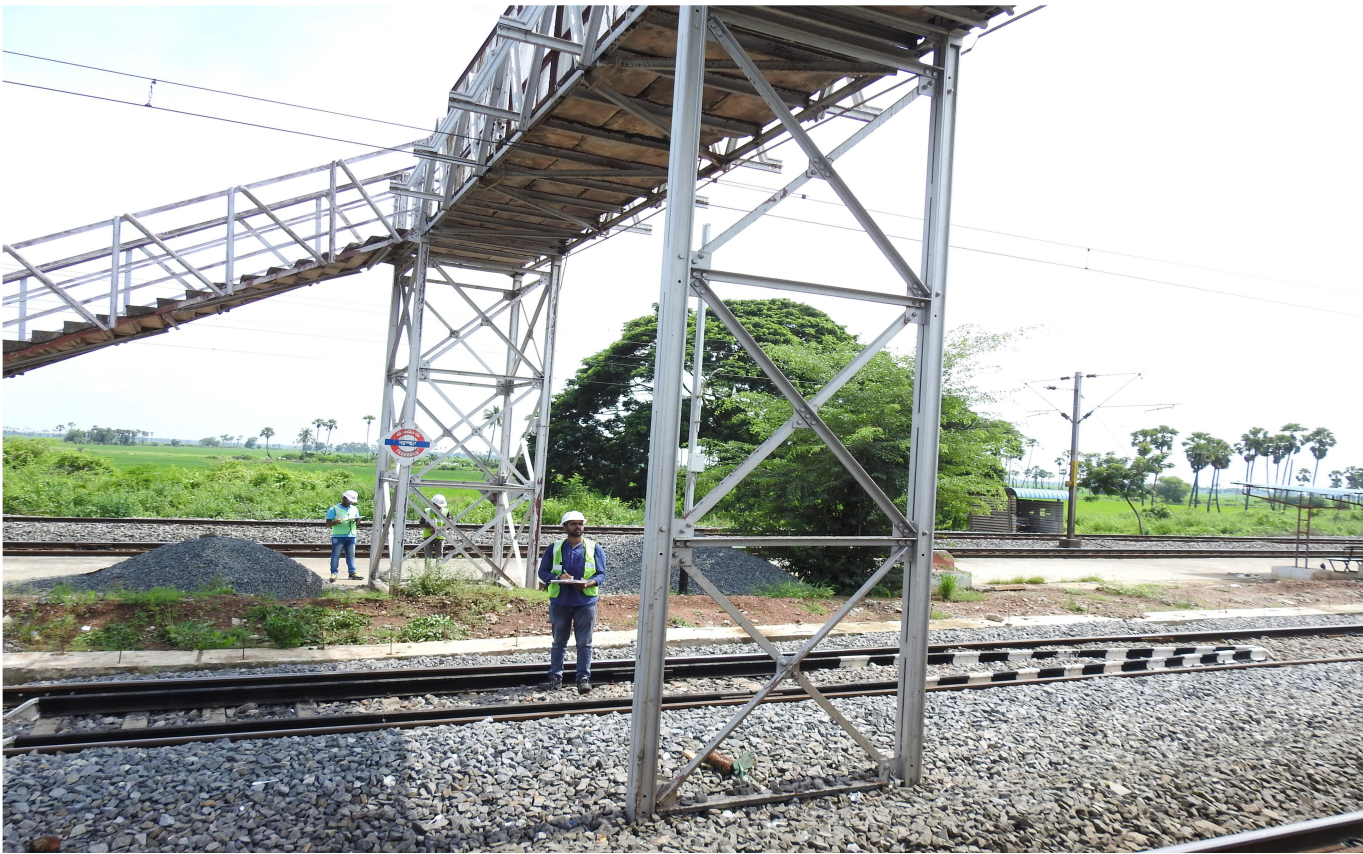
**Fig 9: Trestle and Stanchion**

| PART 3 STRUCTURAL SYSTEM OF THE BRIDGE | | | |
|---|---|---|---|
| | Type/Shape of Column section | Built up Rail Section with Bull headed rail | a. FOB is supported on vertical column of 2 Rail section 65 x 135 x 65, with bracings of 65 x 65 x 10 mm angle section (Refer <b>fig :9</b> ) |
| | No of Columns per support | 4, 2 | b. Trestles 1 and 3 have 4 columns where as Trestles 2 (Stanchion) have only 2 columns. (Refer <b>fig :9</b> )<br>c. Staircase landing is 2 Rail section 65 x 135 x 65, with bracings of 65 x 65 x 10 mm angle section (Refer <b>fig :10</b> ) |

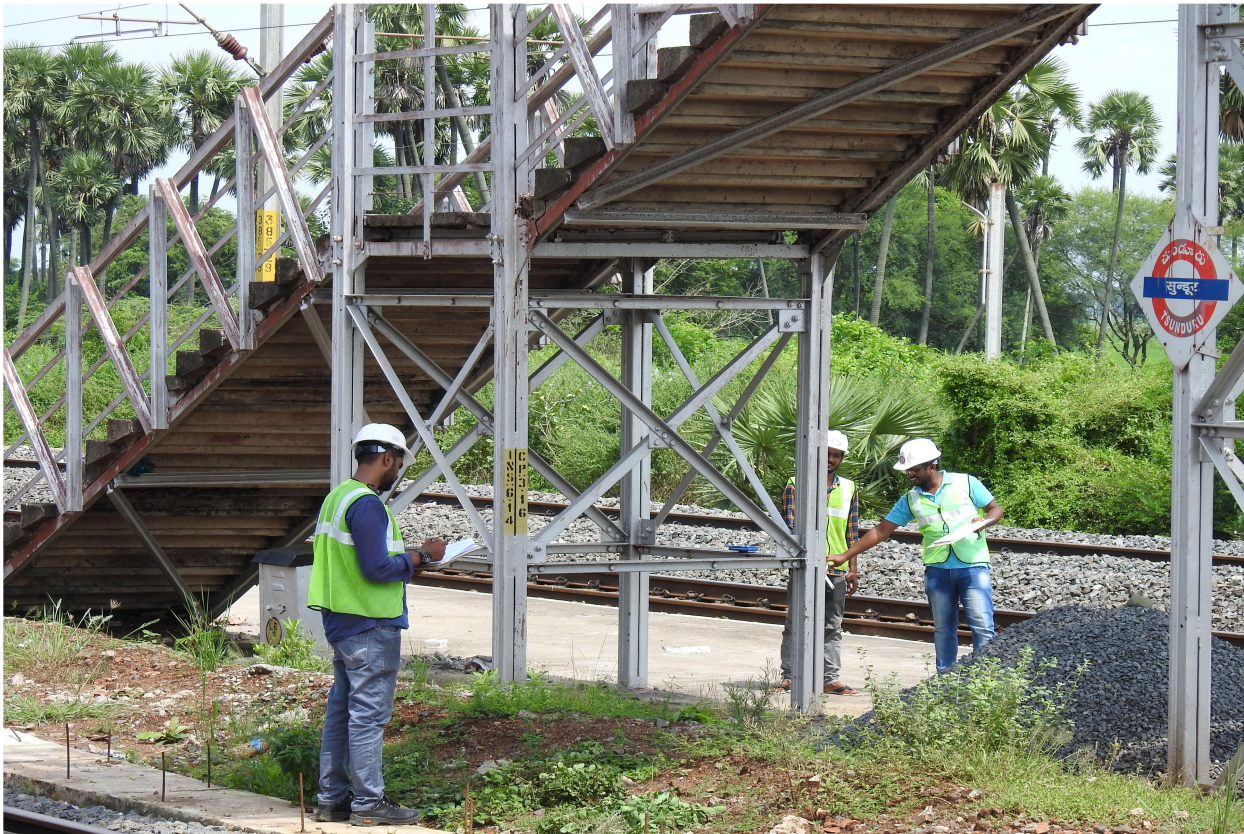
**Fig 9: Staircase Mid-landing**

e) Severe Spalling, Reinforcement visible in staircase 2 (Mid landing)
