| <b>Name of the Project</b> | <b>:</b> | <b>VISUAL INSPECTION OF FOB AT MUSTABADA RAILWAY STATION</b> |
| <b>Location</b> | <b>:</b> | <b>MUSTABADA RAILWAY STATION</b> |
| <b>Date of Inspection</b> | <b>:</b> | <b>20<sup>th</sup> OCTOBER, 2019</b> |

### **VISUAL INSPECTION OF STEEL FOOT OVER BRIDGE**

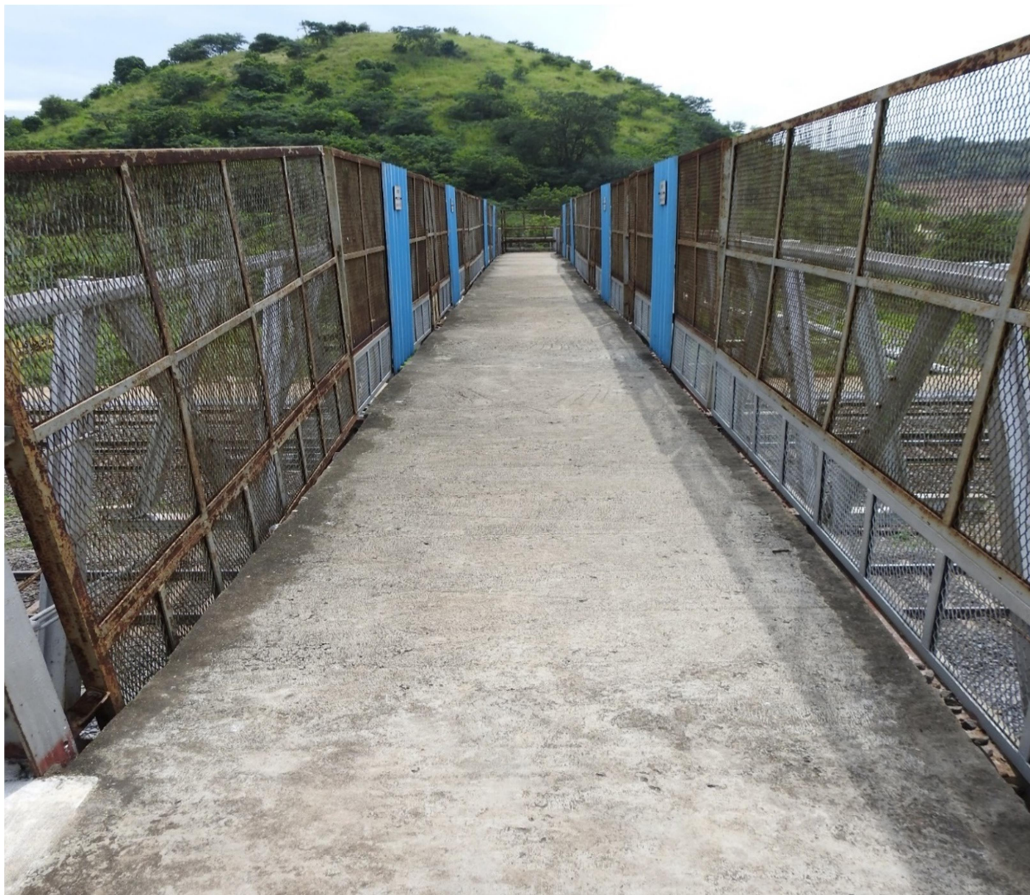
***Fig 2:*** Pathway, Protective screen

| | | Yes/No | Notes |
|---|---|---|---|
| | b) Provision of protective screen for passengers | Yes | Fence made of galvanized wire of 2 mm gauge and 2 mm galvanized sheet is used above OHE Line on both side of pathway is used for passengers Protection.<br>(Refer <b>fig :2</b> ) |

| | Material of Slab | RCC | a. Cast-in-situ Reinforced concrete slab used for floor of 150 mm thick, RCC slab supported on Floor beams<br><br>b. Cement concrete layer is used for flooring. (Refer <b>fig : 2</b> ) |

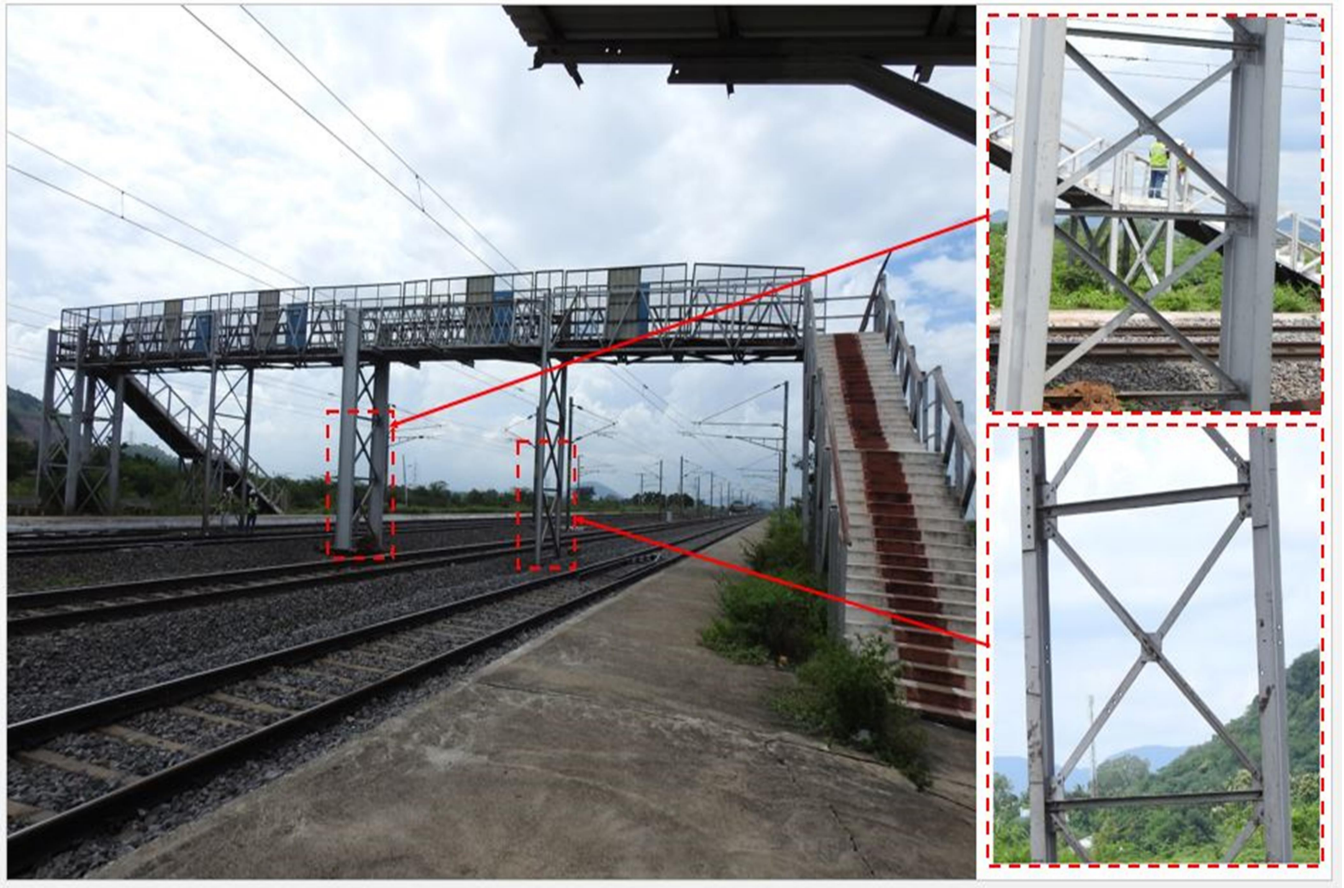
**Fig 3:** Stanchion details

| | Type/Shape of Column section | I- Section Railing | <p>a. FOB is supported on vertical column of ISMB 400, with bracings of 75 x 75 x 12 mm angle section.</p> <p>b. Trestles 1 and 5 have 4 columns whereas Trestles 2, 3 and 4 (Stanchions) have only 2 columns. (Refer <b>fig: 3</b>).</p> <p>c. Stanchion - 1 has ISMB 200 column section, Stanchion - 2 has ISMB 600 column section and Stanchion 3 2 has ISMB 150 column section.</p> <p>d. Staircase landing is supported by ISMB 150, with bracings of 75 x 75 x 12 mm angle section (Refer <b>fig :6</b>)</p> |

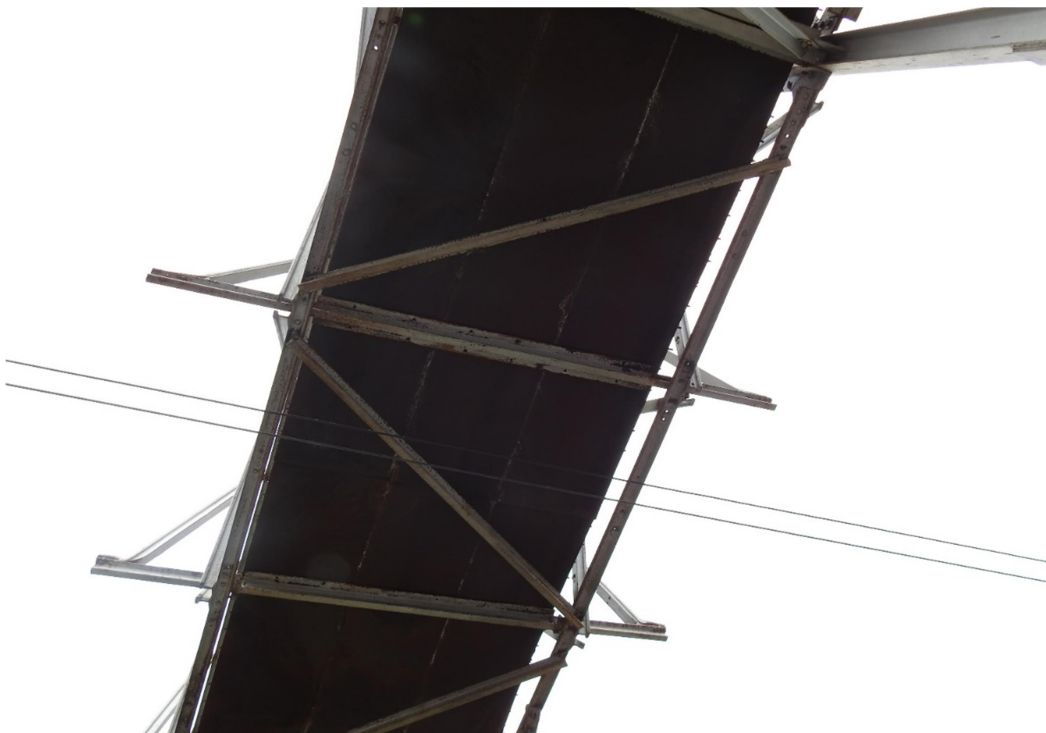
**Fig 4:** Bottom view of FOB

| | Type /Shape of Truss Section | Warren Type (Span-1,3,4), Diamond Mesh (Span-2) | <p><b>Span – 1, 3 &amp; 4:</b></p> <p>a) Top and bottom Chord members are 45 x 90 x 90mm (Head x Height x Base) Rail sections. (Refer <b>fig : 4</b>)</p> <p>b) 45 x 90 x 90mm Rail sections are used as Diagonal &amp; Knee bracing members.</p> <p>c) 45 x 90 x 90mm Rail sections are used as Floor beams supported with Knee bracings 45 x 90 x 90mm rail sections</p> <p>d) Bottom Bracings 45 x 90 x 90mm Rail section in Zig-zag pattern are used</p> <p><b>Span – 2:</b></p> <p>a) Top and bottom Chord members are 75 x 100 x 12mm Double Angle Sections (Refer <b>fig : 1</b>)</p> <p>b) 50x10 mm MS Flat Sections are used as Inclined bracing members.</p> <p>c) ISMC 150 Double Channel sections are used as Floor beams connected with Knee bracings 65x65X8 Angle sections</p> |

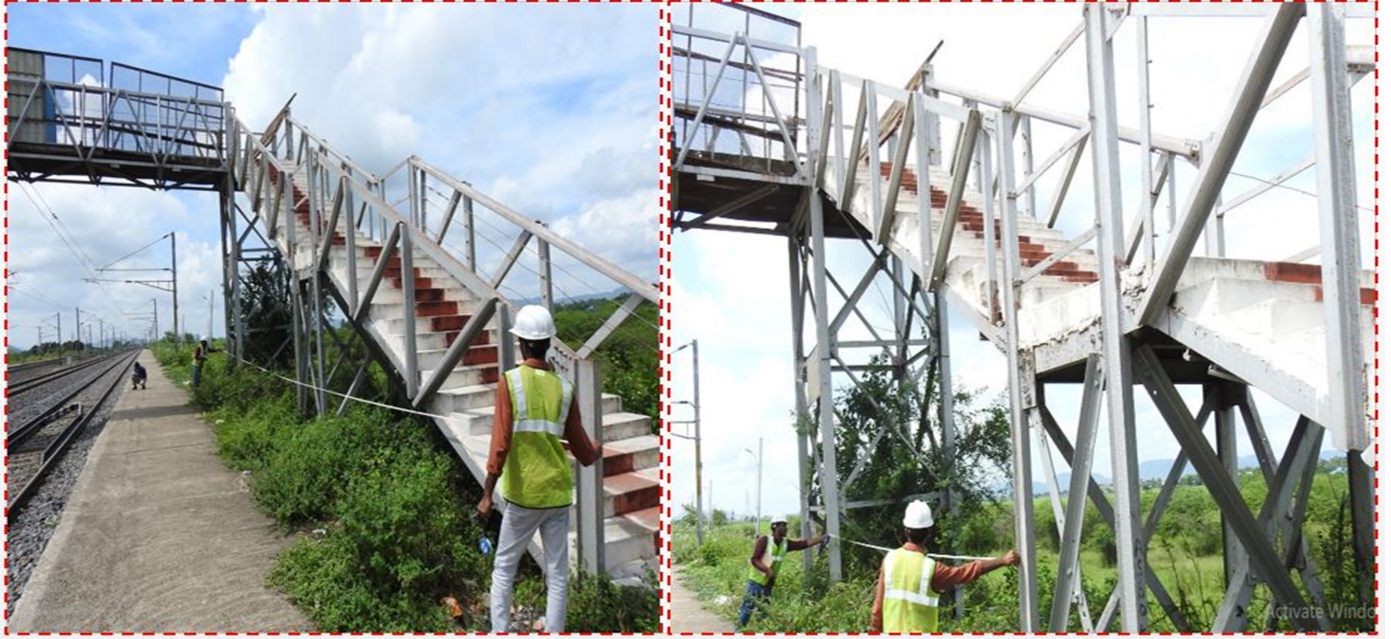
***Fig 5: Stair Case***

| | Number of Staircase | 2 No's | Staircase is observed as Cast-In situ RCC steps supported on 55 x 110 x 110mm Rail Stringer beam and 45 x 90 x 90mm Rail bracings and on both sides of stair case. (Refer <b>fig : 5</b> ) |
