| <b>Name of the Project</b> | <b>:</b> | <b>VISUAL INSPECTION OF FOB/ PF-1 - PF-2 AT CHINNAGANJAM RAILWAY STATION</b> |
| <b>Location</b> | <b>:</b> | <b>CHINNAGANJAM RAILWAY STATION</b> |
| <b>Date of Inspection</b> | <b>:</b> | <b>03<sup>rd</sup> NOVEMBER, 2019</b> |

## **VISUAL INSPECTION OF FOOT OVER BRIDGE**

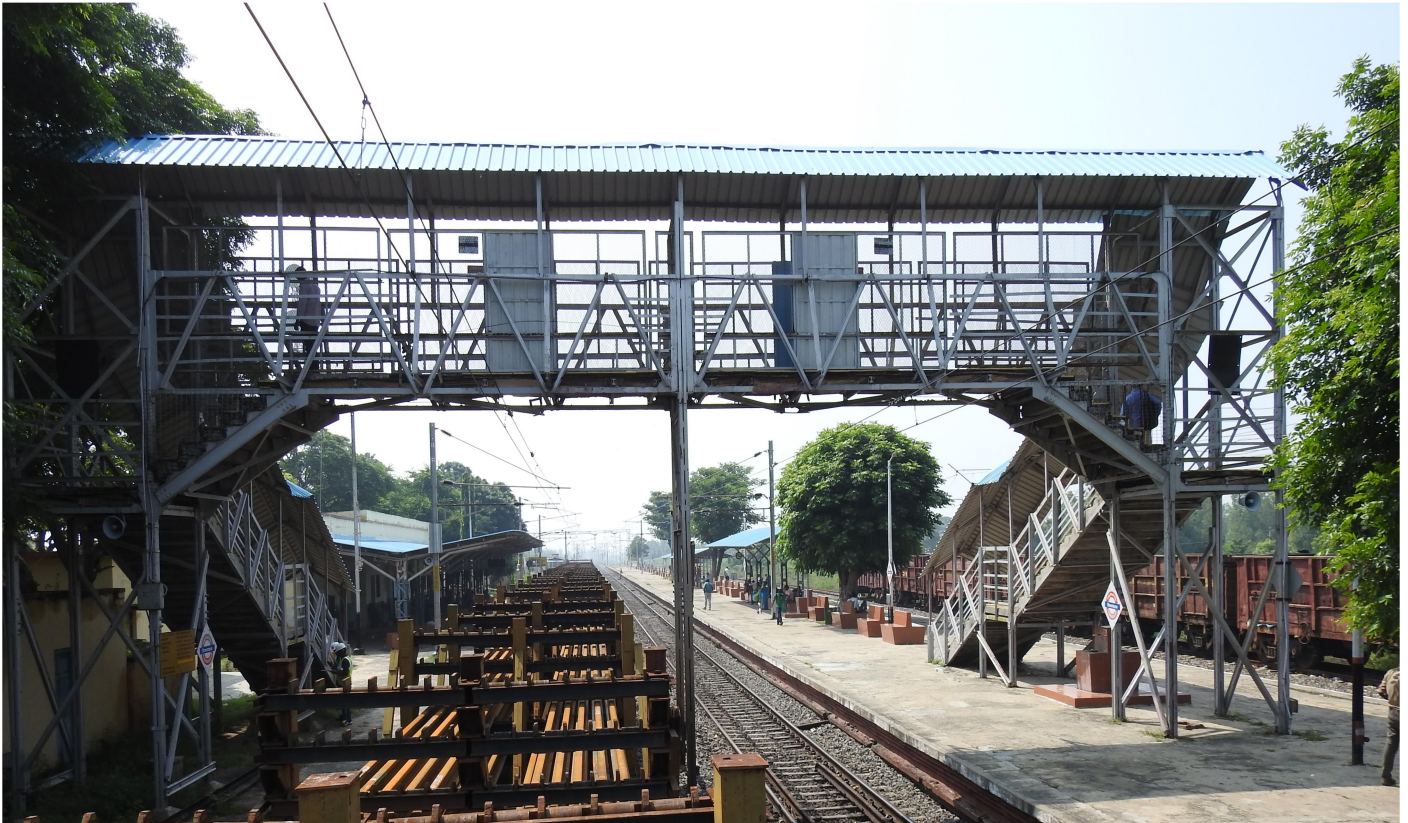
*Fig 1(a):* Front view of FOB span 1 &2

| | Type /Shape of Truss Section | Warren truss with NG Rail | a) Top and bottom Chord members are 50 x 80 x 80 (Head x Height x Base) Rail section (Refer <b>fig : 1</b> )<br>b) 50 x 80 x 80 mm Rail section are used as diagonal bracing members.<br>c) 50 x 80 x 80 mm Rail sections are used as Floor beams supported with Knee bracings 50 x 80x 80 mm rail section.<br>d) Bottom Bracings 50 x 80 x 80 Rail section in Zig-zag pattern are used. |

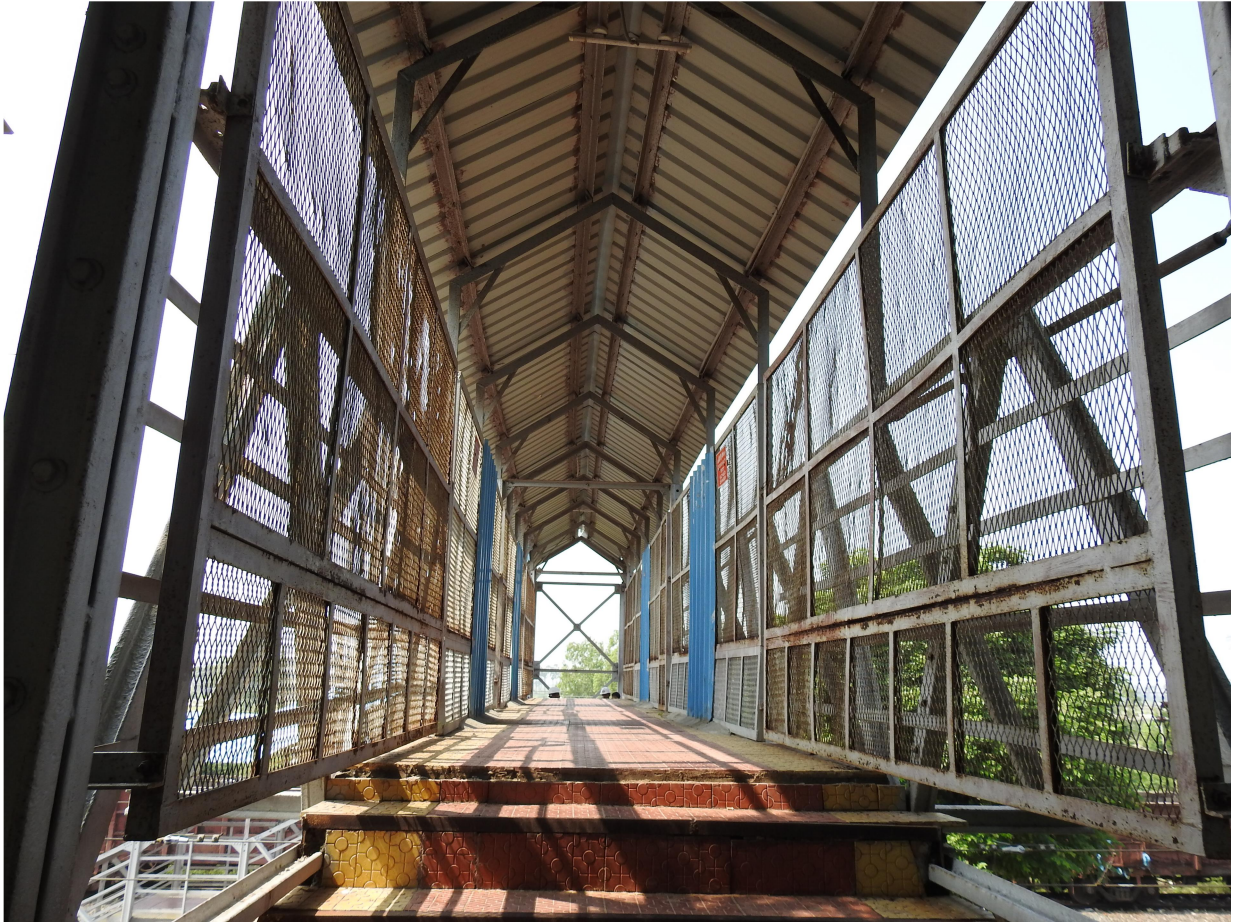
***Fig 2:*** FOB span 1 & 2 pathway, additional wearing coat, protective screen

| | | Yes/No | Notes |
|---|---|---|---|
| | c) Roof Truss | Yes | b. Common Rafter Truss of 75 x 75 x 6 mm Angles are used as Roof truss (Refer <b>fig :2</b> ) |
| | d) Roof Sheet | Yes | c. Metal Sheet is used for Roof (Refer <b>fig : 2</b> ) |
| | a) Additional wearing coat on Floor | Yes | Only Chequered tiles used for Flooring (Refer <b>fig :2</b> ) |
| | b) Provision of protective screen for passengers | Yes | Fence made of galvanized wire of 2 mm gauge and 2 mm galvanized sheet is used above OHE Line on both side of pathway is used for passengers Protection. (Refer <b>fig :2</b> ) |

| | Element of roof truss section | Angle section | Common Rafter Truss of 75 x 75 x 6 mm Angles are used as Roof truss supported on Vertical members of 75 x 75 x 6 mm Angle section (Refer <b>fig : 2</b> ) |
| | Material of Slab | RCC | a. Cast in-situ Reinforced concrete slab is used for floor slab of 75 mm thick, RCC slab covered by Sacrificial Plate is resting on Floor beams.<br>b. Chequered tile flooring is laid on the top of the Pre-cast slab panels.(Refer <b>fig : 2</b> ) |

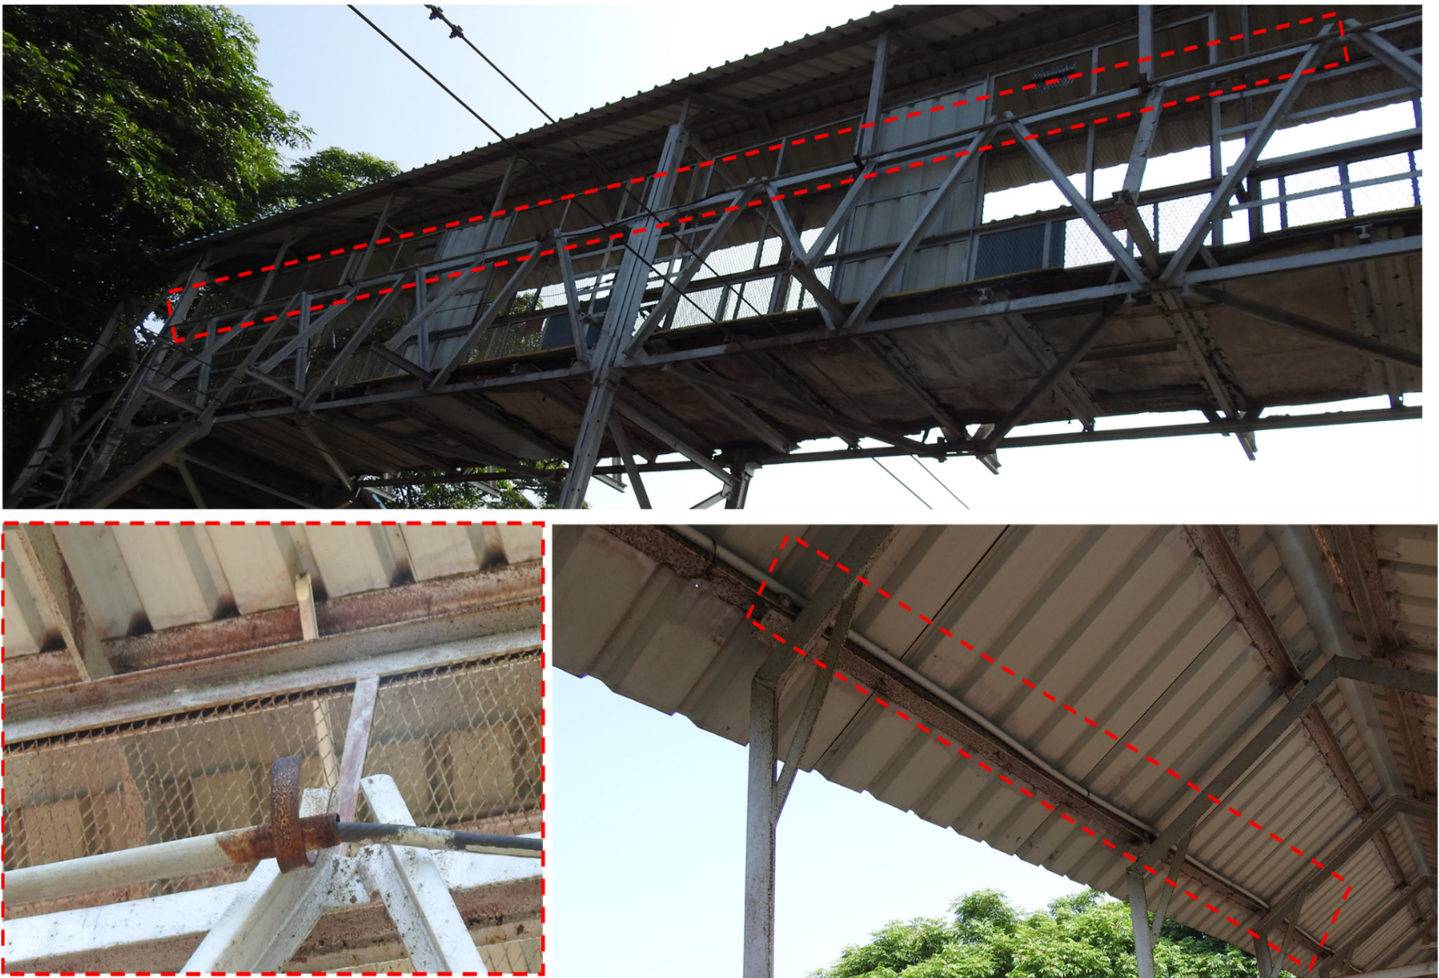
**Fig 3:** Additional loads of HDPE, PVC pipes

| | | Yes/No | Notes |
|---|---|---|---|
| | b) Cables | Yes | a. Cables are protected with 1-inch HDPE pipe, 1.5-inch GI pipe supported on Top Chord, 1-inch PVC pipe supported on Roof Truss. (Refer <b>fig :3</b> ) |

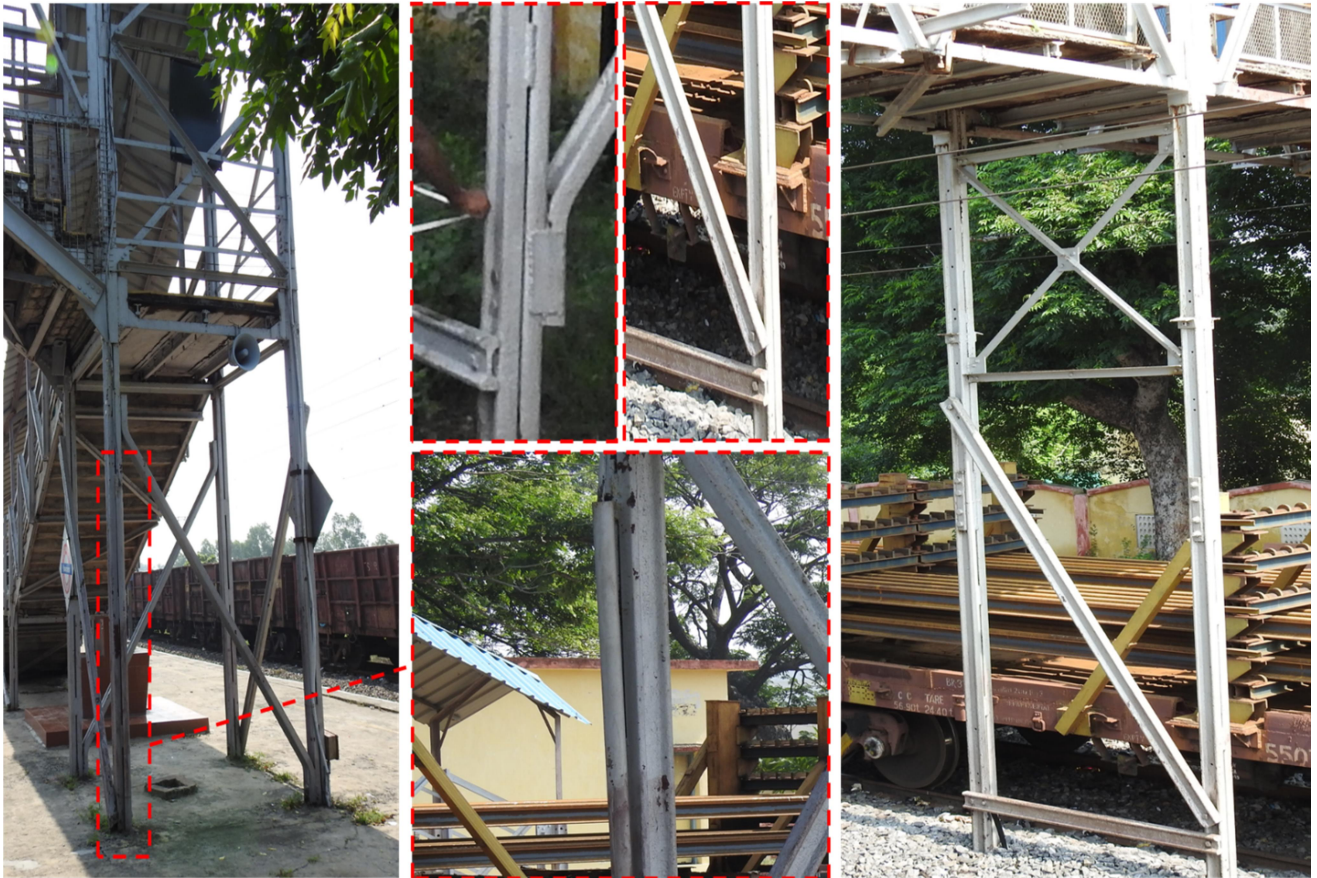
**Fig 4:** Trestles, Stanchion column Rail sections details.

| | Type/Shape of Column section | Built up Section with Bull Headed Rail | a. FOB is supported on vertical column of 2 Rail section 65 x 130 x 65, with bracings of 65 x 130 x 65 Rail section<br>b. Trestles 1 and 3 have 4 columns whereas Trestles 2 (Stanchion) had only 2 columns. (Refer Fig 4)<br>c. Stanchion column has built up section of 2 rail sections 65 x 130 x 65mm with bracings of 65 x 130 x 65 Rail section and 65 x 65 x 8 mm angle section (Refer <b>fig : 4</b> )<br>d. Staircase landing is supported by 2 Rail section of 65 x 130 x 65mm, with bracings of 65 x 130 x 65 Rail section (Refer <b>fig : 6</b> ) |

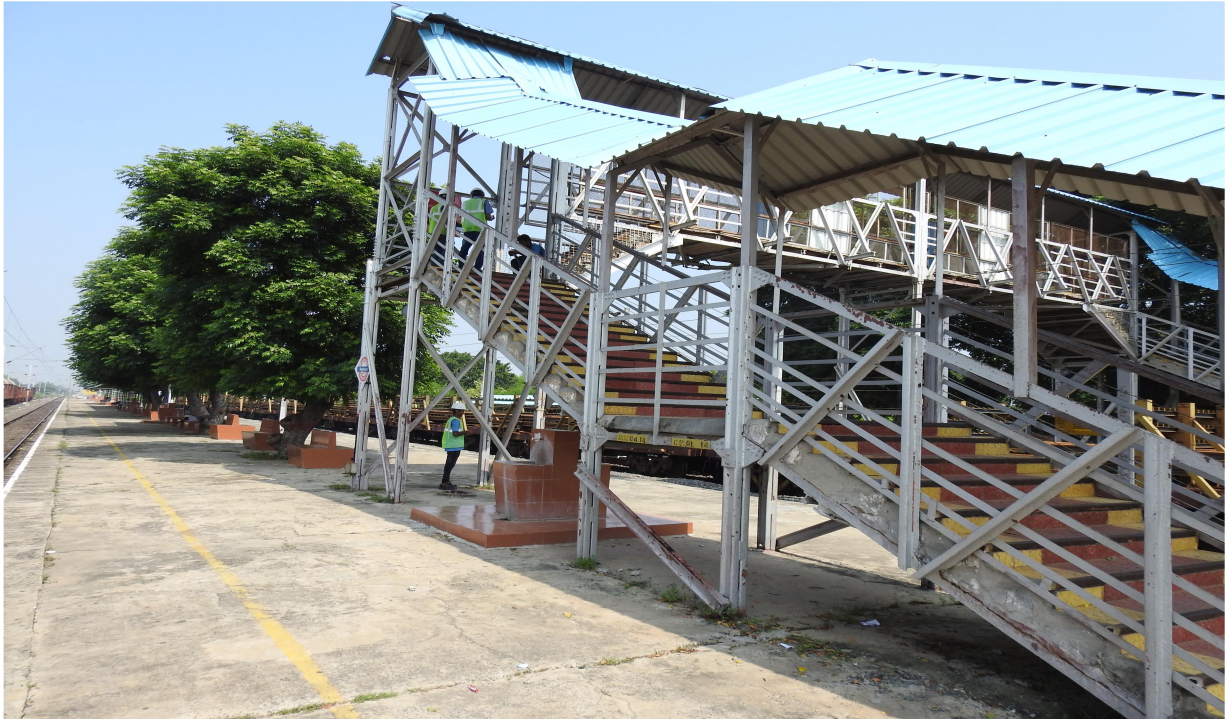
***Fig 6: Railing Details***

| | Type of Parapet Railing | Steel Railing | Staircase is provided with railing on both sides using 50 x 80 x 80 Rail section and 50 x 6 mm M.S flats are used. (Refer <b>fig : 6</b> ) |
