| <b>Name of the Project</b> | <b>:</b> | <b>VISUAL INSPECTION OF FOB AT PASIVEDALA RAILWAY STATION</b> |
| <b>Location</b> | <b>:</b> | <b>PASIVEDALA RAILWAY STATION</b> |
| <b>Date of Inspection</b> | <b>:</b> | <b>9<sup>th</sup> NOVEMBER, 2019</b> |

### **VISUAL INSPECTION OF STEEL FOOT OVER BRIDGE**

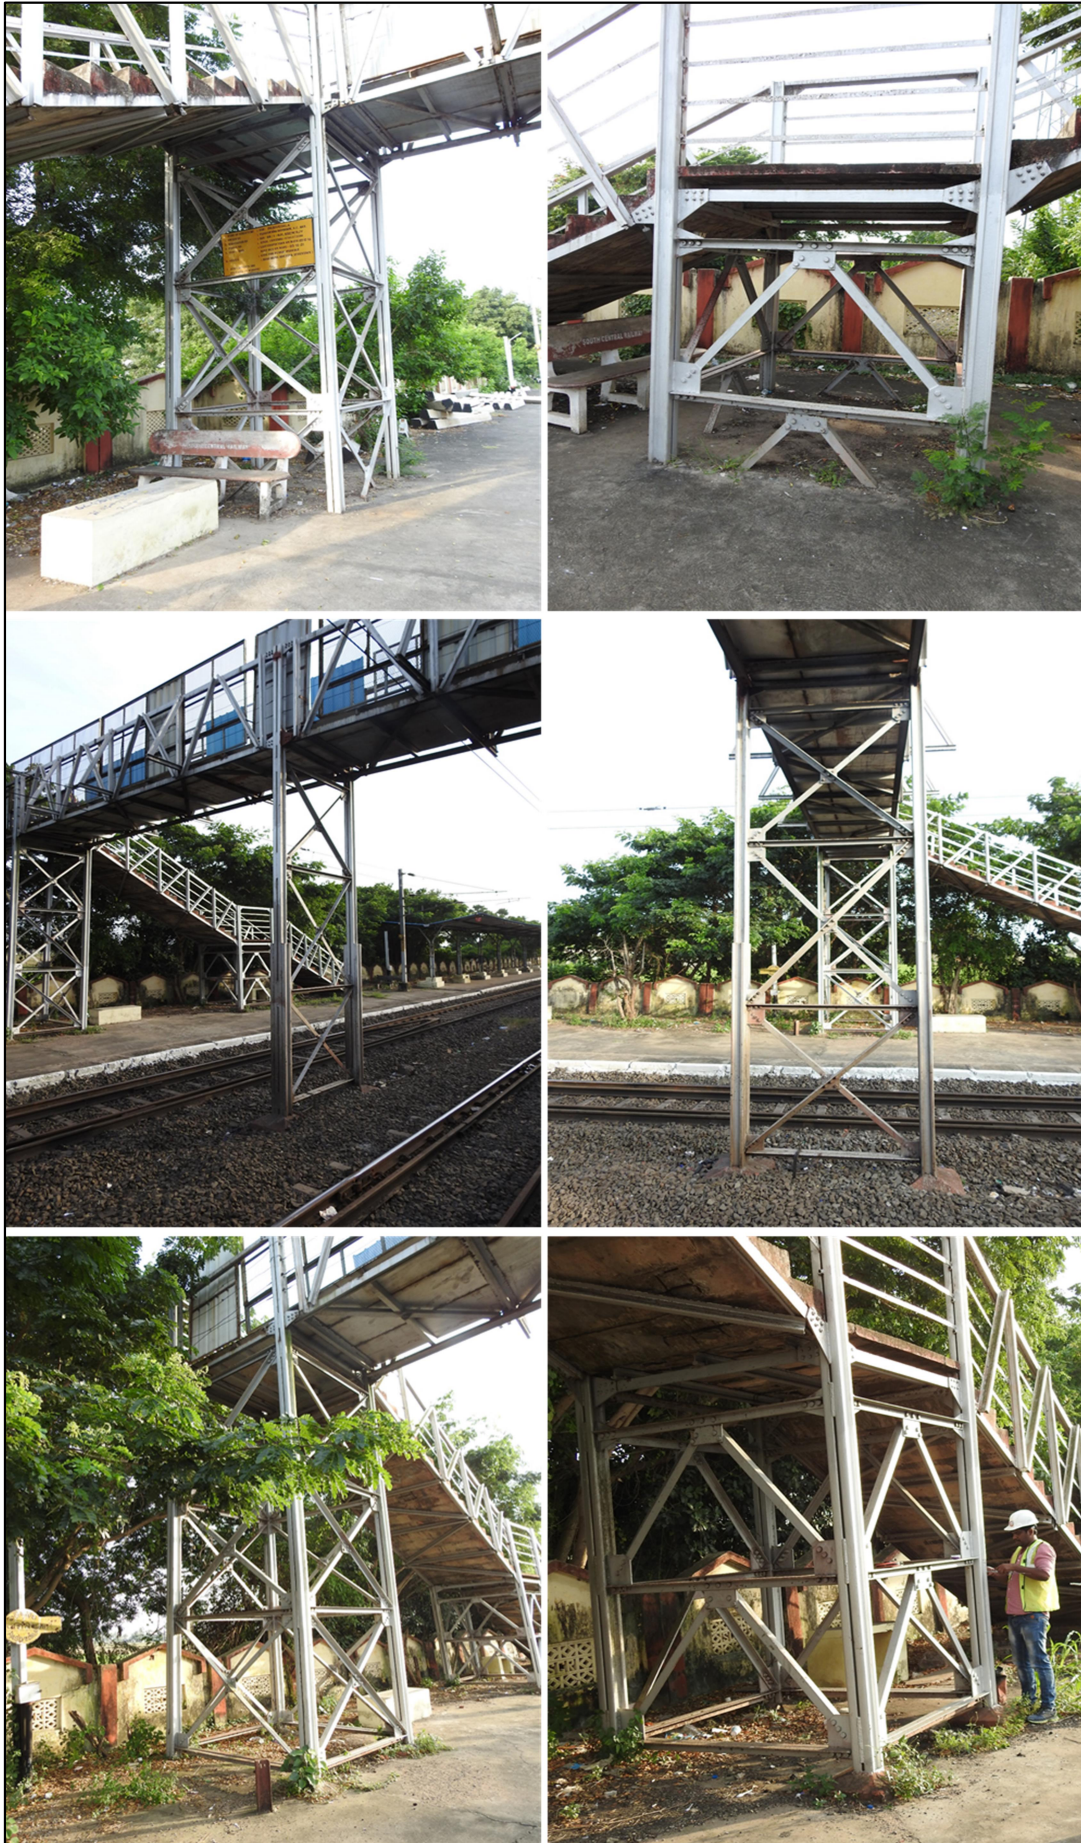
**Fig 3:** Stanchion column details

| | Type/Shape of Column section | Bull headed Rail Sections | a. Trestles & Stanchion Columns are 2/ 65 x 135 x 135 (Head x Height x Base) Rail sections.<br>b. Cross Bracings in Trestles & Stanchions are 65 x 65 x 8 mm Angle are used. (Refer <b>fig : 3</b> ) |

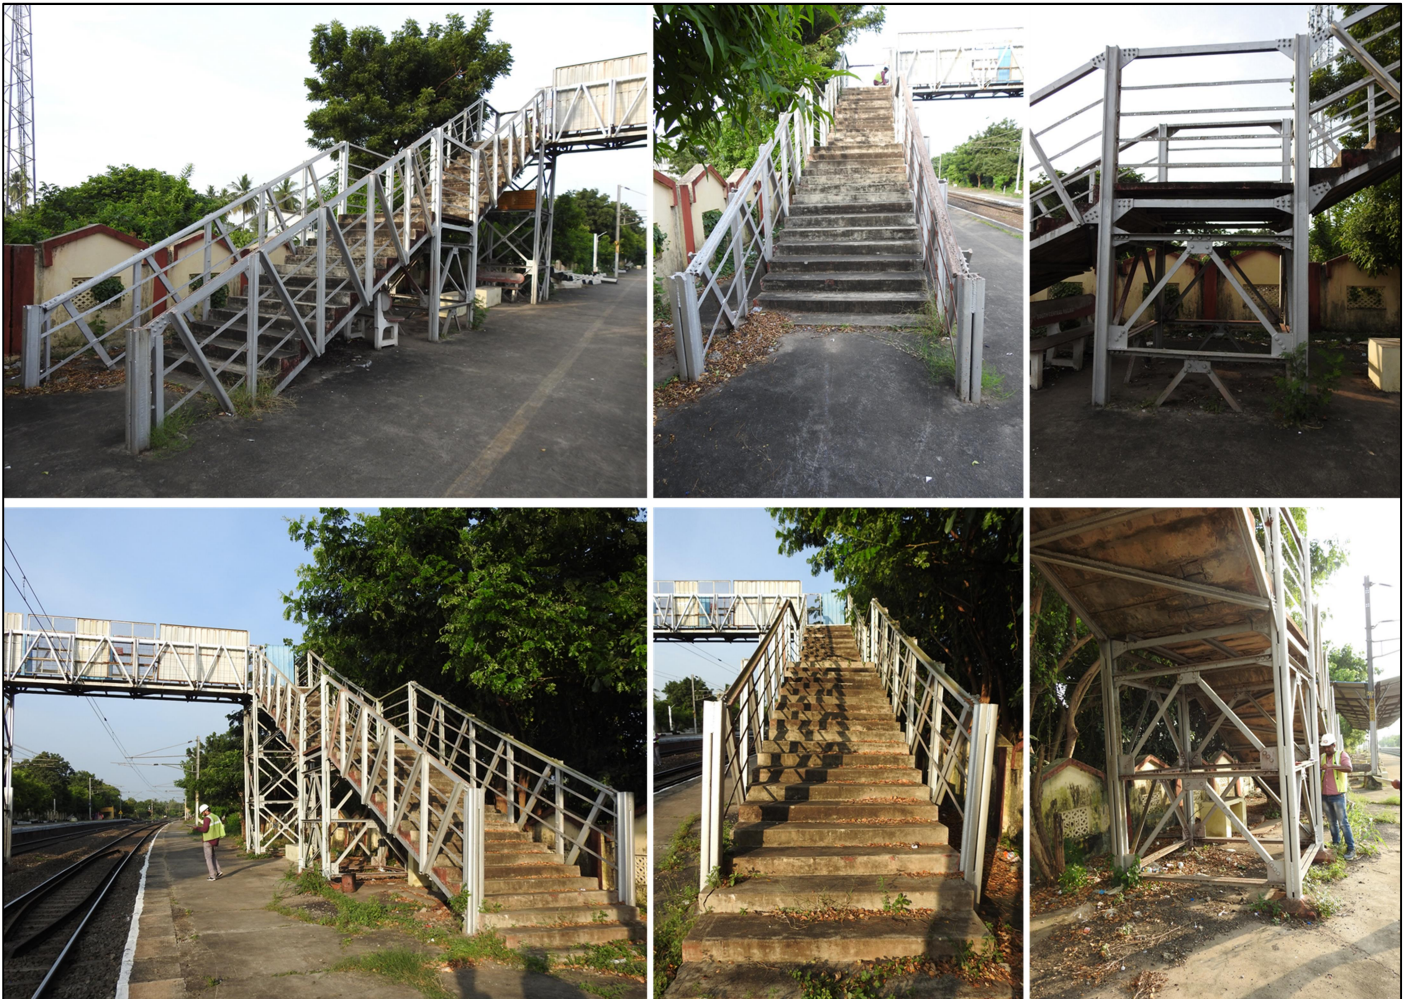
***Fig 5:*** Details of staircase

| | Number of Staircase | 2 No's | Staircase is observed as Pre cast RCC Slab panels supported on 45 x 80 x 80 (Head x Height x Base) Rail Stringer Beams on both sides. (Refer <b>fig :5</b> ) |
| | Type of Parapet Railing | Steel Railing | Staircases are provided with railing on both sides using 45 x 80 x 80 (Head x Height x Base) Rail sections. (Refer <b>fig :5</b> ) |

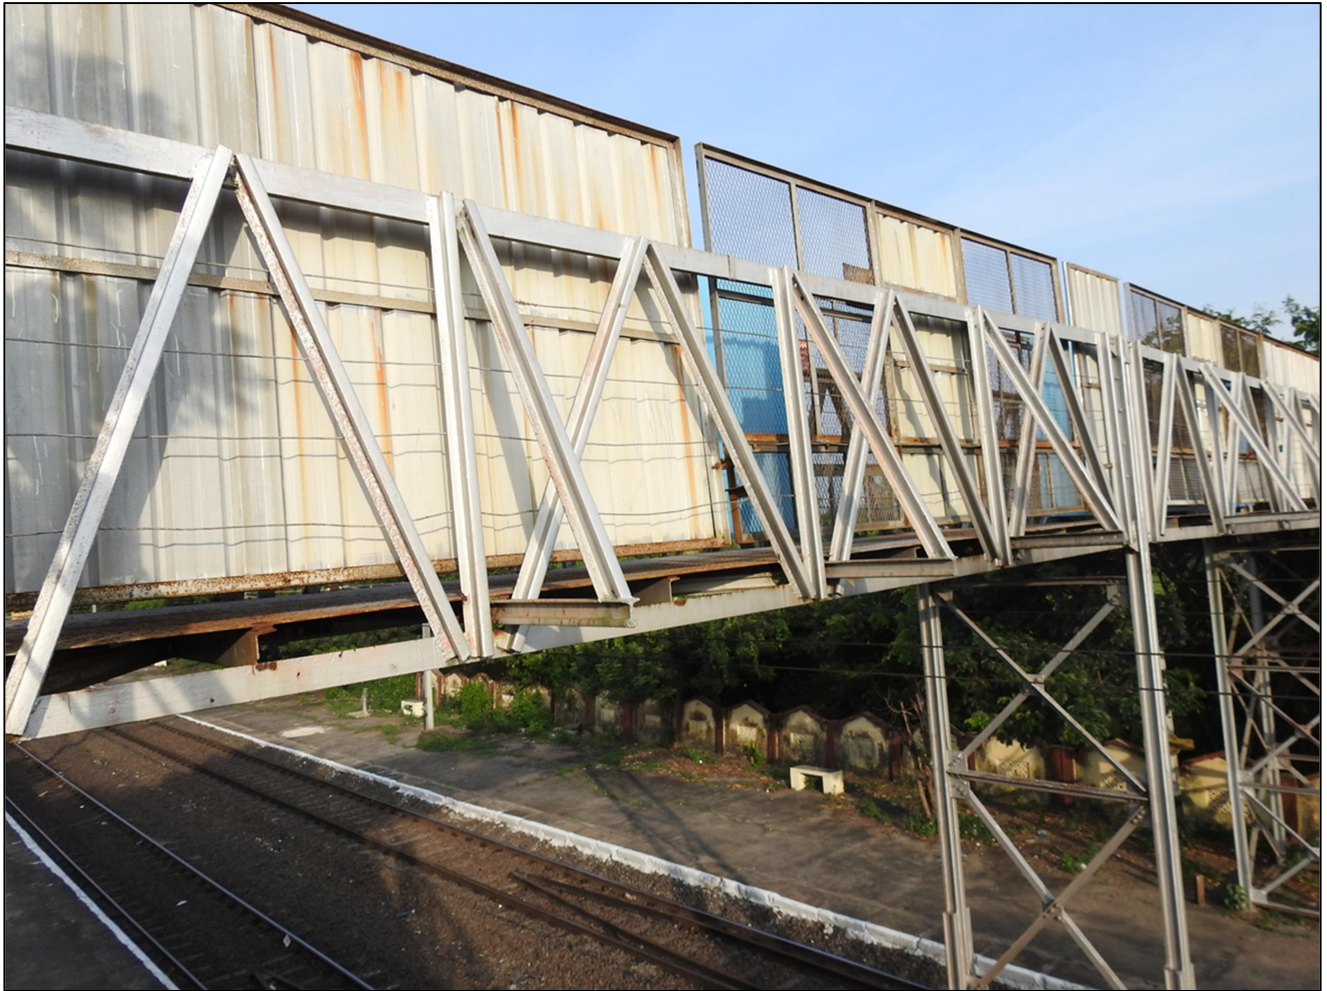
***Fig 6: Arrangement of Truss***

| | Type /Shape of Truss Section | NG Rail sections | a) Top Chord & Bottom Chord members are 45 x 85 x 85 (Head x Height x Base) Rail sections.<br>b) 45 x 85 x 85 (Head x Height x Base) Rail sections are used as vertical members.<br>c) 45 x 85 x 85 (Head x Height x Base) Rail sections and ISMC 150 are used as Floor beams.<br>d) 45 x 85 x 85 (Head x Height x Base) Rail sections are used as Bracings.(Refer <b>fig : 6</b> ) |
