| <b>Name of the Project</b> | <b>:</b> | <b>VISUAL INSPECTION OF FOB AT MUGAT RAILWAY STATION</b> |
| <b>Location</b> | <b>:</b> | <b>MUGAT RAILWAY STATION</b> |
| <b>Date of Inspection</b> | <b>:</b> | <b>22<sup>nd</sup> NOVEMBER 2019</b> |

### **VISUAL INSPECTION OF STEEL FOOT OVER BRIDGE**

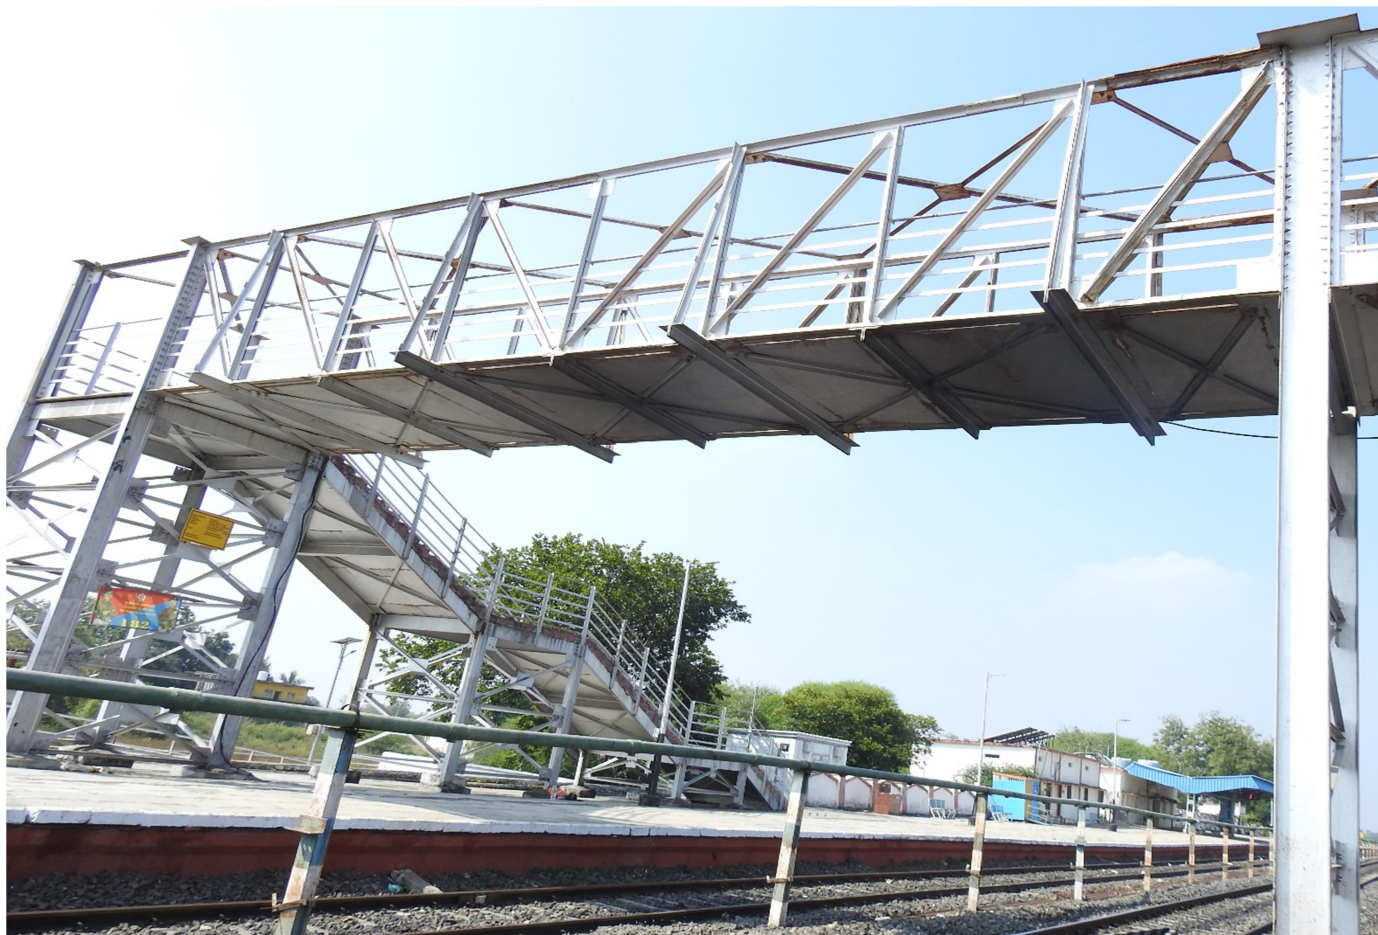
***Fig 1(a):*** Front & Bottom view of FOB span 1

| PART 3 STRUCTURAL SYSTEM OF THE BRIDGE | | | |
|---|---|---|---|
| | Type /Shape of Truss Section | Angle section | a) Top and Bottom chord members are 100 x 100 x 10 Double angle sections. (Refer <b>fig: 1(a), 1(b)</b> )<br>b) 75 x 75 x 8 mm Double Angle sections are used as diagonal bracing members.<br>c) 150 x 150 x 12 mm Double Angle sections are used as floor beams with Knee bracings 75 x 75 x 8 mm Double Angle section.<br>d) Bottom bracings of 75 x 75 x 8 Angle sections are used. |

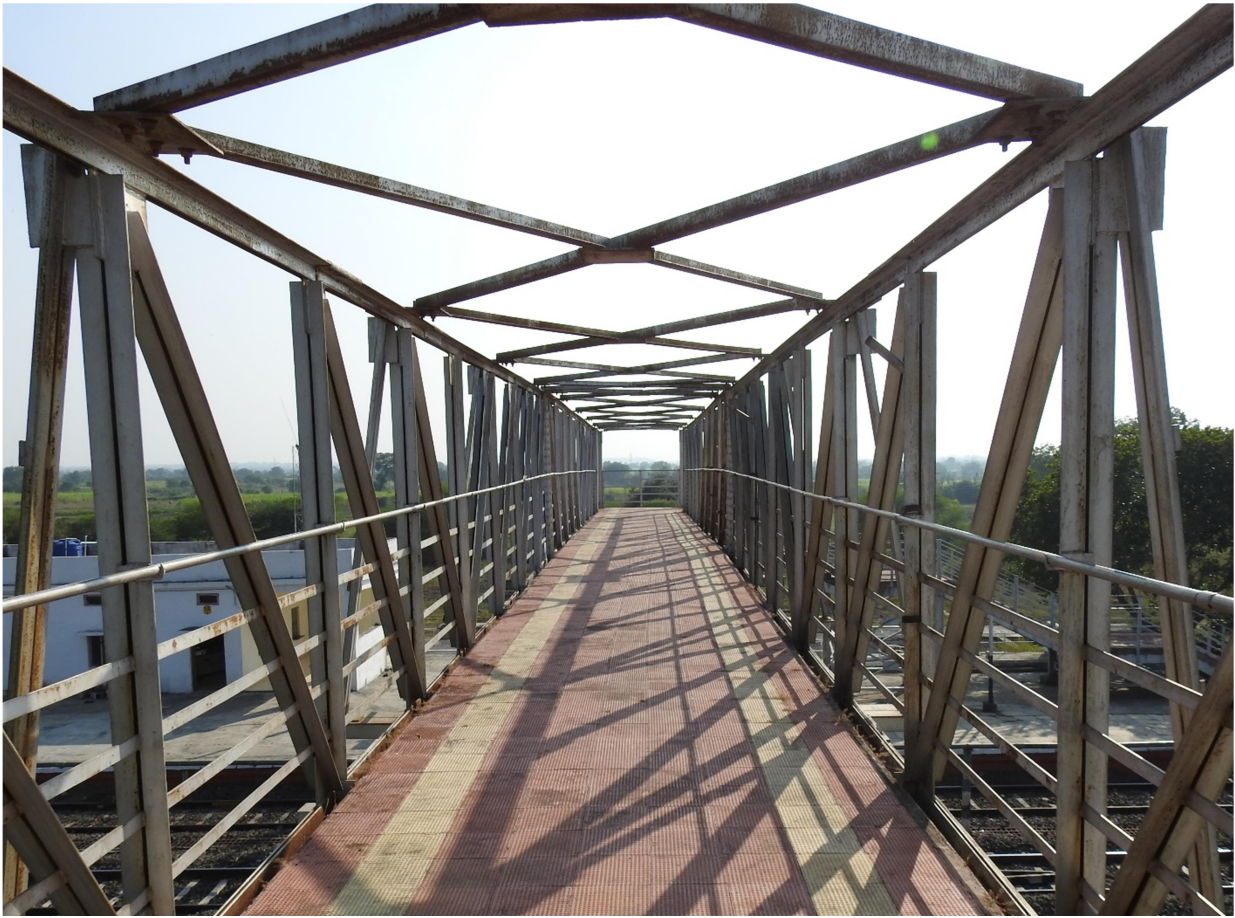
***Fig 2:*** Pathway of FOB

| | | Yes/No | Notes |
|---|---|---|---|
| | a) Additional wearing coat on Floor | Yes | Chequered tiles is used as Flooring (Refer <b>fig :2</b> ) |

| | Material of Slab | Cast in-situ RCC | Cast in-situ Reinforced concrete slab panels are used for floor slab of 100 mm thick, RCC slab panels are resting on Floor beams and Bottom chord. (Refer <b>fig: 2</b> ) |

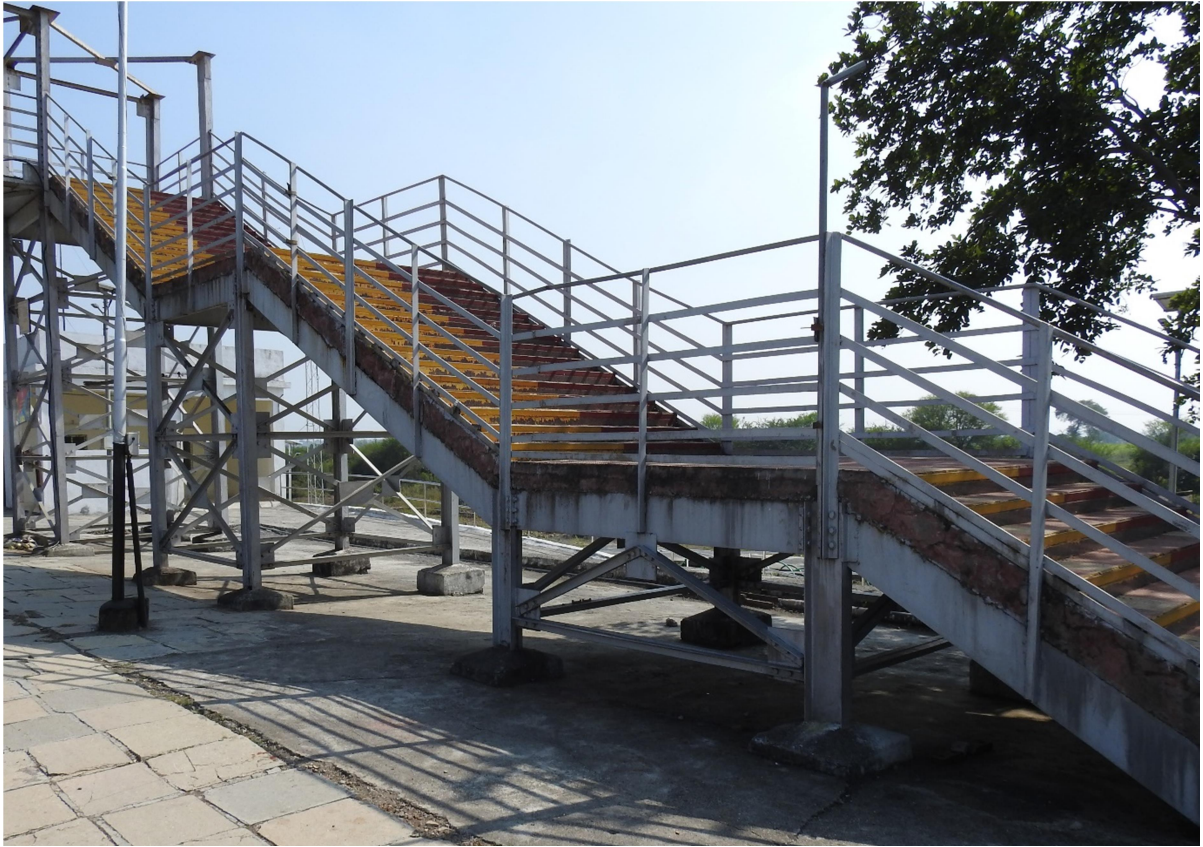
***Fig 4:*** Staircase Details

| | | Yes/No | Notes |
|---|---|---|---|
| | b) Provision of protective screen for passengers | No | Railing is provided with MS plates. (Refer <b>fig :4</b> ) |

| | Type of Parapet Railing | Steel Railing | Staircase is provided with railing on both sides using 32 mm dia. and 50X8 mm M.S Flats are used. (Refer <b>fig: 4</b> ) |
