| <b>Name of the Project</b> | <b>:</b> | <b>VISUAL INSPECTION OF FOB AT REPALLE RAILWAY STATION</b> |
| <b>Location</b> | <b>:</b> | <b>REPALLE RAILWAY STATION</b> |
| <b>Date of Inspection</b> | <b>:</b> | <b>09<sup>th</sup> NOVEMBER,2019</b> |

## **VISUAL INSPECTION OF FOOT OVER BRIDGE**

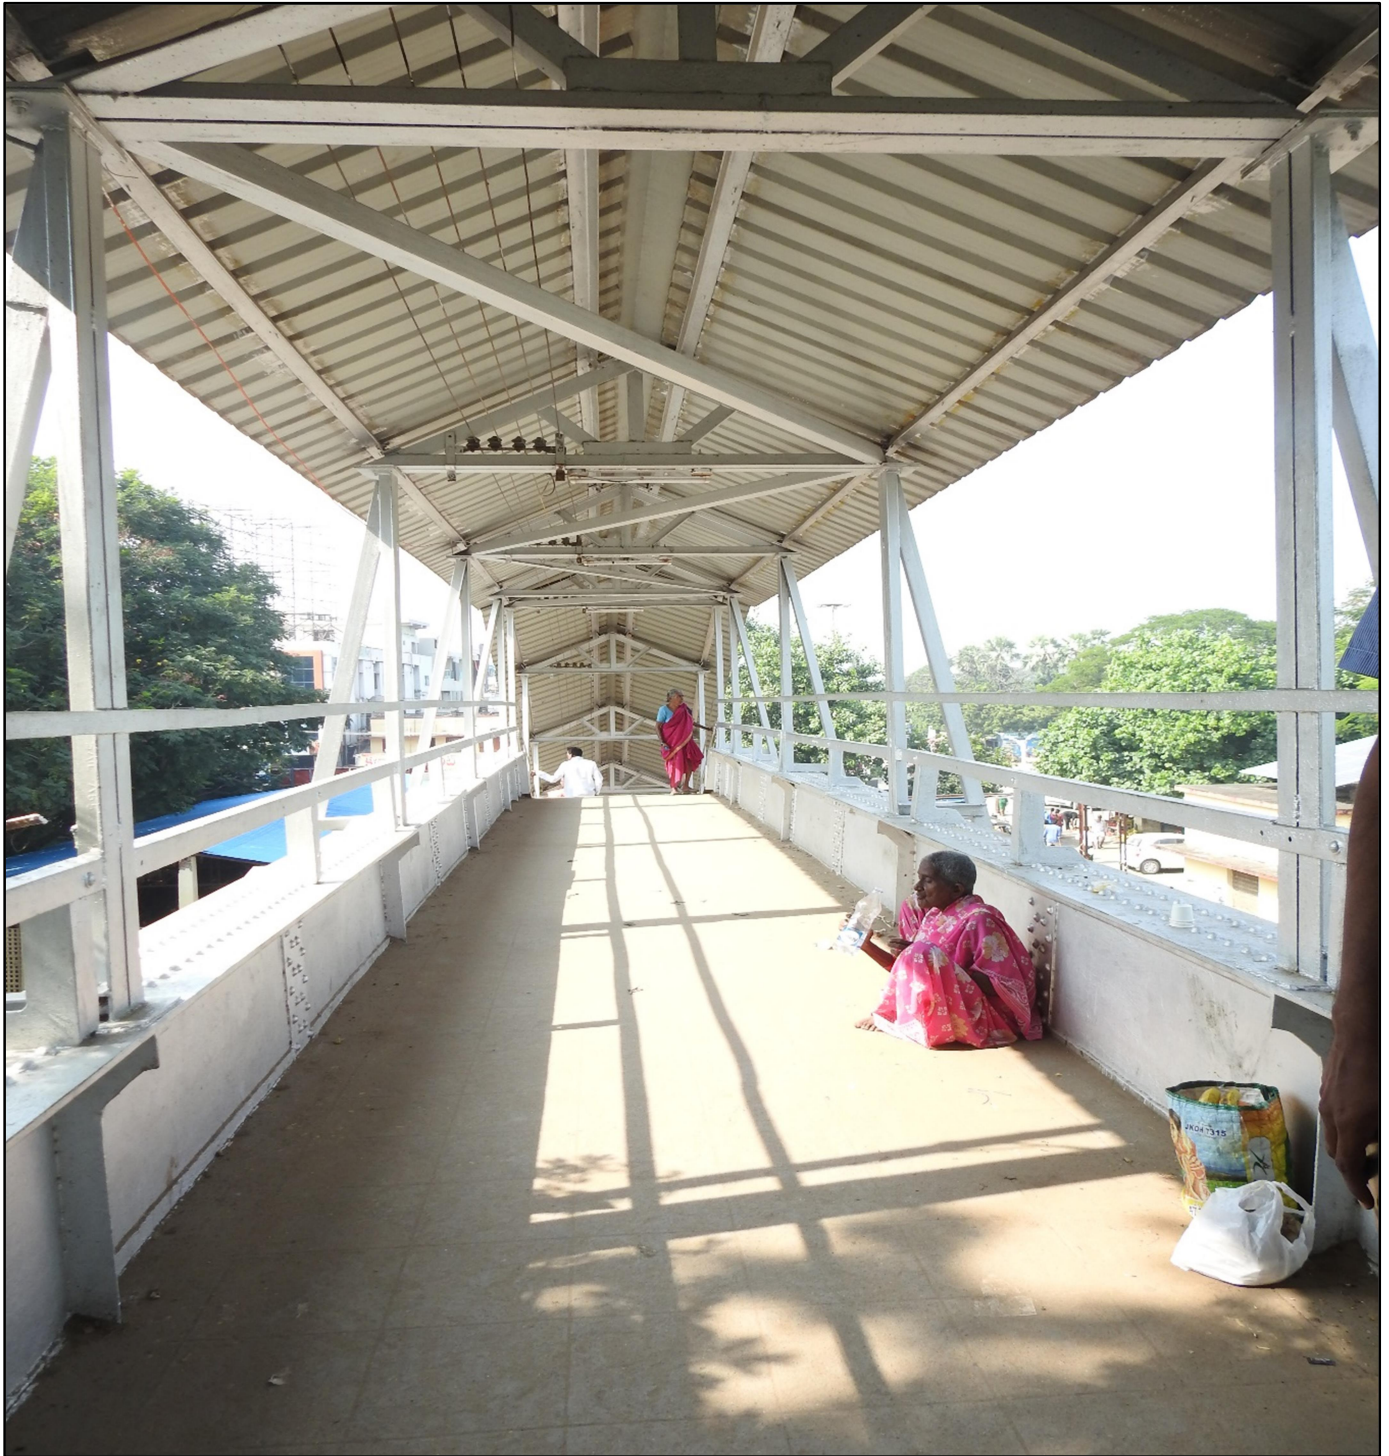
| | | Yes/No | Notes |
|---|---|---|---|
| | a) Additional wearing coat on Floor | Yes | CC Flooring(Refer <b>fig :2</b> ) |

| | Material of Slab | RCC | a. Cast in-situ Reinforced concrete slab is used for floor slab of 200 mm thick, on Sacrificial Plate.<br>b. CC flooring is laid on the top of the Floor slab.(Refer <b>fig : 2</b> ) |

***Fig 2: Pathway, Steel Railing of FOB***

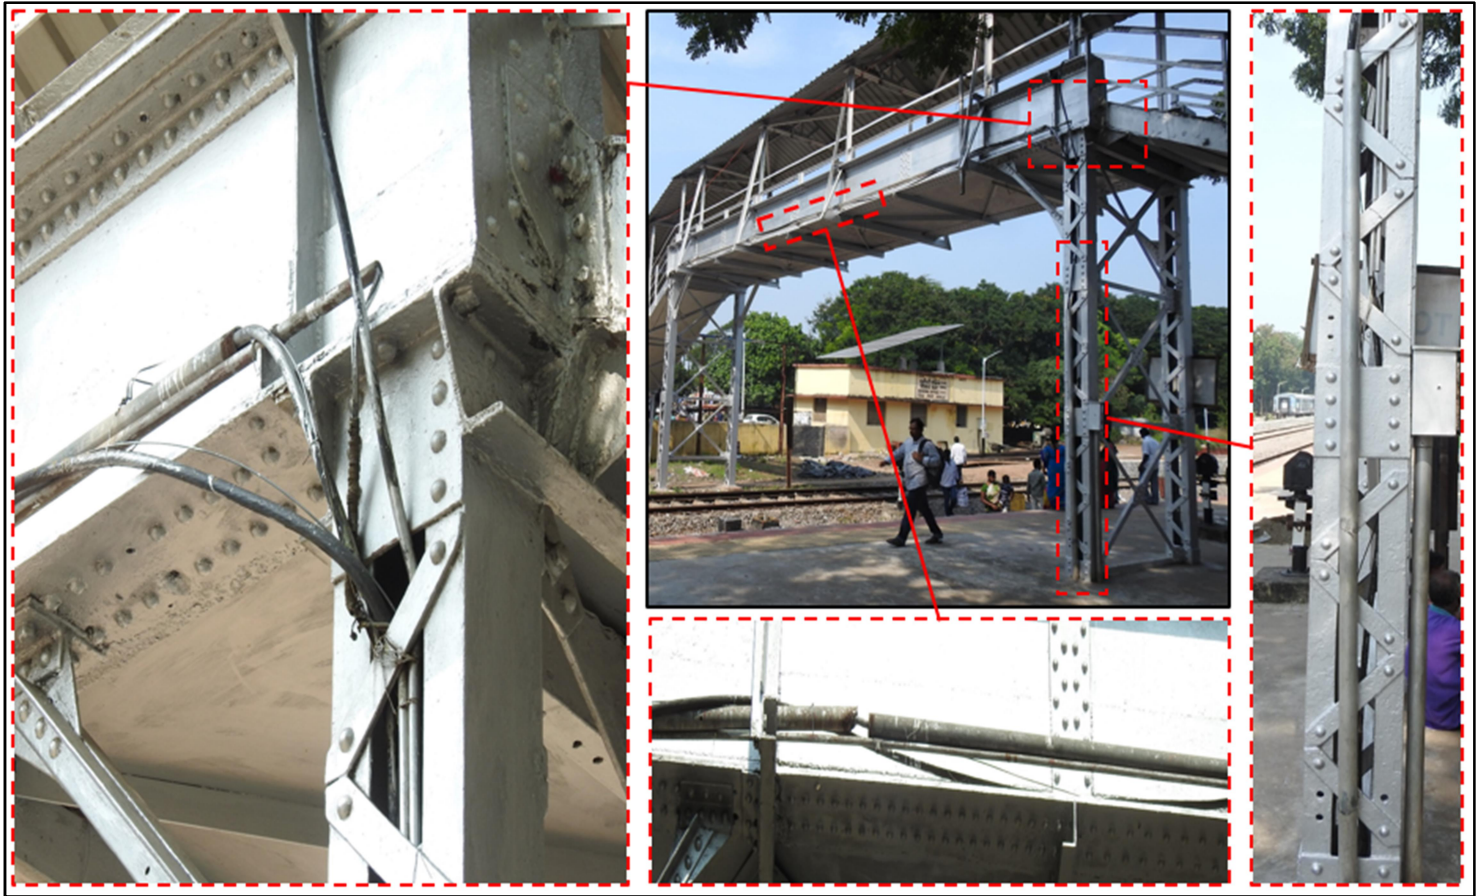
| | | Yes/No | Notes |
|---|---|---|---|
| 2.1 | a) Pipeline - Utilities | Yes | a. 1" & 2" GI pipes and 1" HDPE pipe - 3 Nos are supported along the length of girder and 1.5" GI pipe is supported on Stanchions and Mid landing. (Refer <b>fig :3</b> )<br>b. King post Trusses are used for Roof truss(Refer <b>fig :9</b> )<br>c. Insulated Electrical Lines are supported on Roof Truss. (Refer <b>fig :9</b> )<br>d. Corrugated Metal Sheet is used for Roofing (Refer <b>fig : 1</b> ) |

**Fig 3:** Additional loads of HDPE, GI pipes

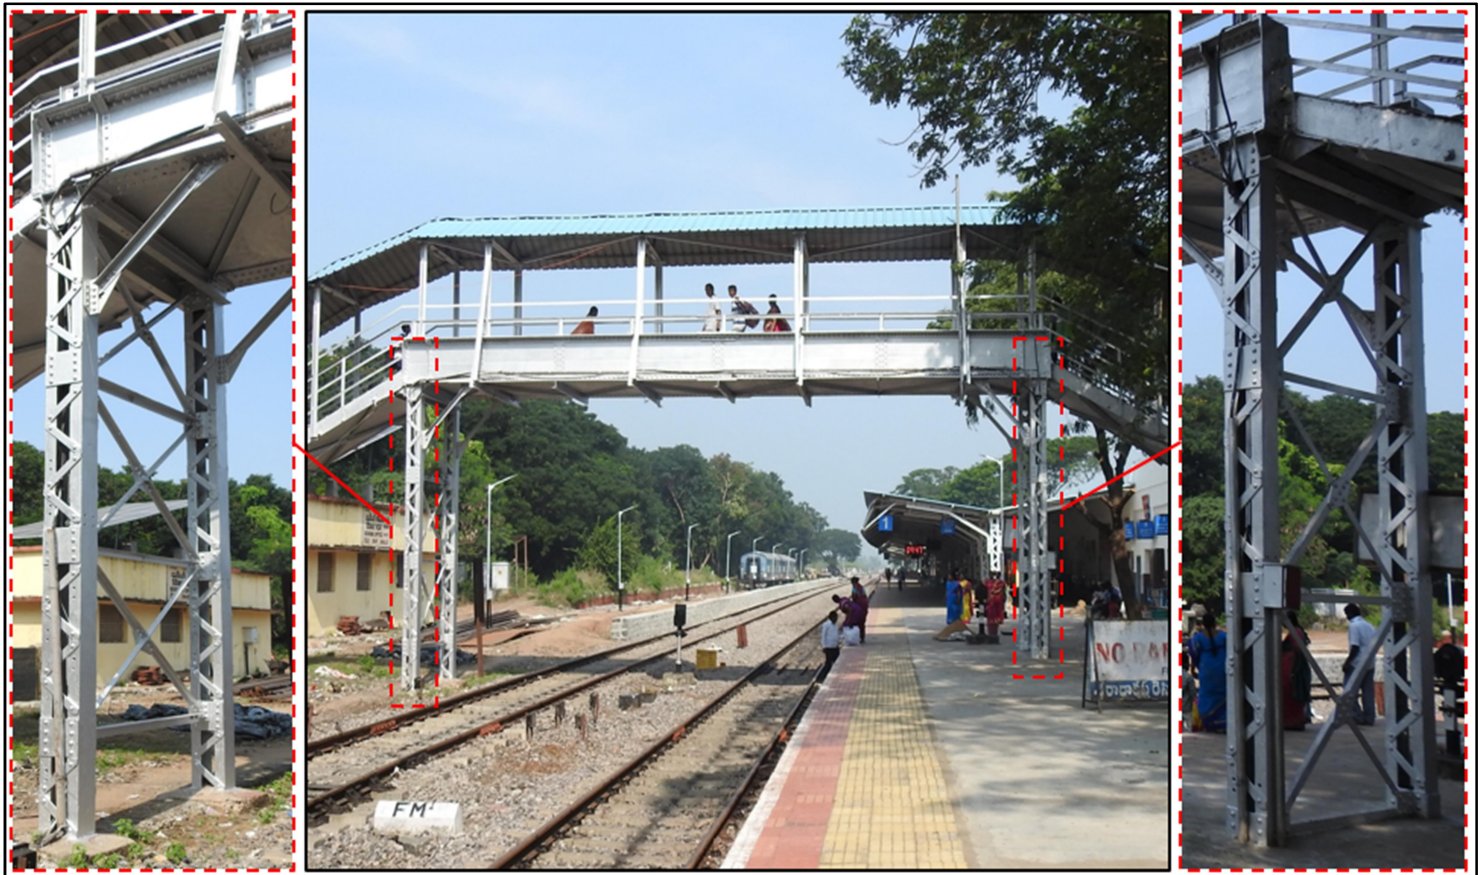
**Fig 4:** Stanchions column details and additional GI pipe Connected.

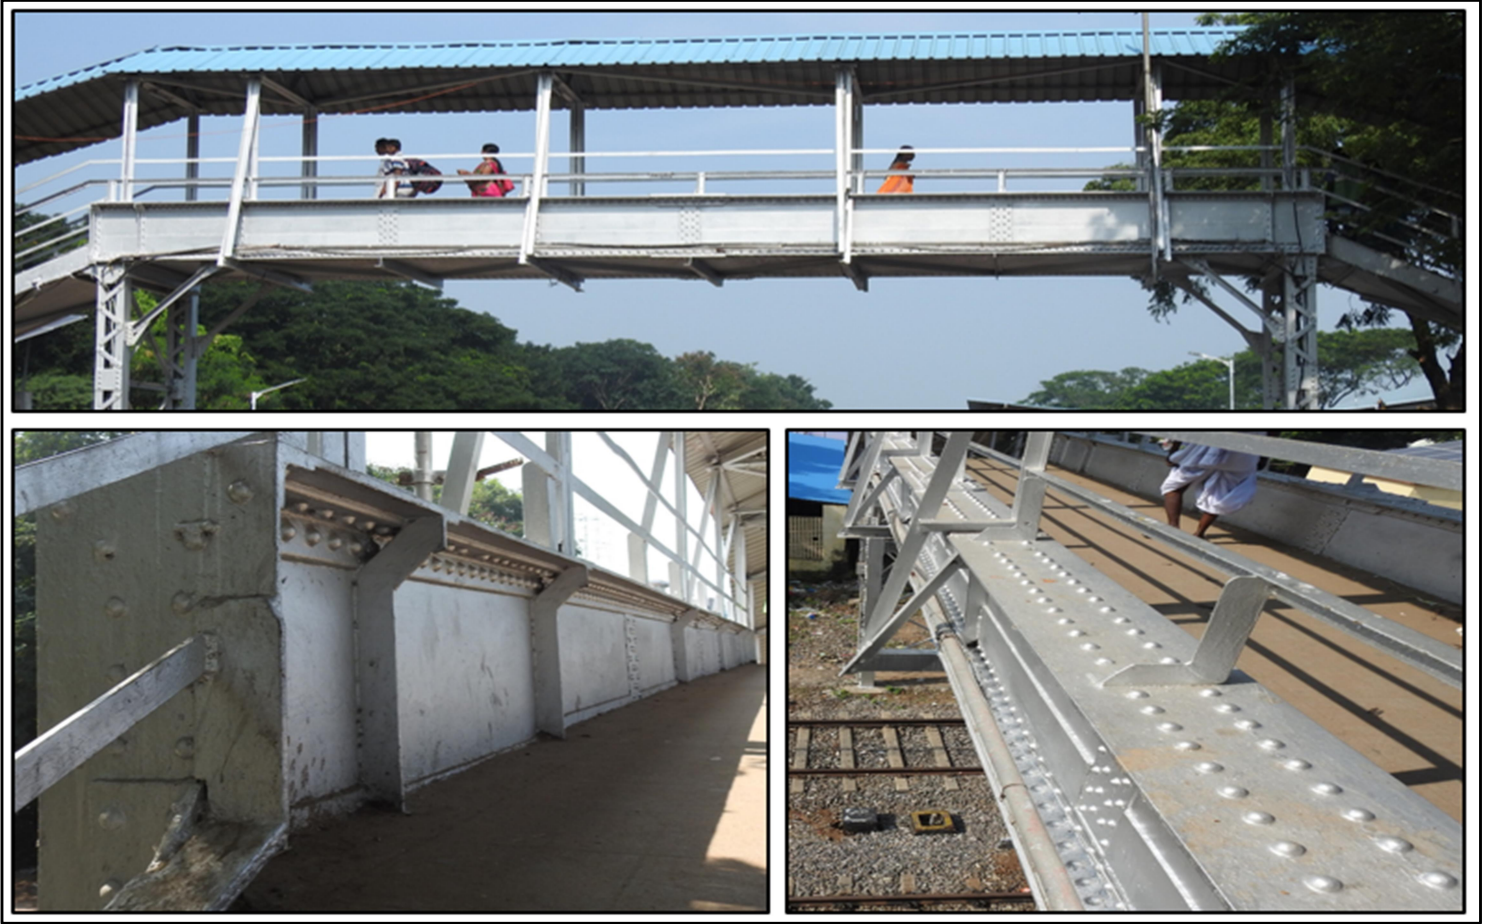
| | Type /Shape of Truss Section | Plate Girder | a) Built-up Plate girder of 850 x 350mm ( Height x Flange)I-section with 16mm thick plate supported by 75 x 75 x 10mm Angle stiffeners with Riveted joint. (Refer <b>fig : 5</b> )<br>b) ISMC 150 mm Channel sections are used as Floor beams.<br>c) Bottom Lateral Bracings 75x75x8mm Angle section in Zig-zag pattern are used |

*Fig 5: Plate Girder*

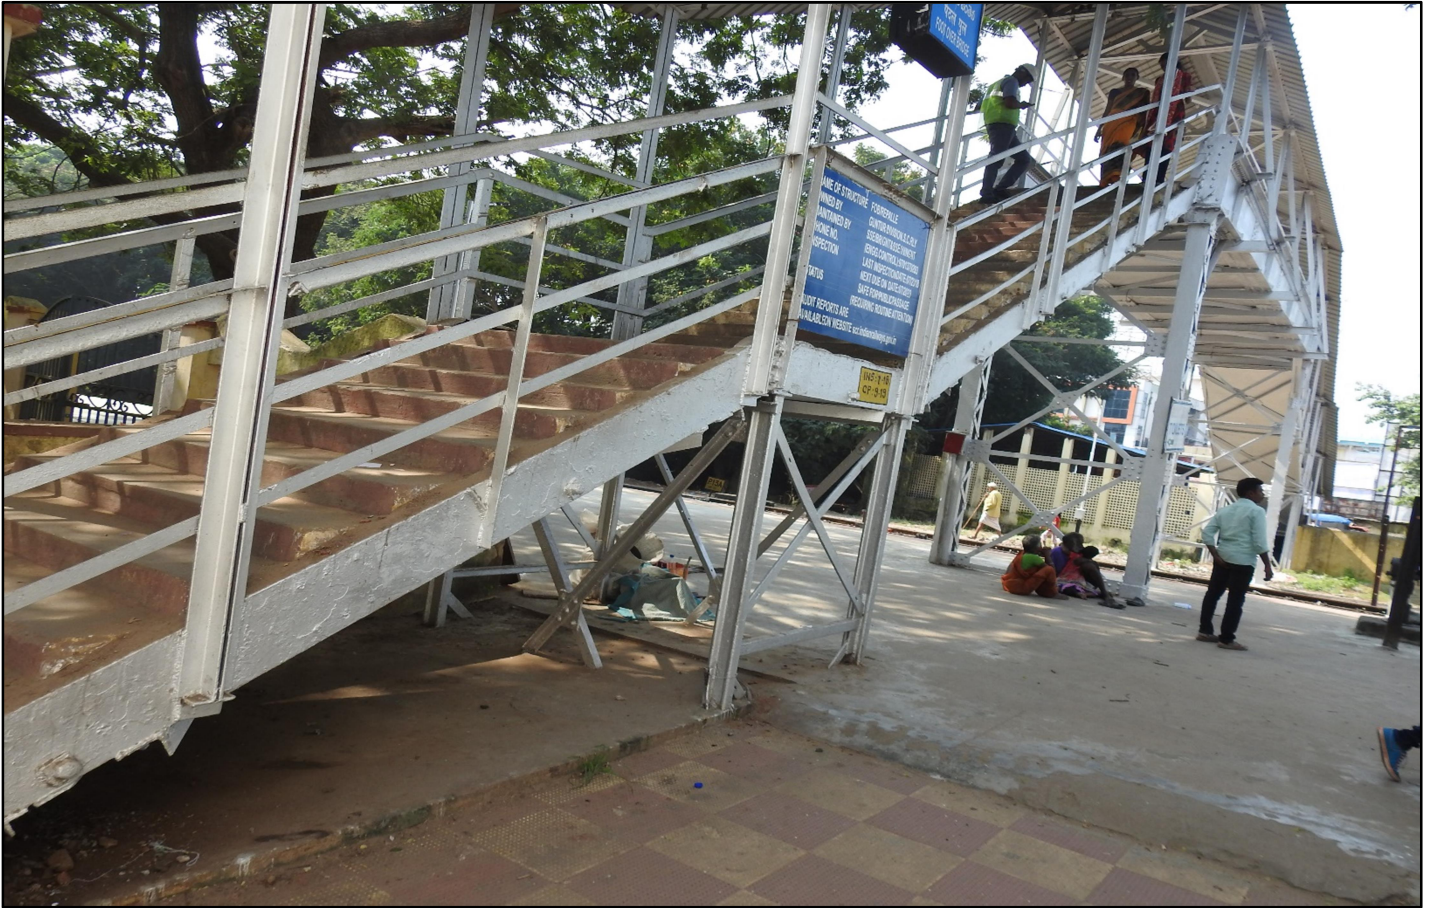
| | Number of Staircase | 2 No's | Staircase is observed as Cast in-situ RCC Slab supported on Stringer beam of ISMC 200 mm Channel section and cross bracings of 75 x 75 x 8mm angle section.(Refer <b>fig : 6</b> ) |
| | Type of Parapet Railing | Steel Railing | Staircase is provided with railing on both sides using 65 x 50 x 10 angle section and 45 x 10 mm M.S flats are used.(Refer <b>fig : 6</b> ) |

**Fig 6: Railing Details**

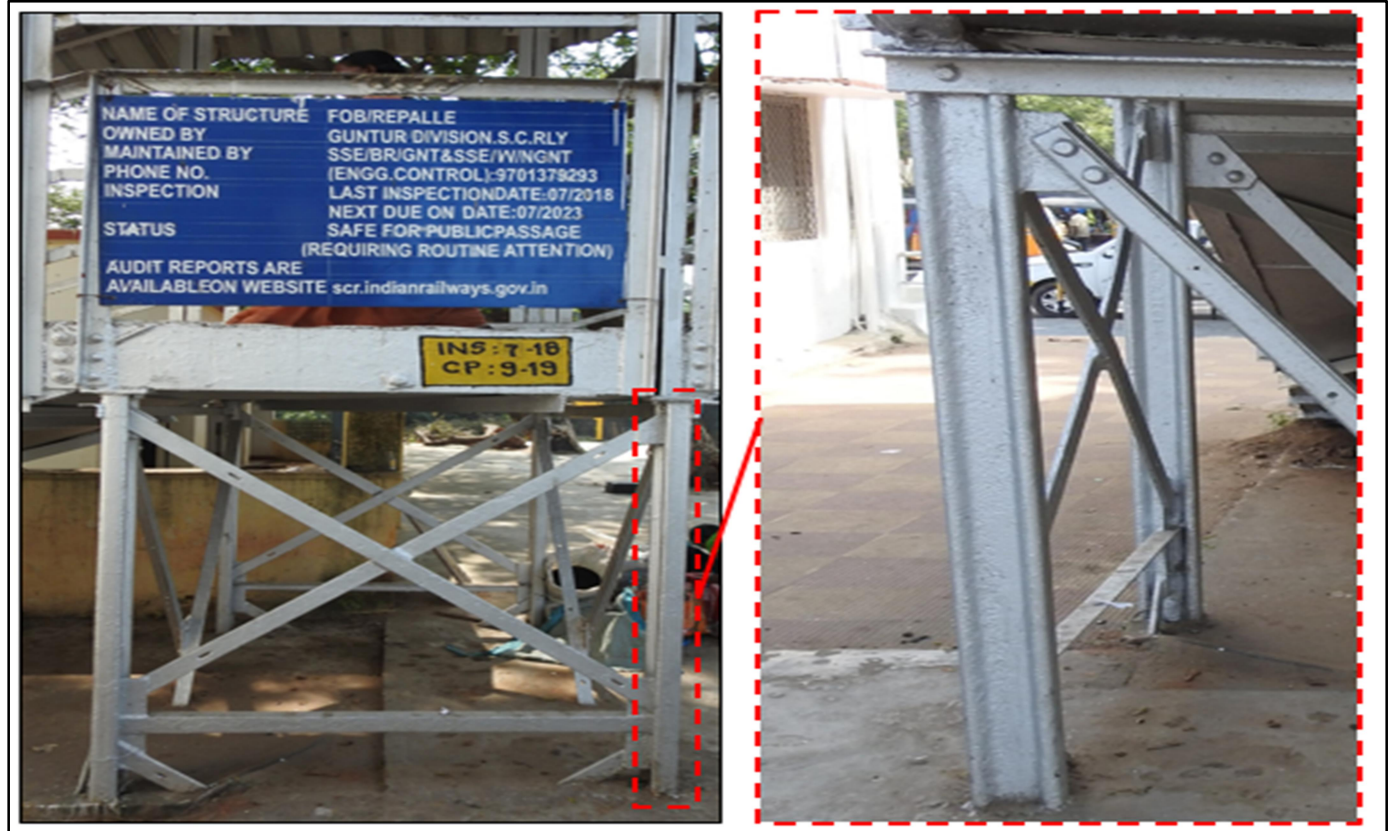
| | Type/Shape of Column section | Built up Section with Channels | a. FOB is supported on vertical column of Built-up Channel section 300 x 200, with bracings of 50 x 65 x 8 Angle section.<br>b. Stanchion 1 and 2 column has built up section of Two channels of ISMC 300 mm with Single lacing system of 65 x 14mm M.S flat. (Refer <b>fig : 4</b> )<br>c. Staircase Mid landing is supported by Rail section of 65 x 130 x 65mm, with bracings of 50 x 65 x 10 angle section and 64 x 14 M.S flat (Refer <b>fig : 7</b> ) |

**Fig 7: Staircase Mid-landing Rail Section Details**

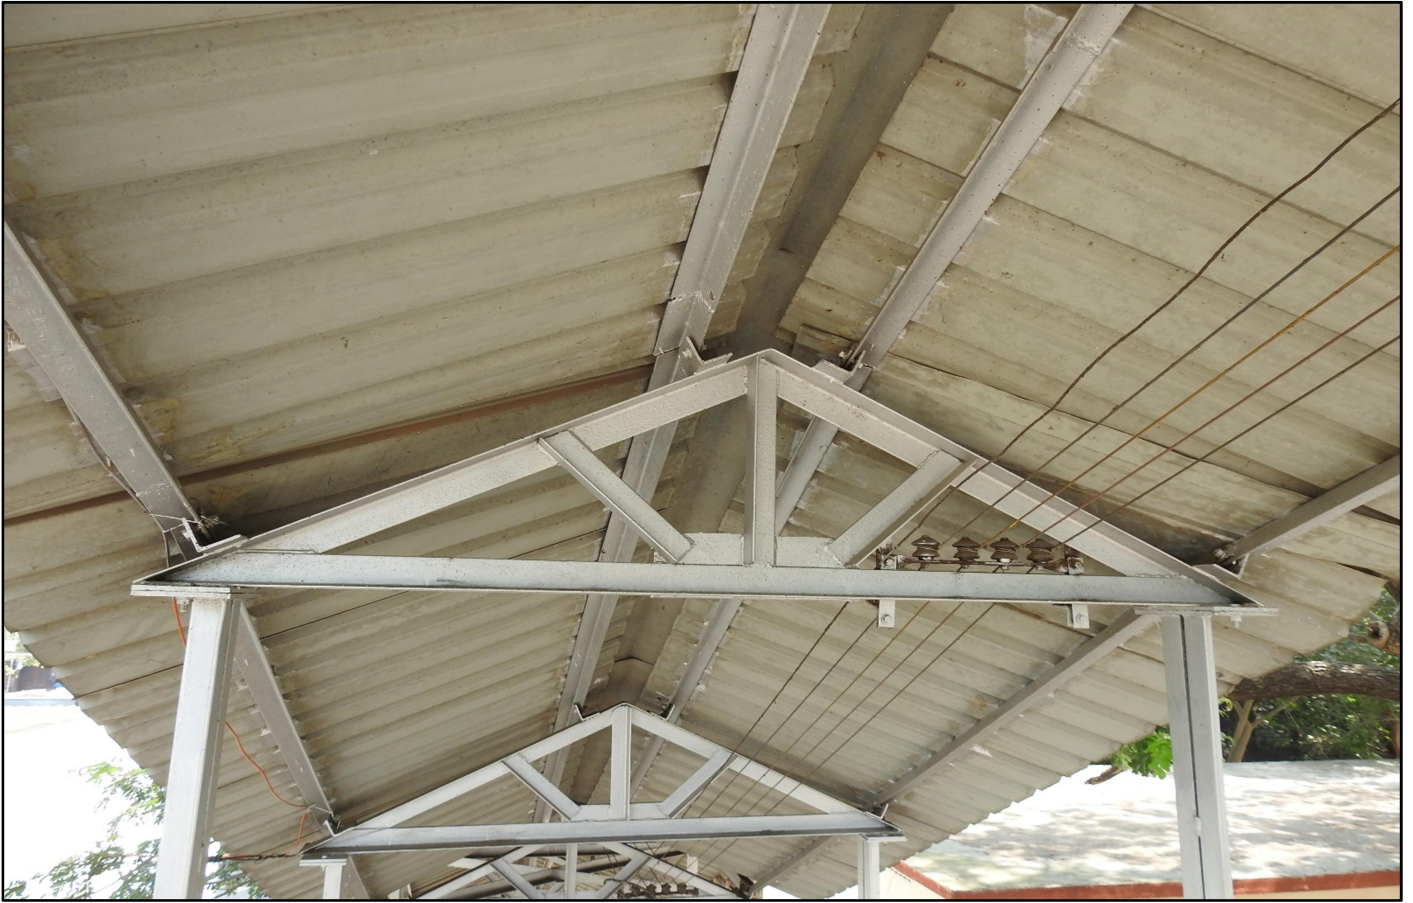
| | Element of roof truss section | Angle section | King post Truss of 75 x 75 x 8 mm Angles are used as Roof truss supported with bracings of 65 x 65 x 8 mm Angle section(Refer <b>fig: 9</b> ) |

***Fig 9:*** Insulated Electrical lines on Roof truss
