| <b>Name of the Project</b> | <b>:</b> | <b>VISUAL INSPECTION OF FOB/ PF-1 - PF-2 AT AMMANBROLU RAILWAY STATION</b> |
| <b>Location</b> | <b>:</b> | <b>AMMANABROLU RAILWAY STATION</b> |
| <b>Date of Inspection</b> | <b>:</b> | <b>04<sup>th</sup>NOVEMBER, 2019</b> |

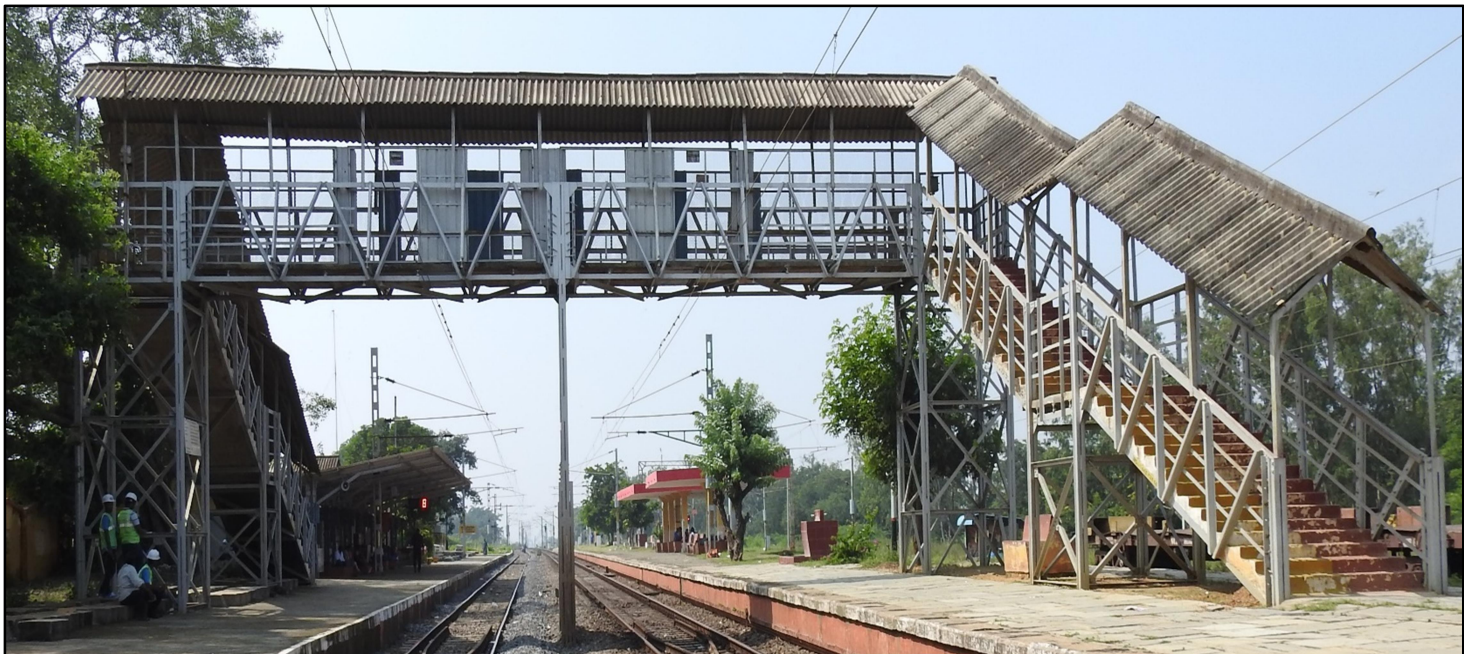
**Fig 1:** Front view of FOB

| PART 3 STRUCTURAL SYSTEM OF THE BRIDGE | | | |
|---|---|---|---|
| | Type /Shape of Truss Section | Rail section | a) Top and bottom Chord members are 50 x 100 x 90 (Head x Height x Base) Rail section (Refer <b>fig :1</b> )<br>b) 50 x 100 x 90 mm Rail sections are used as diagonal bracing members.<br>c) 50 x 100 x 90 mm Rail sections are used as Floor beams supported with Knee bracings 50 x 100 x 90 mm rail section to transfer load from slab to Top chord member.<br>d) Bottom Lateral Bracings 50 x 100 x 90 rail section in Zig-zag pattern are used to support Floor beams. |

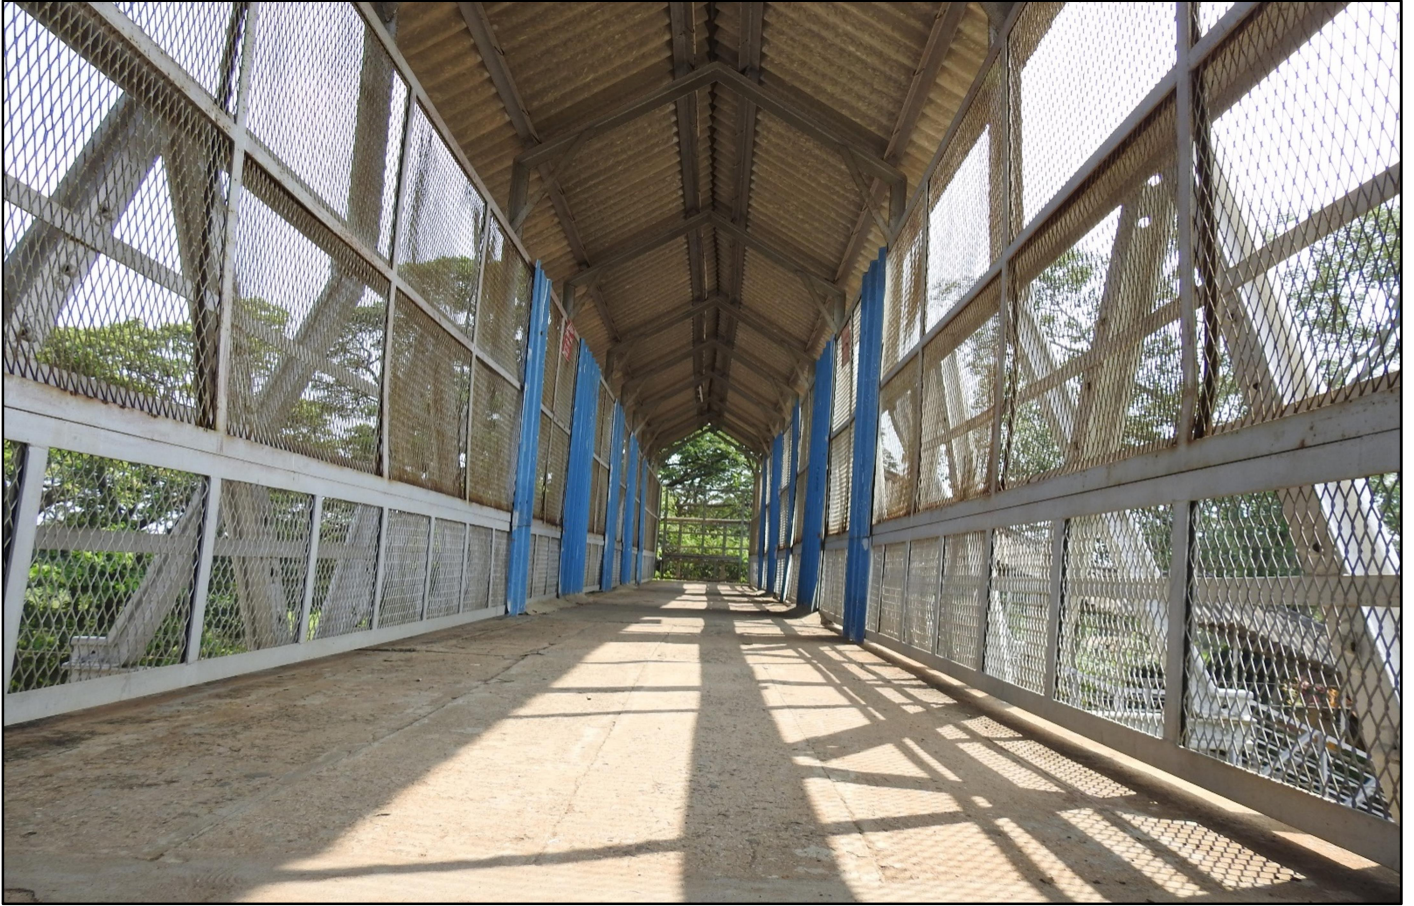
***Fig 2:*** Pathway, protective screen of FOB

| | | Yes/No | Notes |
|---|---|---|---|
| | a) Additional wearing coat on Floor | No | No additional wearing coat is observed on flooring (Refer <b>fig :2</b> ) |
| | b) Provision of protective screen for passengers | Yes | Fence made of galvanized wire of 2 mm gauge and 2 mm galvanized sheet is used above OHE Line on both side of pathway is used for passengers Protection. (Refer <b>fig :2</b> ) |

| PART 3 STRUCTURAL SYSTEM OF THE BRIDGE | | | |
|---|---|---|---|
| | Element of roof truss section | Angle section | Common Rafter Truss of 75 x 75 x 6 mm Angles are used as Roof truss supported on Vertical members of 75 x 75 x 6 mm Angle section (Refer <b>fig :2</b> ) |

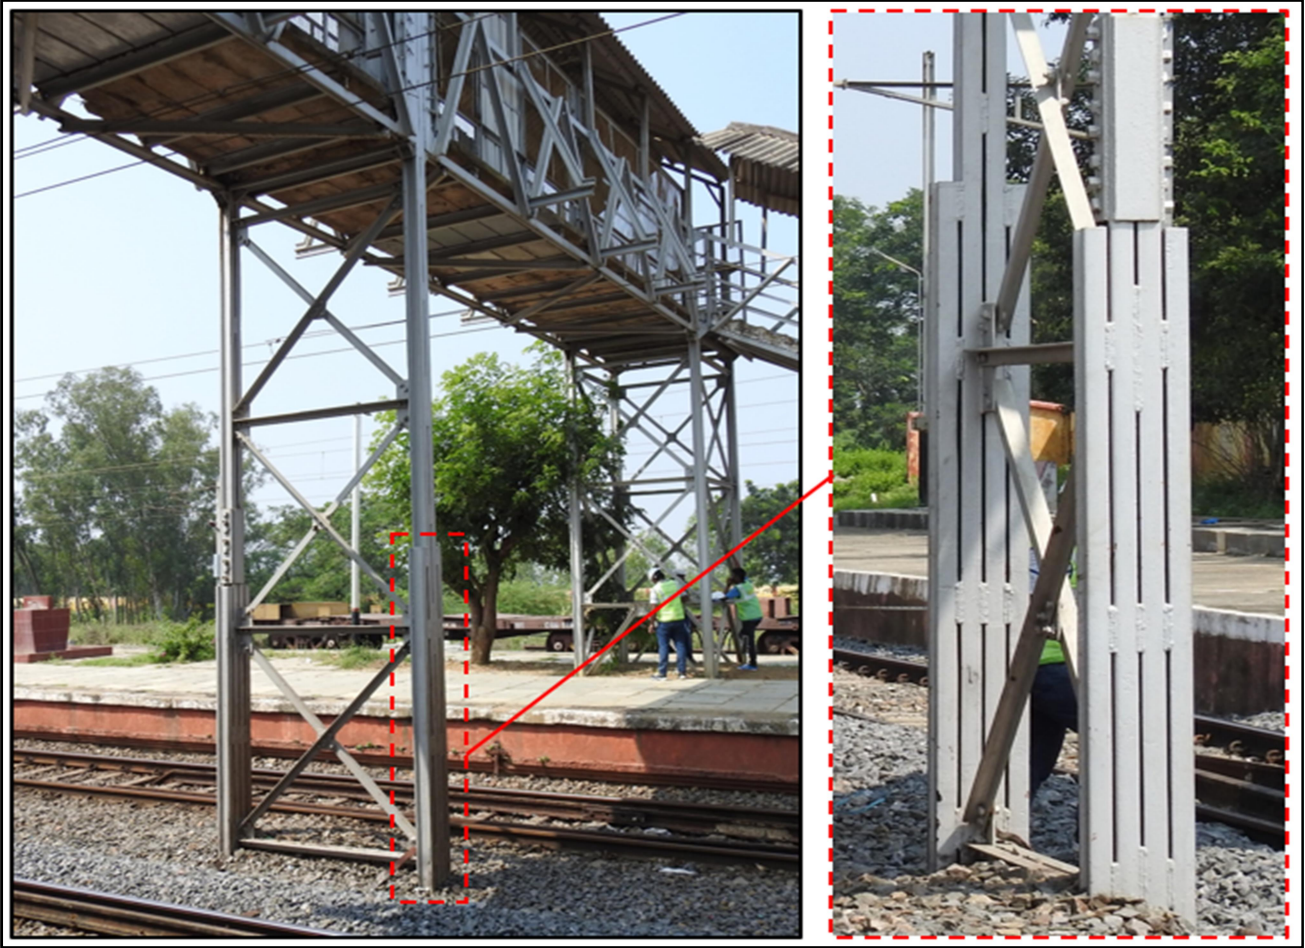
**Fig 4:** Stanchion column Rail sections details

| PART 3 STRUCTURAL SYSTEM OF THE BRIDGE | | | |
|---|---|---|---|
| | Type/Shape of Column section | Built up Rail Section | a. FOB is supported on vertical column of 2 Rail section 65 x 130 x 65mm with bracings of 65 x 65 x 10mm angle section<br>b. Trestles 1 and 3 have 4 columns whereas Trestle 2 (Stanchion) have only 2 columns. (Refer Fig 4)<br>c. Stanchion column has built up section of 4 rail sections 65 x 130 x 65mm up to a height of 2.4 m and continued with 2 rails, Supported by bracings of 65 x 65 x 10 mm angle section (Refer <b>fig : 4</b> )<br>d. Staircase landing is supported by 2 Rail section of 65 x 130 x 65mm, with bracings of 65 x 65 x 10 mm angle section (Refer <b>fig :6</b> ) |

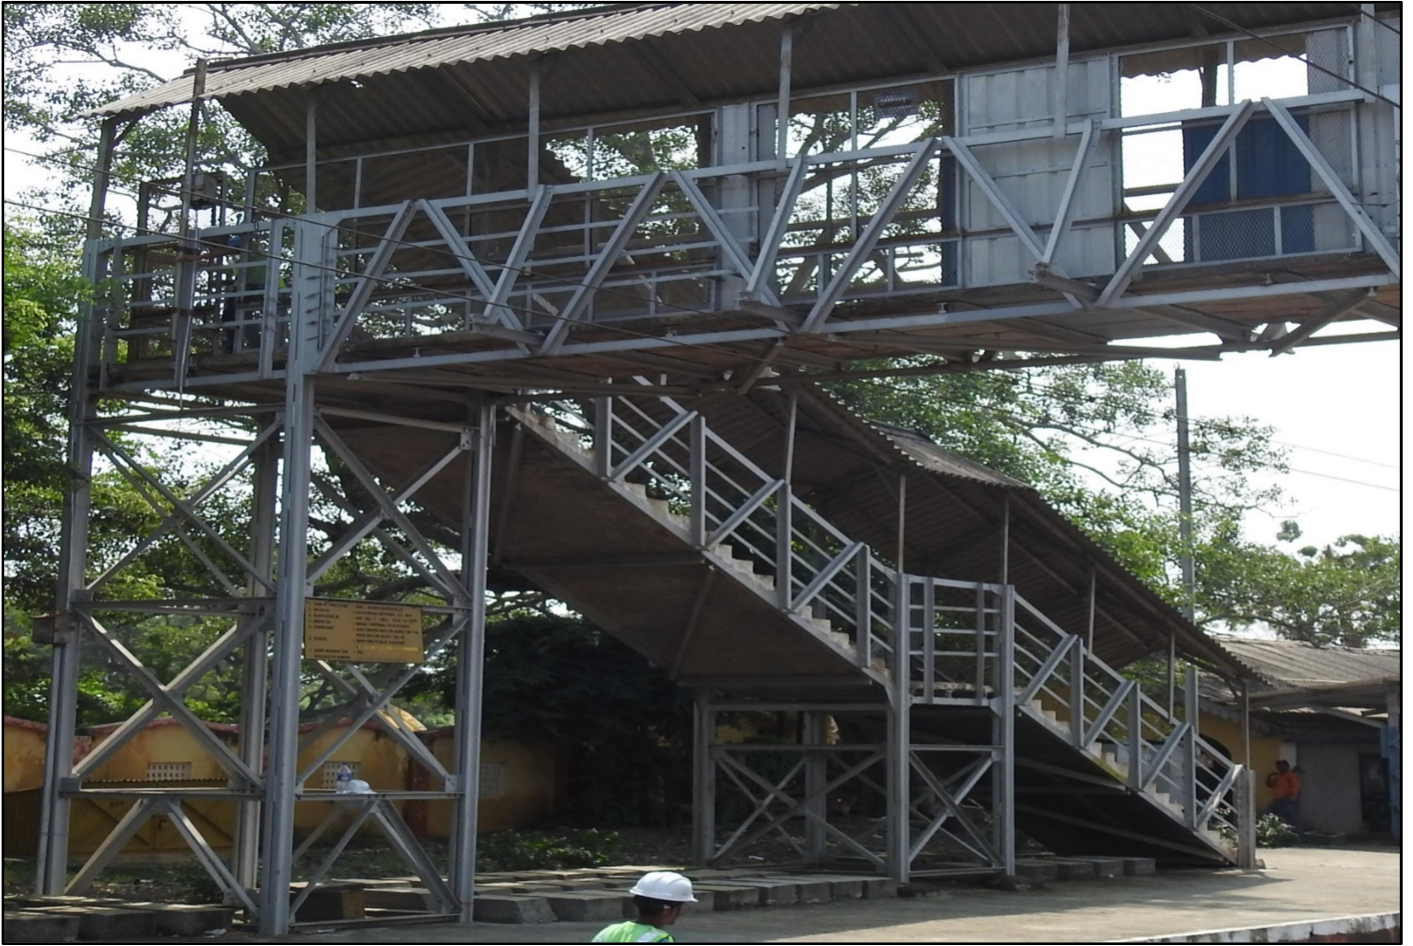
***Fig 5:*** Staircase bottom view

| | Number of Staircase | 2 Nos | Staircase is observed as Cast In-situ RCC Slab supported on 50 x 100 x 90mm Rail tie beam and 50 x 100 x 90mm Rail Stringer beam on both sides of stair case.(Refer <b>fig :5</b> ) |
