**Name of the Project** : VISUAL INSPECTION OF ROB NO. 871A  
**Location** : NEAR GUNTAKAL RAILWAY STATION  
**Location Co-ordinates** : 15°10'23.3"N 77°22'19.6"E  
**Date of Inspection** : 25<sup>th</sup> NOVEMBER, 2019

## VISUAL INSPECTION OF ROAD OVER BRIDGE

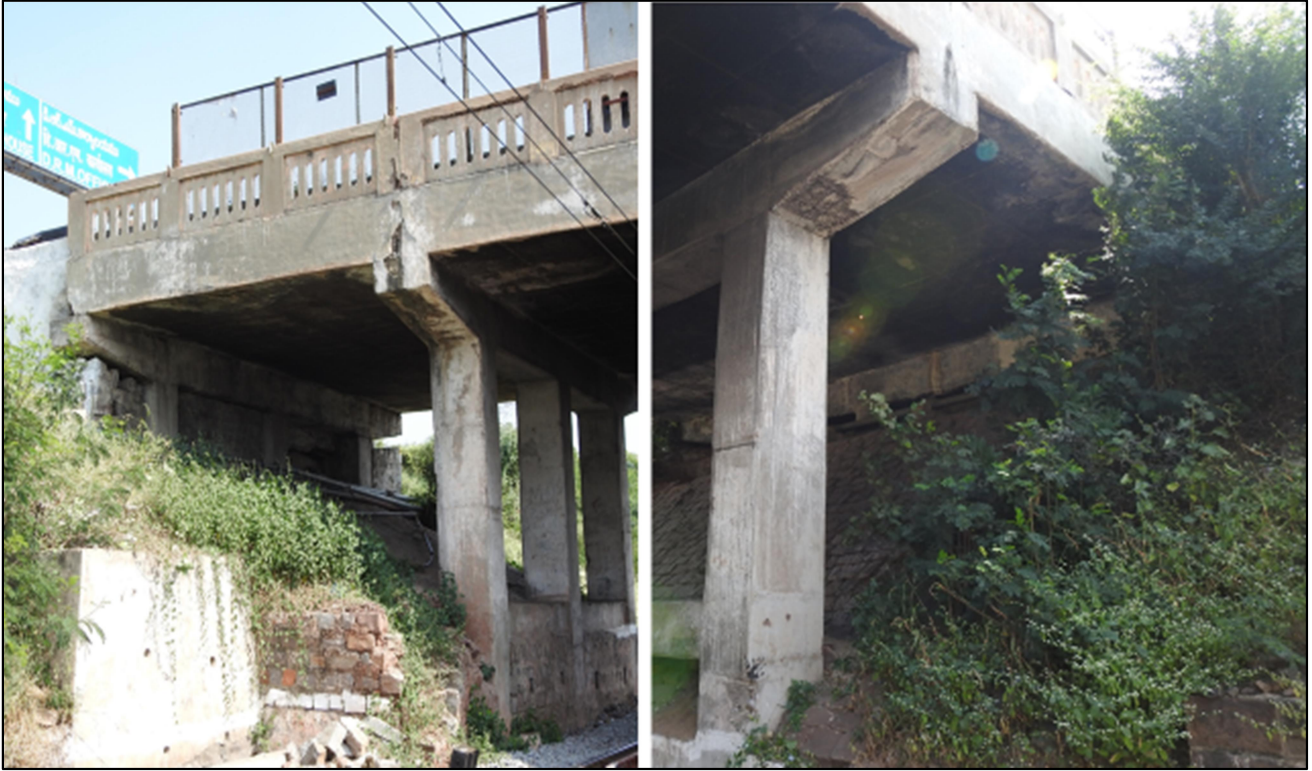
**Fig: 2** View of Abutment (A1 and A2)

| PART 2 STRUCTURAL SYSTEM OF THE BRIDGE | | | |
|---|---|---|---|
| | Condition (Crack, Settlement, Scour, Tilting, Steel Corrosion, Strains and other damages etc...) | Fair Condition | Cracks, Spalling, Delamination and Reinforcement exposure observed |

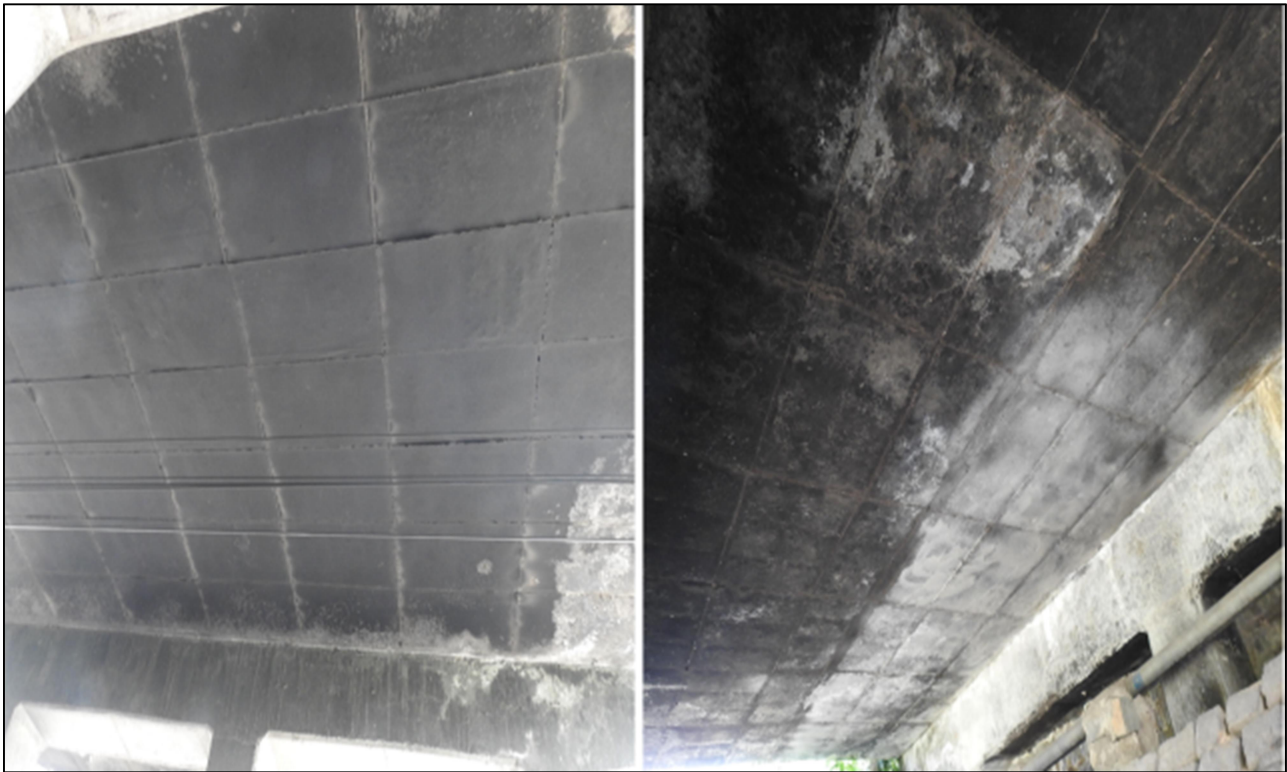
**Fig: 3** Bottom view of Slab

| | Condition of Slab from Bottom | Distress Found | Cracks, Spalling & Reinforcement exposure has been Observed. (Refer Fig:10, 15) |
