| <b>Name of the Project</b> | <b>:</b> | <b>VISUAL INSPECTION OF ROB No 1216A<br/>NEAR YADGIR RAILWAY STATION</b> |
| <b>Location</b> | <b>:</b> | <b>YADGIR</b> |
| <b>Date of Inspection</b> | <b>:</b> | <b>23<sup>rd</sup> NOVEMBER, 2019</b> |

## VISUAL INSPECTION OF ROAD OVER BRIDGE

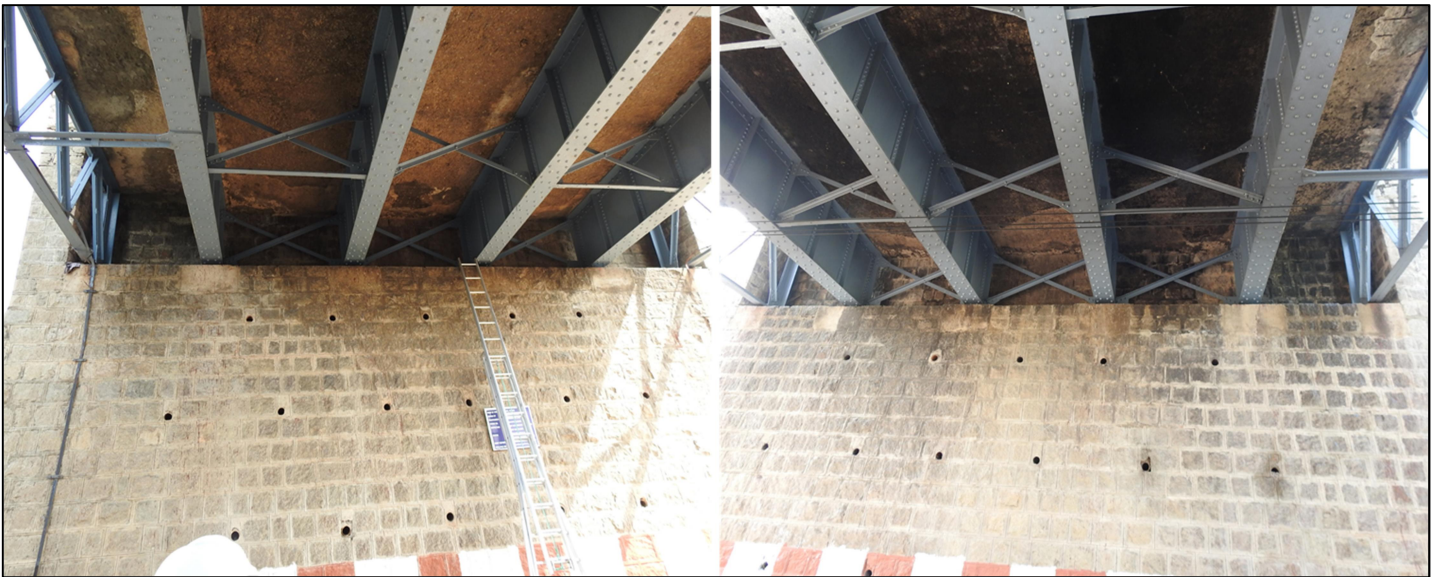
**Fig: 3** Bottom view

| PART 2 STRUCTURAL SYSTEM OF THE BRIDGE | | | |
|---|---|---|---|
| | Efficiency of drainage of backfill Behind Abutments (Check functioning of weep holes, evidence of moisture on Abutment faces, etc.) | | Weep holes are in dry condition. (Refer Fig:3) |

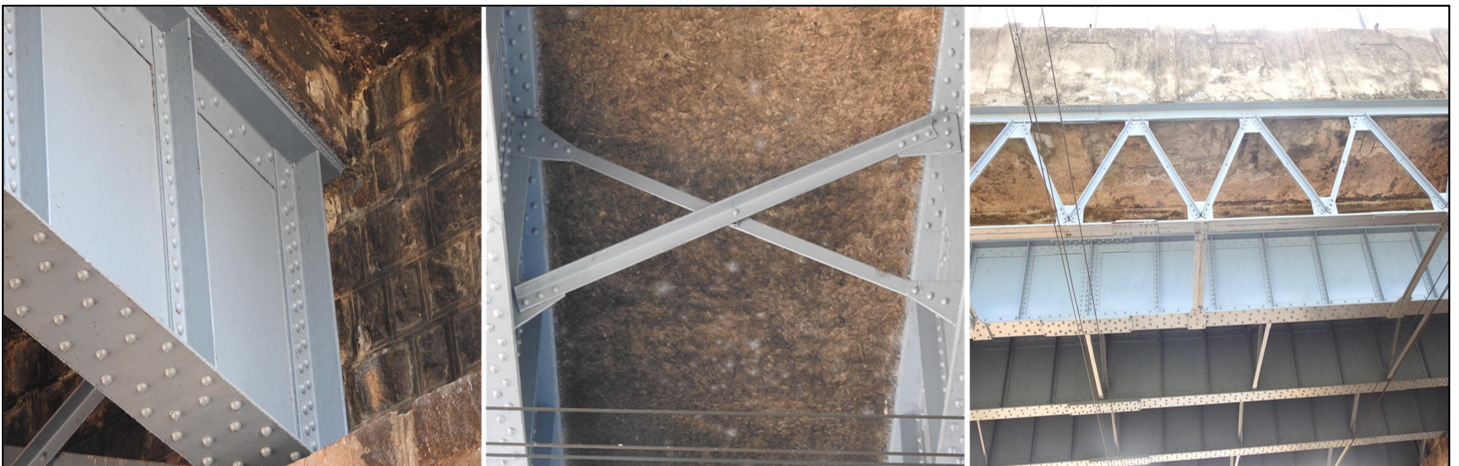
**Fig: 4** View of Longitudinal & Cross Girders
