| <b>Name of the Project</b> | <b>:</b> | <b>VISUAL INSPECTION OF ROB 295A</b> |
| <b>Location</b> | <b>:</b> | <b>NEAR KOMMARAPUDI RAILWAY STATION</b> |
| <b>Date of Inspection</b> | <b>:</b> | <b>28<sup>th</sup> NOVEMBER, 2019</b> |

## VISUAL INSPECTION OF ROAD OVER BRIDGE

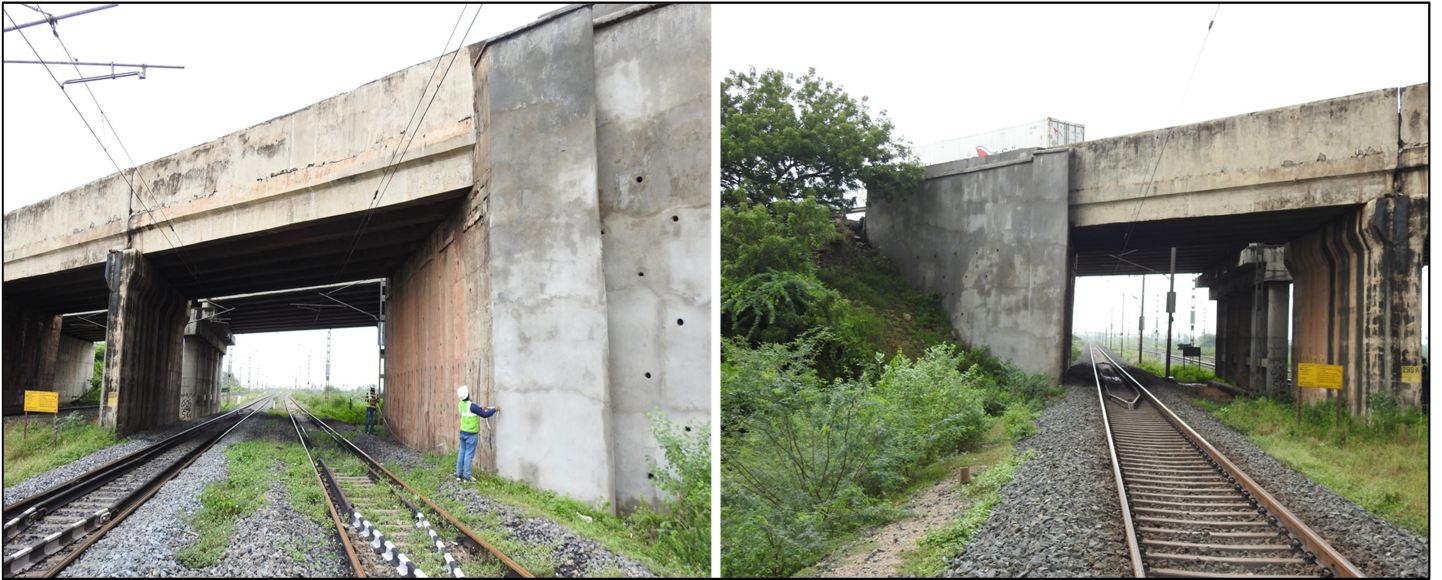
***Fig: 2*** View of Abutments (A1 and A2)

| PART 2 STRUCTURAL SYSTEM OF THE BRIDGE | | | |
|---|---|---|---|
| | Condition (Crack, Settlement, Scour, Tilting, Steel Corrosion, Strains and other damages etc...) | | Cracks, Spalling, Honeycombing, Reinforcement exposure are observed at Abutment<br><br>Patching works and Epoxy grouting done. |

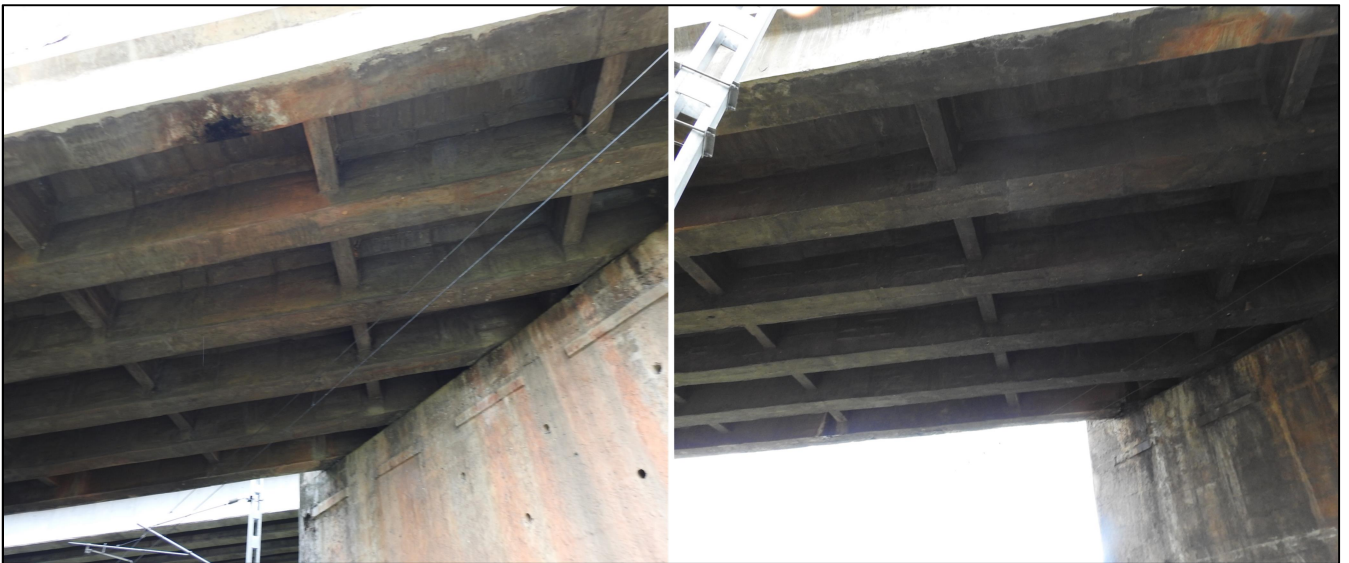
***Fig: 3*** Bottom view of Bridge

| | Condition of Slab from Bottom | | Leaching has been Observed. |
