## 1. VISUAL INSPECTION REPORT

| <b>Name of the Project</b> | : VISUAL INSPECTION OF FOB AT MALKAJGIRI RAILWAY STATION |
| <b>Location</b> | : MALKAJGIRI RAILWAY STATION |
| <b>Date of Inspection</b> | : 4 <sup>th</sup> March 2020. |

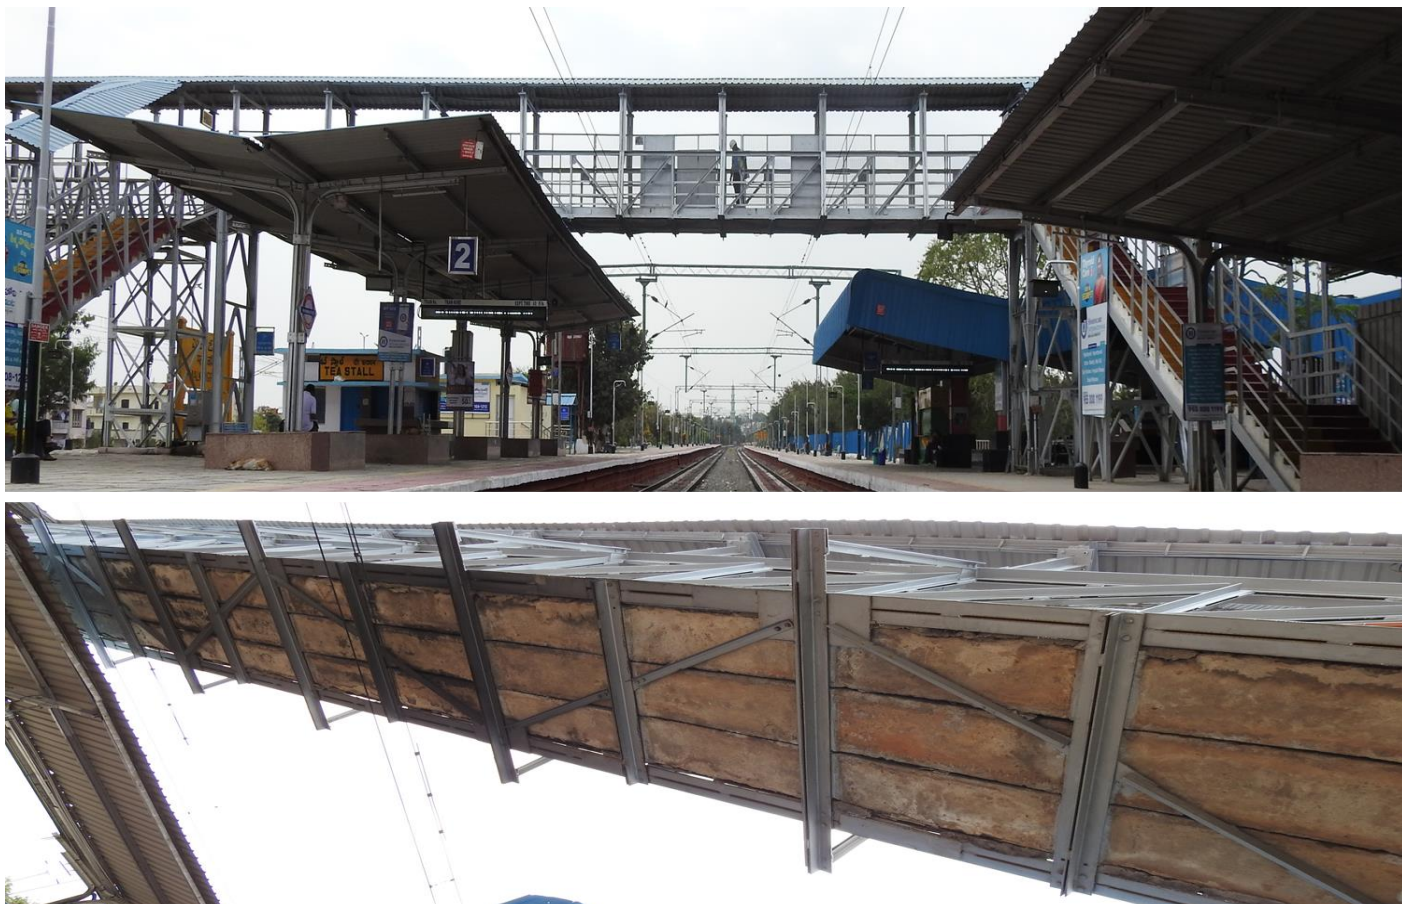
**Fig 3:** Front view and bottom view of span 1

- a. ✓ Spalling and Reinforcement exposure of RCC slab observed along the 1<sup>st</sup> span of FOB

Spalling and reinforcement exposure in span 1

Spalling at bottom chord and slab panels connecting joint

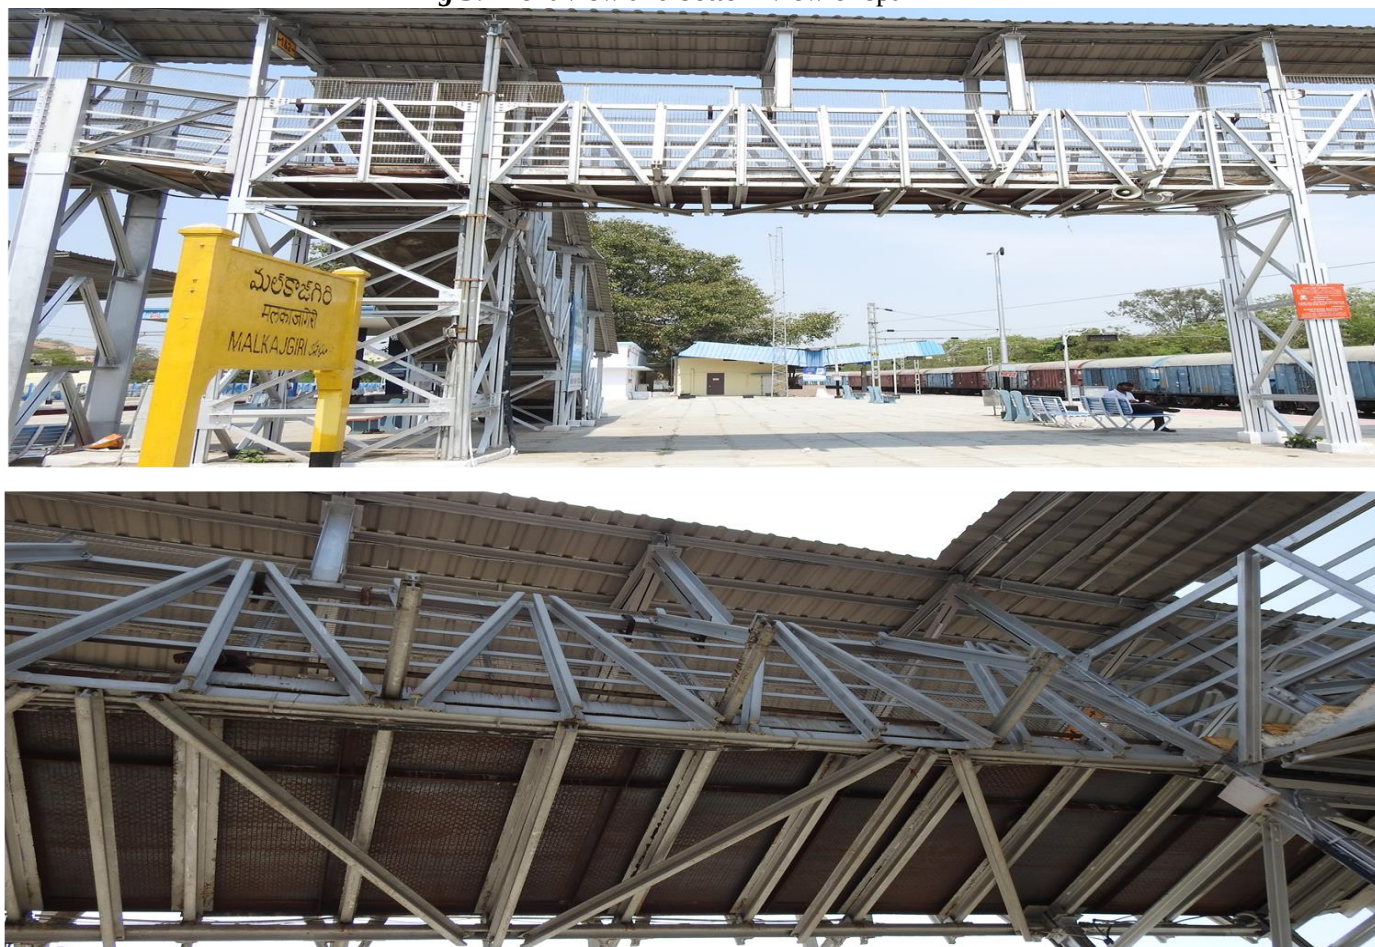
**Fig 4:** Front view and bottom view of span 2

b. ✓ Slight Corrosion is observed floor beams of span 2

Slight Corrosion of Floor beams

| SURVEY OF SIGNS OF DISTRESS, DEFORMATION IN BRIDGES | | | |
|---|---|---|---|
| | Extent of Corrosion | Floor beams | Slight corrosion is observed at floor beams of span 2 (Refer <b>Part 1.4 – 1.4(b)</b> ) |

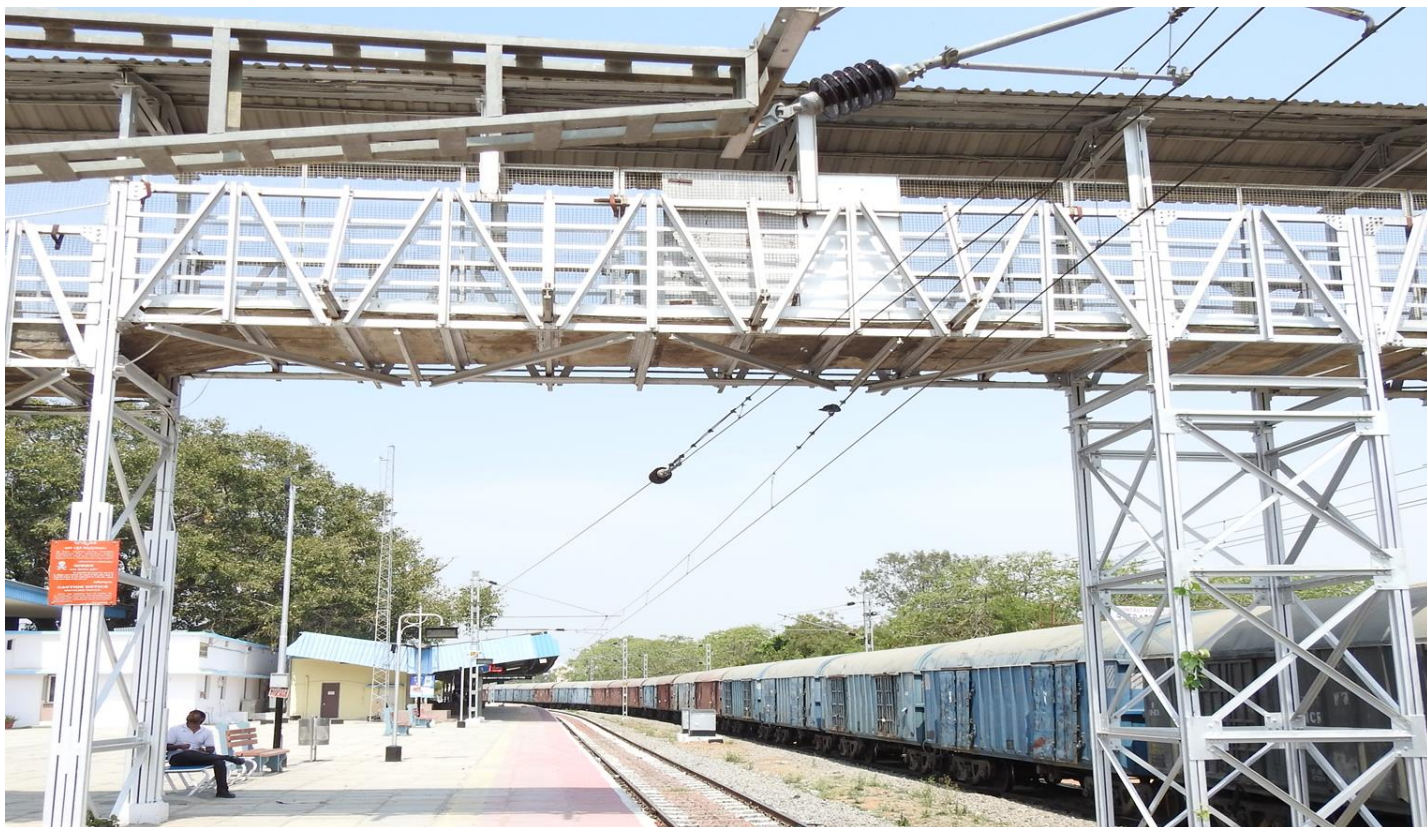
**Fig 5:** Front view and bottom view of span 3

- a) Spalling and reinforcement exposure is observed at floor slab of span 3 and at floor slab and steel joint along the 1<sup>st</sup> span
- b) Spalling is also observed at Staircase 2 and 3
- c) Slight corrosion is observed at bottom chord members.
