## 1. VISUAL INSPECTION REPORT

| <b>Name of the Project</b> | : | VISUAL INSPECTION OF FOB AT FALAKNUMA RAILWAY STATION |
| <b>Location</b> | : | FALAKNUMA RAILWAY STATION |
| <b>Date of Inspection</b> | : | 3 <sup>rd</sup> March 2020 |

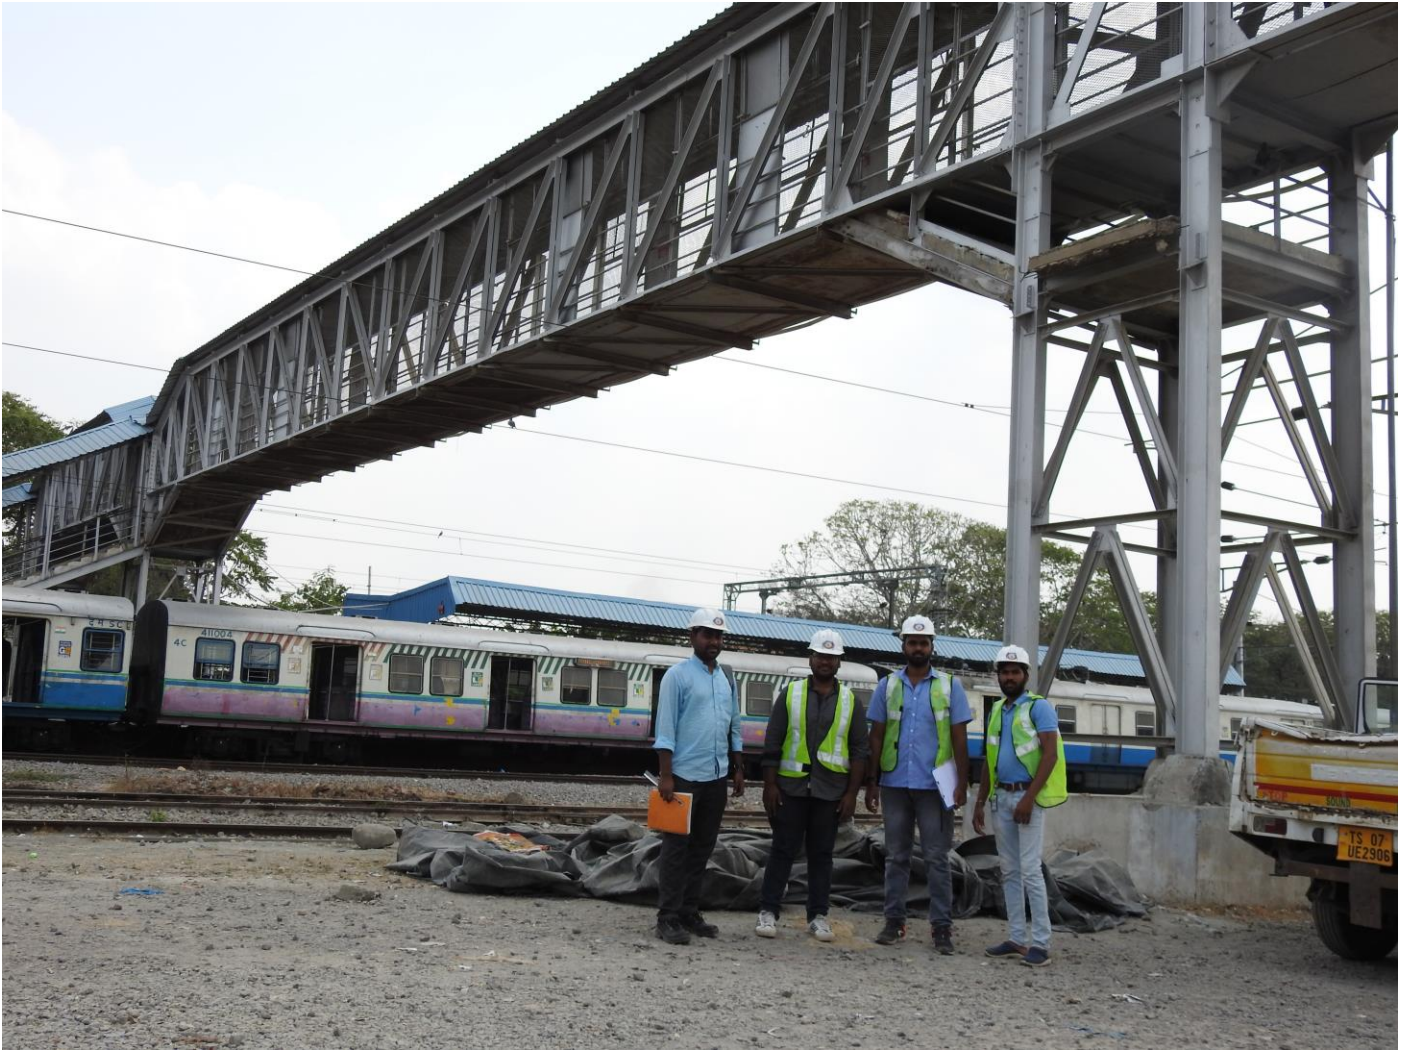
**Fig 6:** Staircase details

| | Number of Staircase | 3 no's | Staircase steps are observed as RCC slab, Steps are supported on stringer beams of ISMB 250 section, horizontal members of ISMB 150 and diagonal bracings with 65 x 65 x 8mm angle sections.<br>(Refer <b>fig :6</b> ) |
| | Type of Parapet Railing | Steel railing | Staircase is provided with railing on both sides of one-meter height using 65 x 65 x 8 mm double angle sections and 35 mm dia MS pipes are used. (Refer <b>fig :6</b> ) |
