## Third Party Audit of ROB's and FOB's of SCR

### INSPECTION OF FOB AT NAMPALLY RAILWAY STATION

**Final Report**  
SEPTEMBER | 2020

| Name of the Project | : | VISUAL INSPECTION OF FOB/ PF-2 - PF-6 AT HYDERABAD RAILWAY STATION |

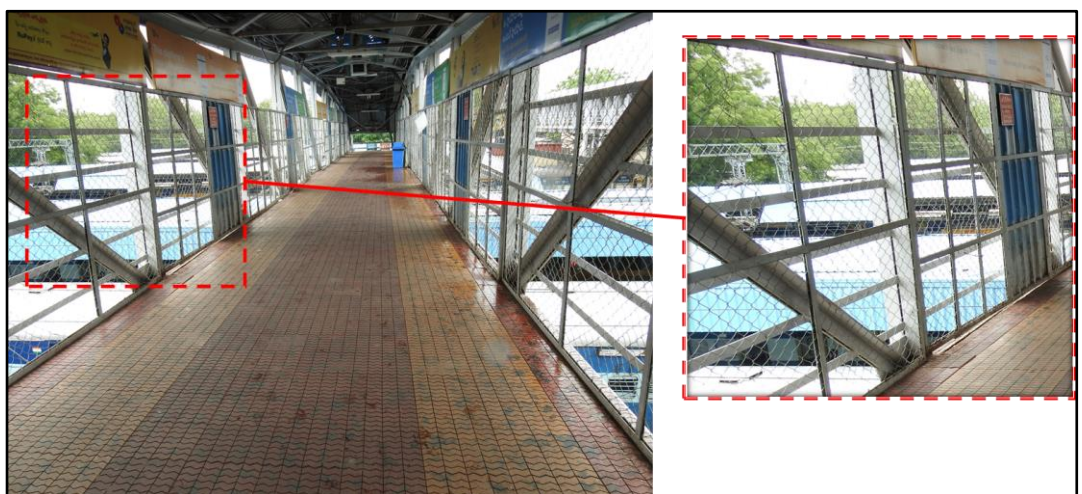
**Fig 1.3:** Provision of protective screen for passengers over FOB

| 1.2 IDENTIFICATION OF LOADS ON BRIDGE | | | |
|---|---|---|---|
| | b) Provision of protective screen for passengers | Yes | Chain link fence made of galvanized wire of 2 mm Gauge and metal sheet is used above OHE line on both sides of pathway is used for protection, mesh is supported by angular sections and flats. (Refer <b>fig :1.3</b> ) |

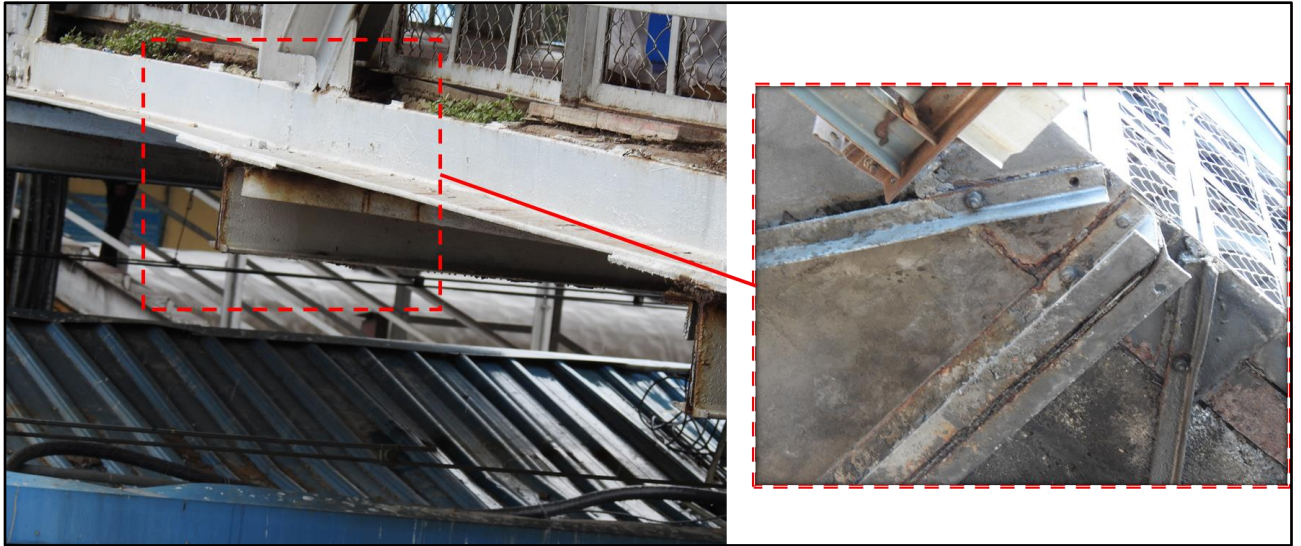
**Fig 1.6:** Main and Secondary girder with joint details

| | Type/Shape of Secondary Girder /Bracings | Double Channel and Angular section | ISMC 150 Double Channel are used as secondary girders supported with 65 x 65 x 8 mm angular sections to transfer load from slab to roof truss. Secondary girders are connected with tie member using bolts and bracing are connected to tie members using welding (Refer <b>fig :1.6</b> ) |

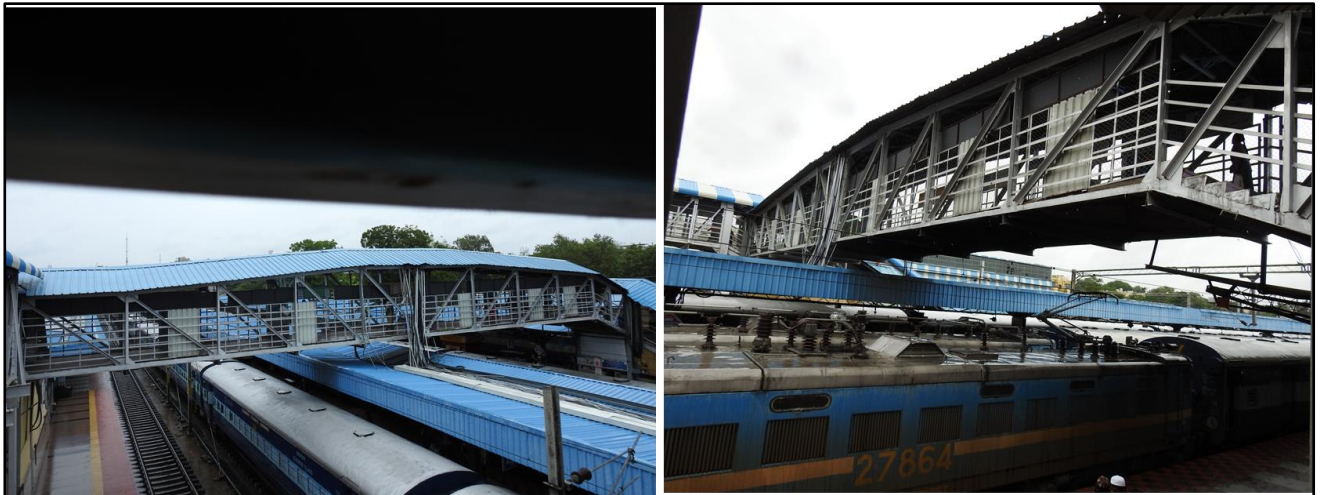
**Fig 1.7:** Arrangement of Bracings

| | Type/Shape of Girder Section | Angular section | a. Main tie members 100x100x12 mm Double angular section<br>b. 65 x 65 x 8 mm double angular are used as bracing members<br>c. 10 mm thick gusset plate is used for welded joint (Refer <b>fig :1.7</b> ) |

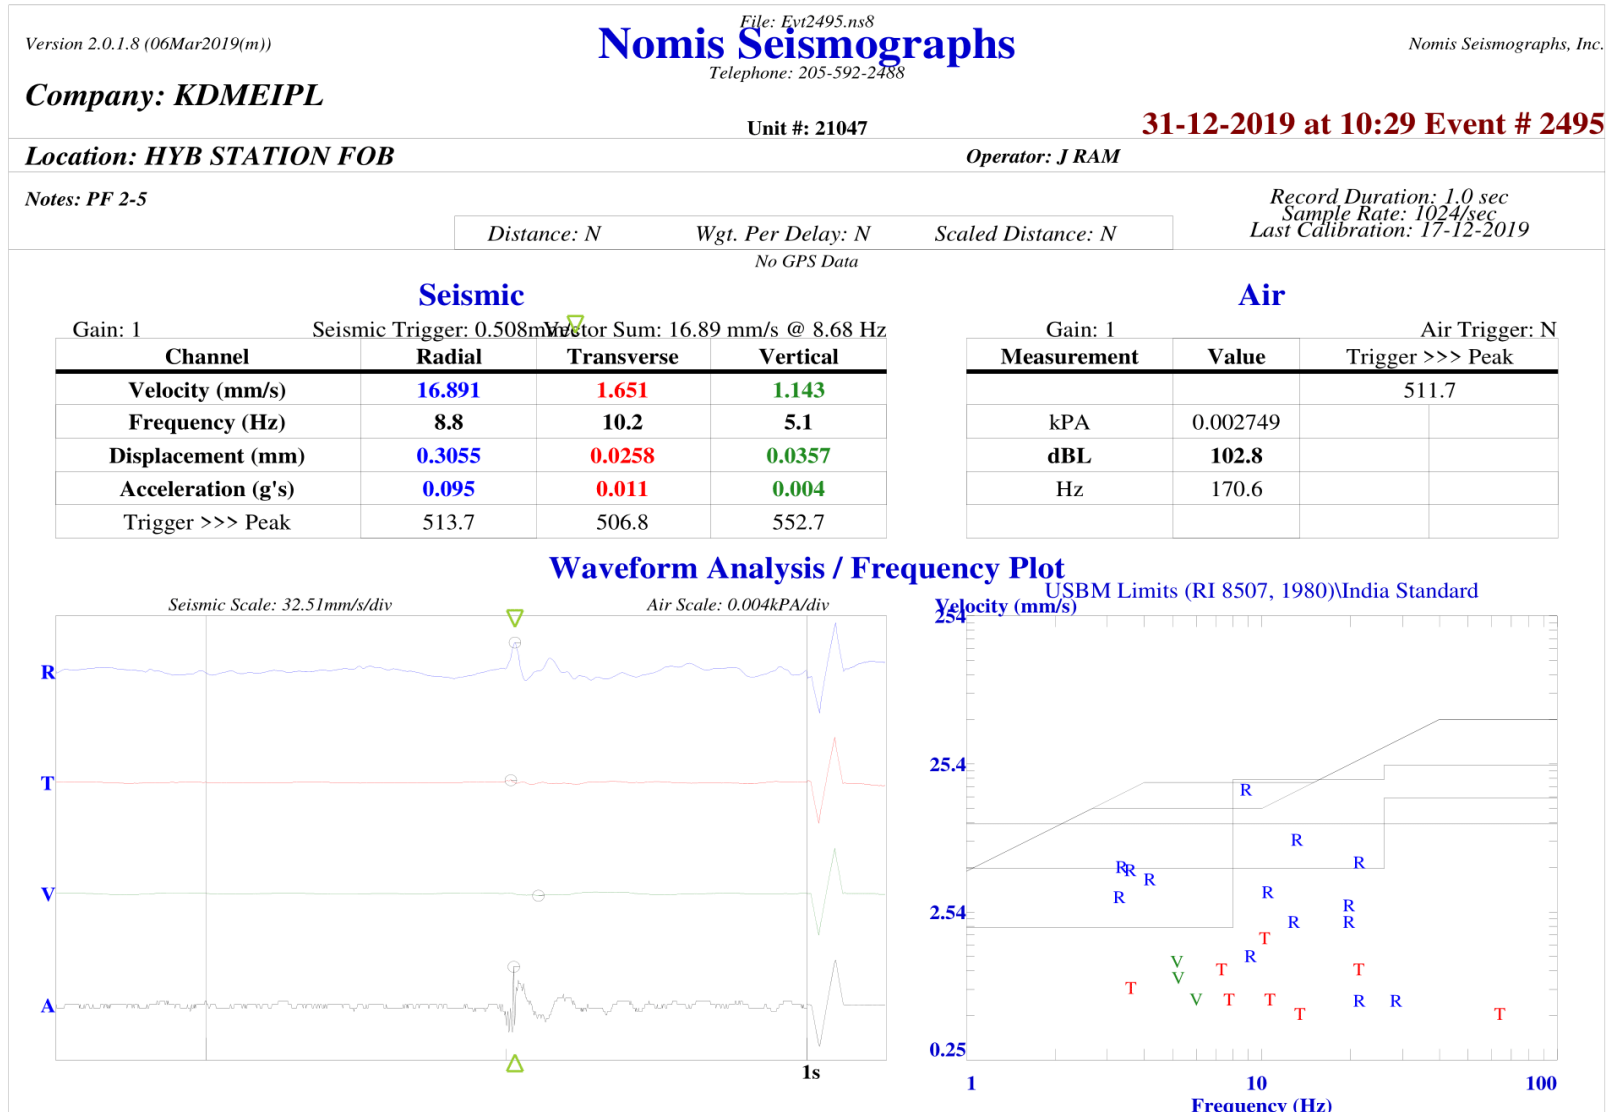
Based on the vibration analysis carried out the structure is undergoing more vibrations than permissible. (Frequency observed is 540 cpm and maximum amplitude observed during the test time of complete 3hrs is 0.305 mm)
