# Third Party Audit of ROB's and FOB's Of SCR

## INSPECTION OF FOB AT KHAIRTHABAD RAILWAY STATION

**Final Report**  
SEPTEMBER | 2020

| <b>Name of the Project</b> | : | INSPECTION OF FOB/ PF-1 - PF-2 AT KHAIRTABAD RAILWAY STATION |

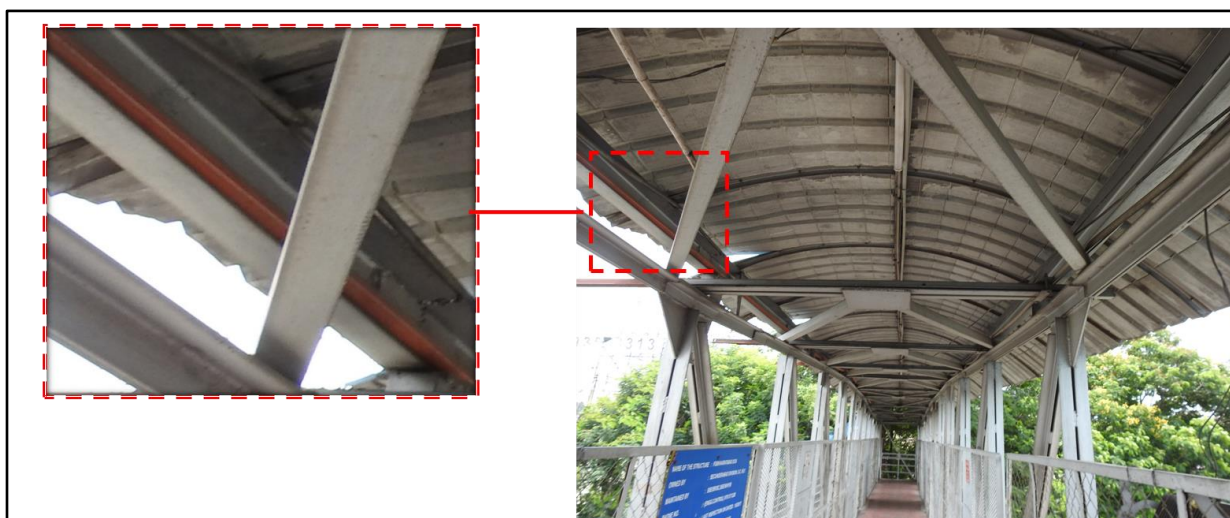
**Fig 1.1:** Electrical Cables, Roof truss and Roof sheet

| 1.2 IDENTIFICATION OF LOADS ON BRIDGE | | | |
|---|---|---|---|
| | c) Roof Truss | Yes | 30 x 30 x 4 mm Angles are used (Refer <b>fig :1.1</b> ) |
| | d) Roof Sheet | Yes | Steel Metal Sheet is used for Roof (Refer <b>fig :1.1</b> ) |

| 1.3 STRUCTURAL SYSTEM OF THE BRIDGE | | | |
|---|---|---|---|
| | Element of roof truss section | Semi-circular angular truss | 30 x 30 x 4 mm Semi-circular Angular section are used for roof truss, supported on 65 x 65 x 8mm Tie Members using welded joints. (Refer <b>fig :1.1</b> ) |

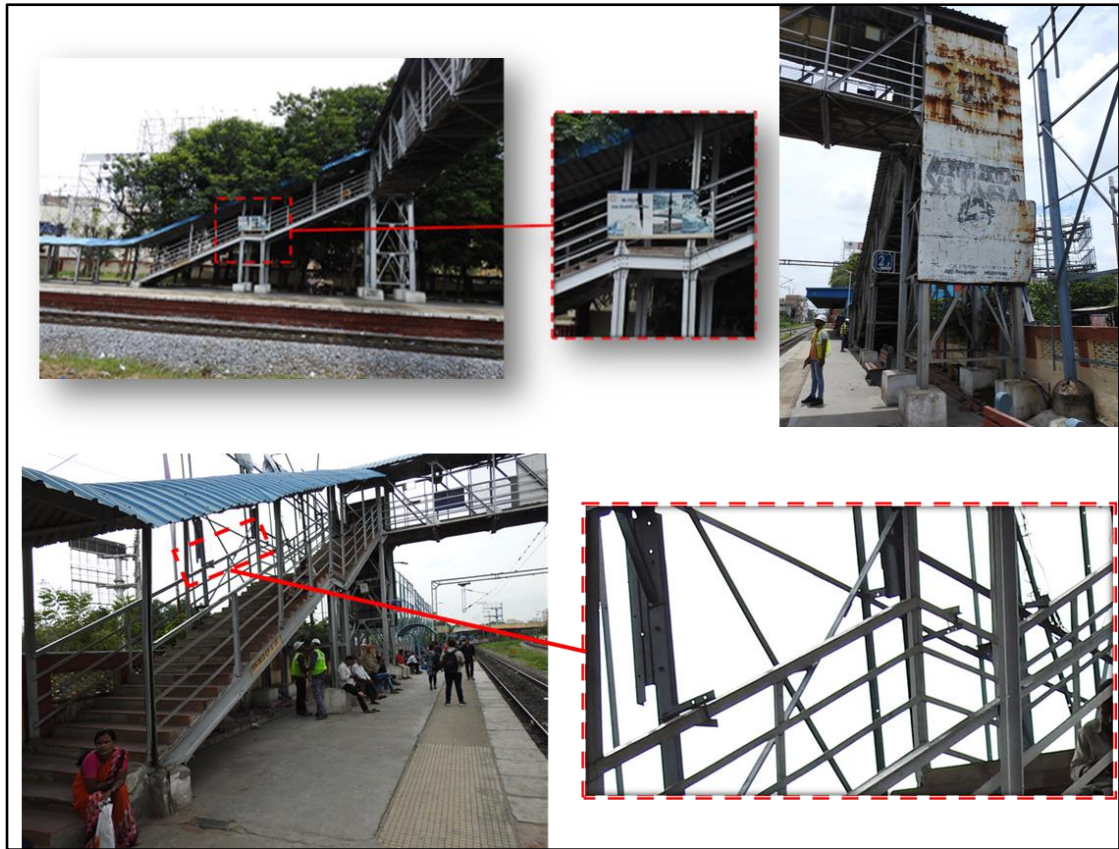
**Fig 1.2:** Load of Advertising Hoarding and staircase details

| 1.2 IDENTIFICATION OF LOADS ON BRIDGE | | | |
|---|---|---|---|
| | e) load of advertising hoarding | Yes | Advertising boards are provided (Refer <b>fig :1.2</b> ) |

| | Type of Parapet Railing | Steel Railing | Stair case is provided with Railing on both sides of one-meter height using Angular and Hollow Circular sections. <u>Billboard is partially supported to staircase railing and landing vertical supports</u> (Refer <b>fig :1.2</b> ) |

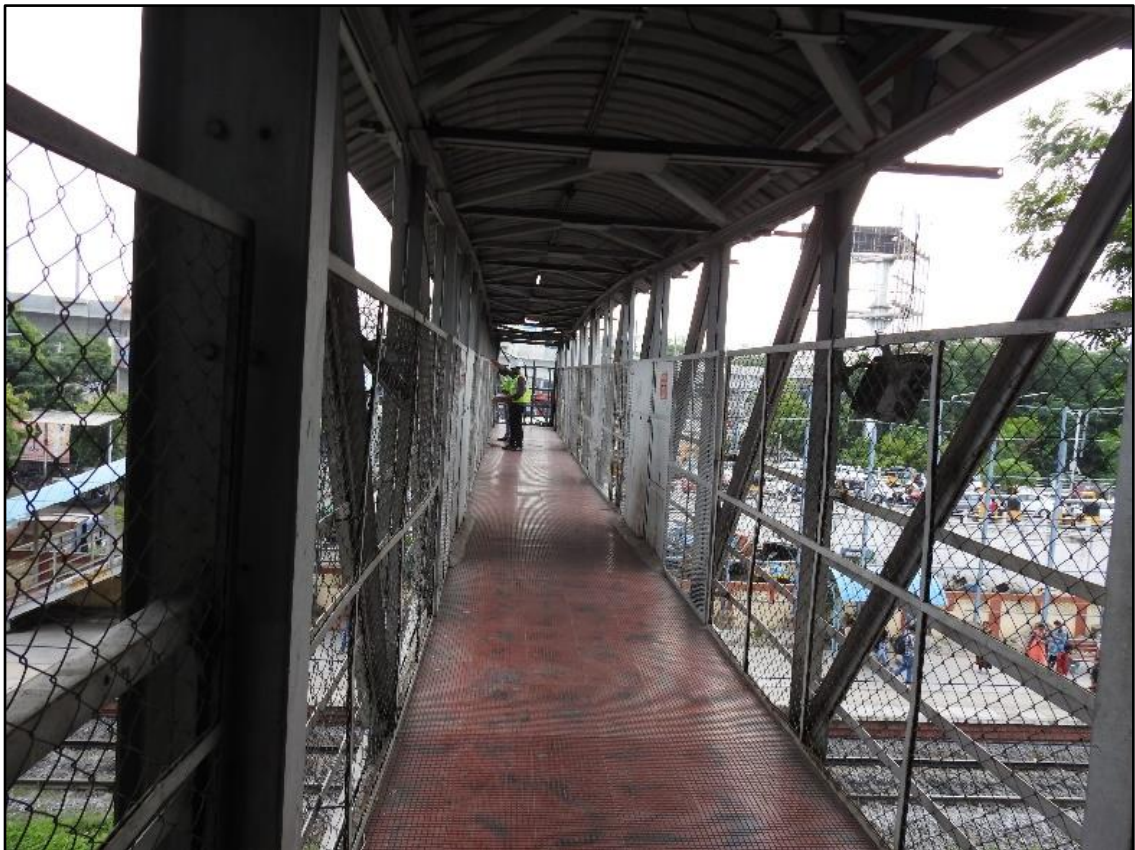
**Fig 1.3(a):** Galvanized wire mesh and Flooring

| 1.2 IDENTIFICATION OF LOADS ON BRIDGE | | | |
|---|---|---|---|
| | a) Additional wearing coat on Floor | No | Only Chequered tiles used for Flooring (Refer <b>fig :1.3</b> ) |
| | b) Provision of protective screen for passengers | Yes | Chain link fence made of Galvanized wire of 2 mm gauge and 2 mm Galvanized sheet is used above OHE Line on both side of Gangway is used for Protection. (Refer <b>fig :1.3</b> ) |

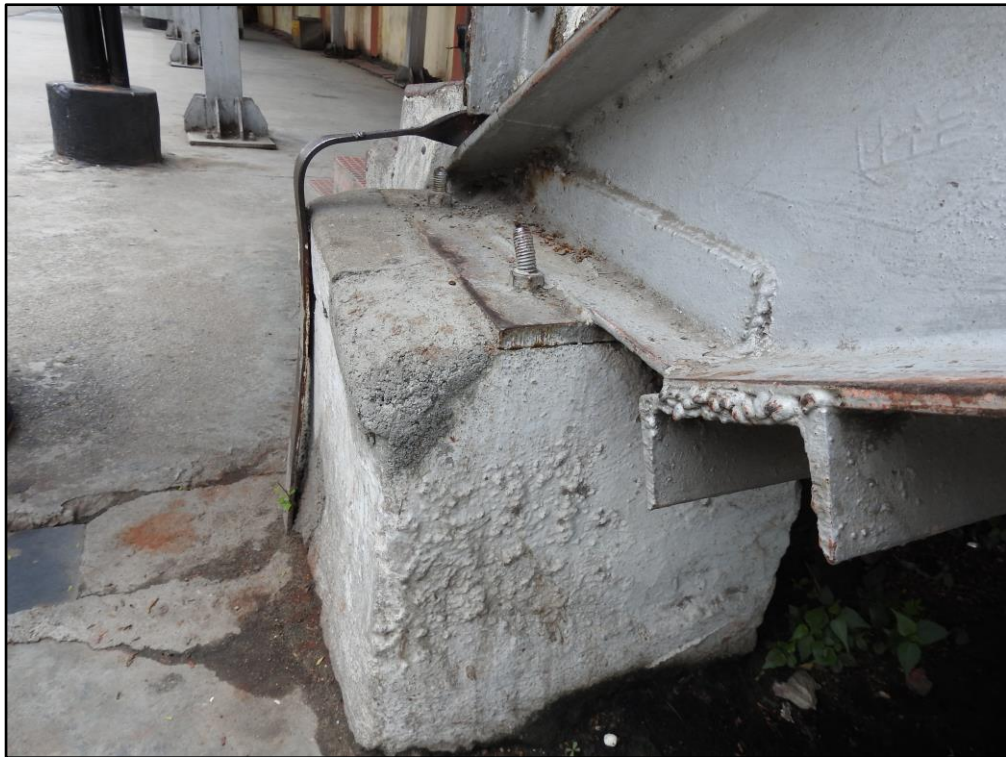
**Fig 1.3(b):** Base plate at staircase

| 1.3 STRUCTURAL SYSTEM OF THE BRIDGE | | | |
|---|---|---|---|
| | a) No of Bolts and size | Not visible, filled with concrete | Base plate is observed at staircase, partially covered by concrete (Refer <b>fig :1.3(a)</b> ) |

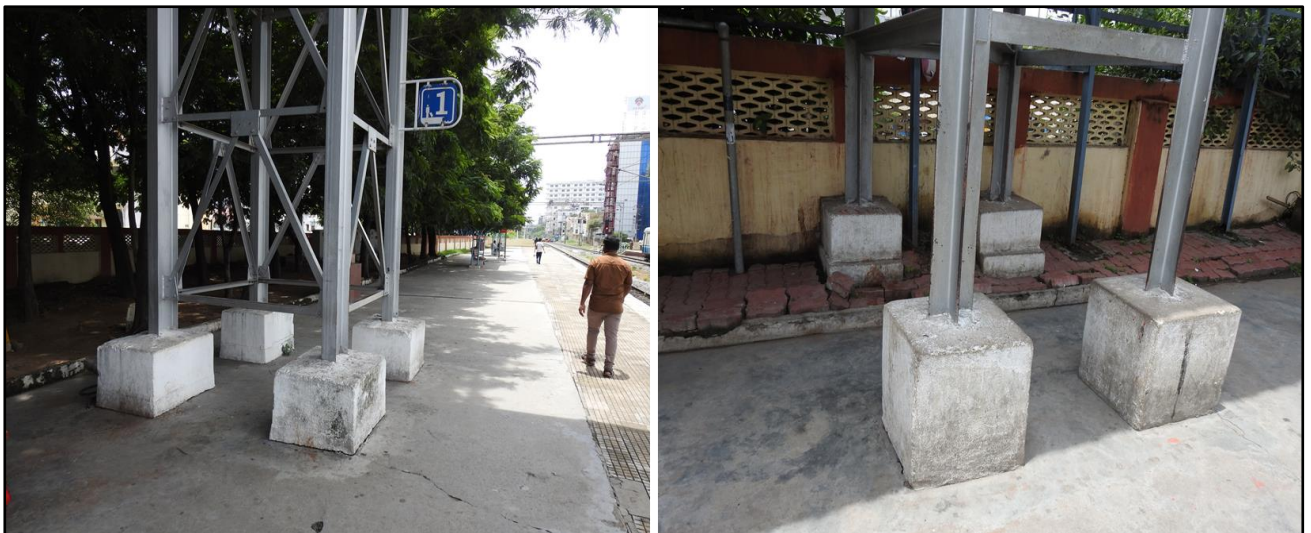
**Fig 1.4:** Concrete encasements

| 1.3 STRUCTURAL SYSTEM OF THE BRIDGE | | | |
|---|---|---|---|
| | Type of Material | Concrete | *To protect the column from corrosion, it is protected with concrete encasement on PF level (Refer <b>fig :1.4</b> ) |

| | Number of Staircase | 2 No's | Staircase steps are observed as Pre-cast RCC slab panels of size 300 x 100 are used. Steps are supported on ISMC 300 Channel using cleat Angles. Staircase Landing of 2 m wide is supported on Vertical and Horizontal Angular Members. (Refer <b>fig 1.4</b> ) |

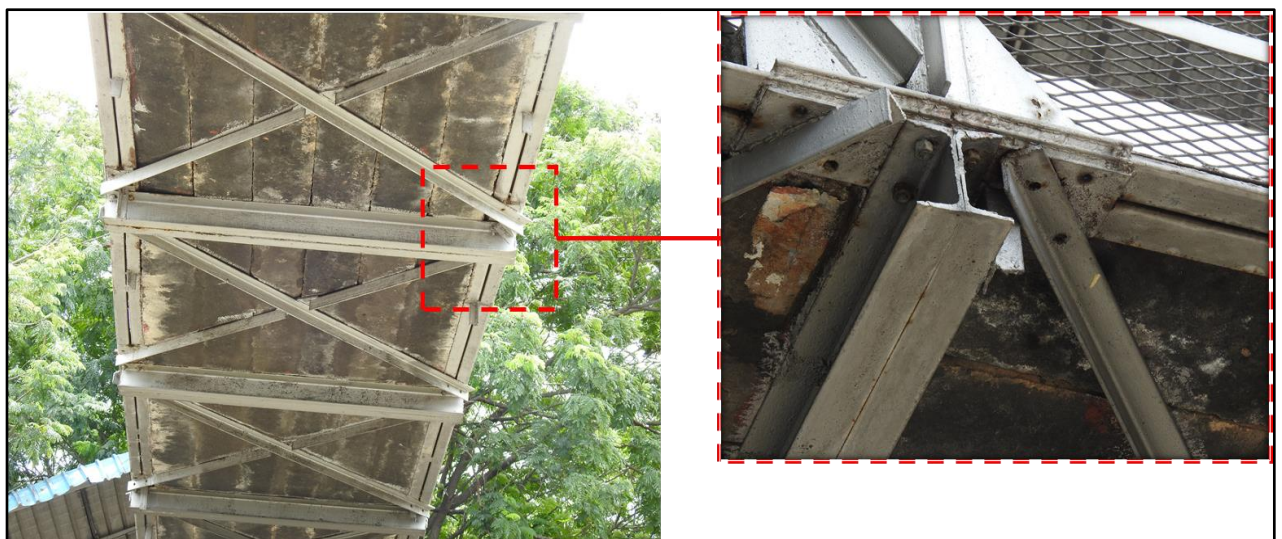
**Fig 1.5:** Shape of main and floor beams

| | Material of Slab | Pre-cast slabs | Pre-cast Reinforced Concrete Slab panels are used for floor slab of 100 mm thick, Pre-cast RCC slab panels are resting on Angular tie members supported on Floor beams and Bracings from bottom. Chequered tile (25 mm thick) flooring is laid on the top of the Pre-cast slab panels.<br>(Refer <b>fig :1.3 and 1.5</b> ) |

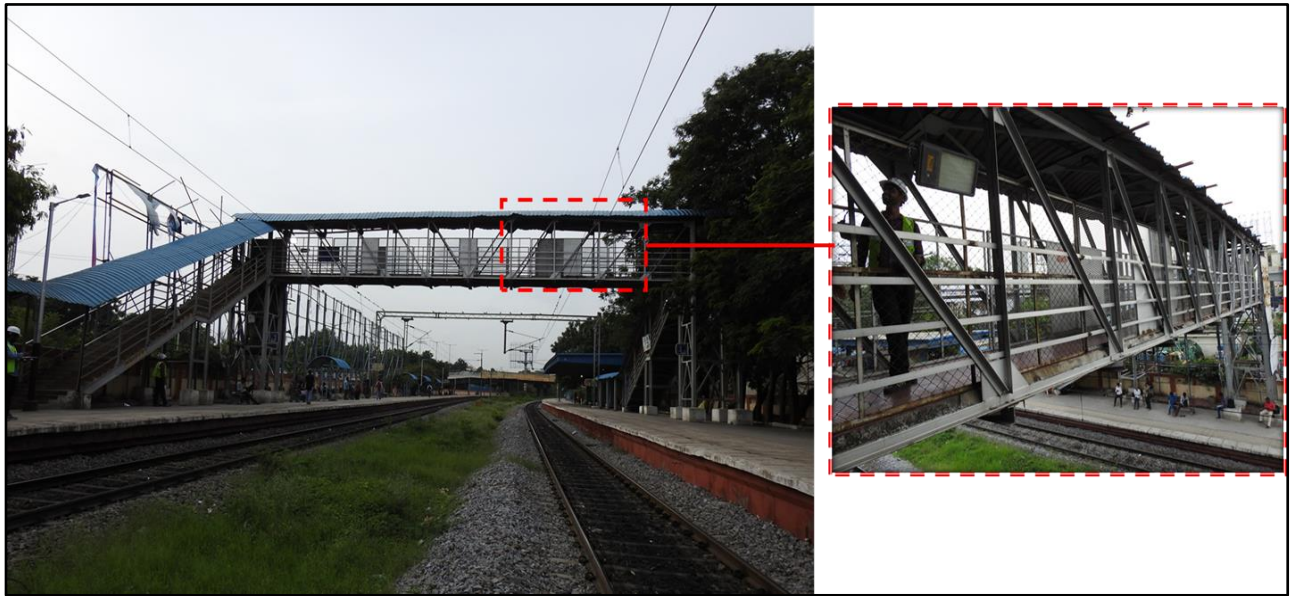
**Fig 1.6:** Main truss details

| | Type /Shape of Truss Section | N- type,<br>Double Angle | a) Main members 75 x 75 x 10 mm Double Angular section<br>b) 65 x 65 x 8 mm Double angular are used as bracing Members<br>c) 10 mm thick gusset plate for welded joint.<br>(Refer <b>fig :1.6</b> )<br>150 x 75 x 6 mm Double Channel Sections are used as Floor beams, supported with 65 x 65 x 8 mm angular sections to Transfer Load from Slab to Roof Truss. Floor beams are connected Tie Member using Bolts and Bracing are connected to Tie members using welding.<br>(Refer <b>fig :1.5</b> ) |

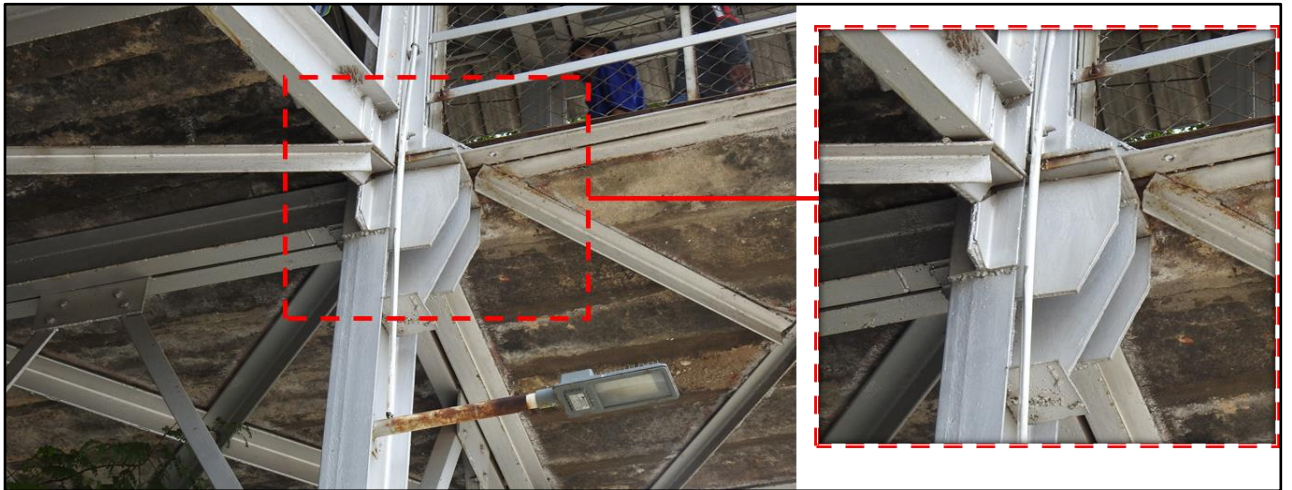
**Fig 1.7:** Beam- column joint

- ✓ Distressing of Cleat angle is observed at Beam – Column joint
- ✓ Rusting is observed at all beam Column joints.

| SIGNS OF DISTRESS, DEFORMATION IN BRIDGES | | | |
|---|---|---|---|
| | Extent of Corrosion | PF – 2 Beam column joints | Distressing is observed at Beam – Column joint |

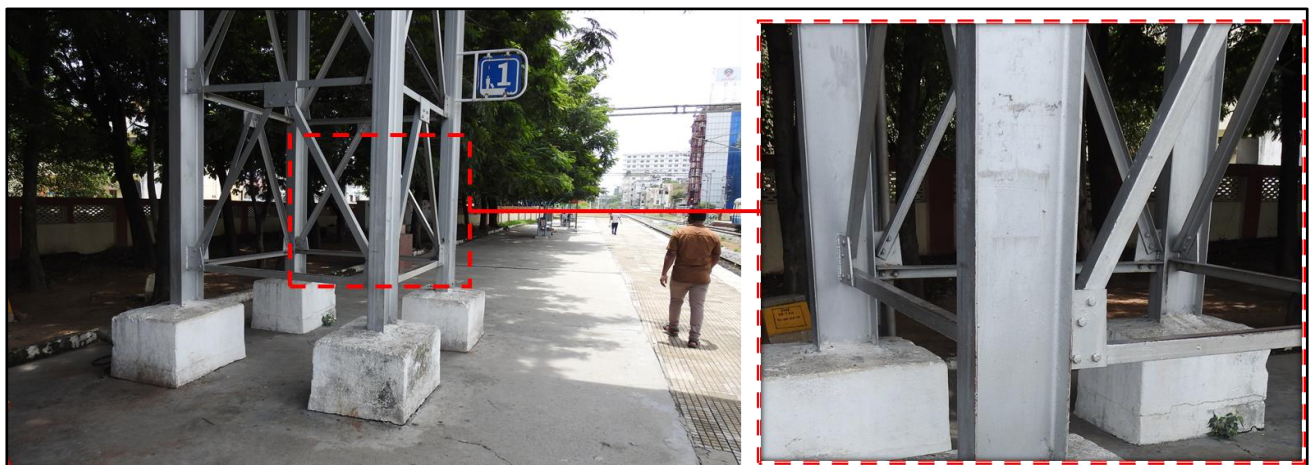
**Fig 1.8:** Shape of column

| | Shape of Column section | I – Section | FOB is Supported on Vertical Column of 4 - ISMB 300 with 65 x 65 x 6 mm Angular Lacing members connected using Gusset plates and bolts. (Refer <b>fig :1.8</b> ) |

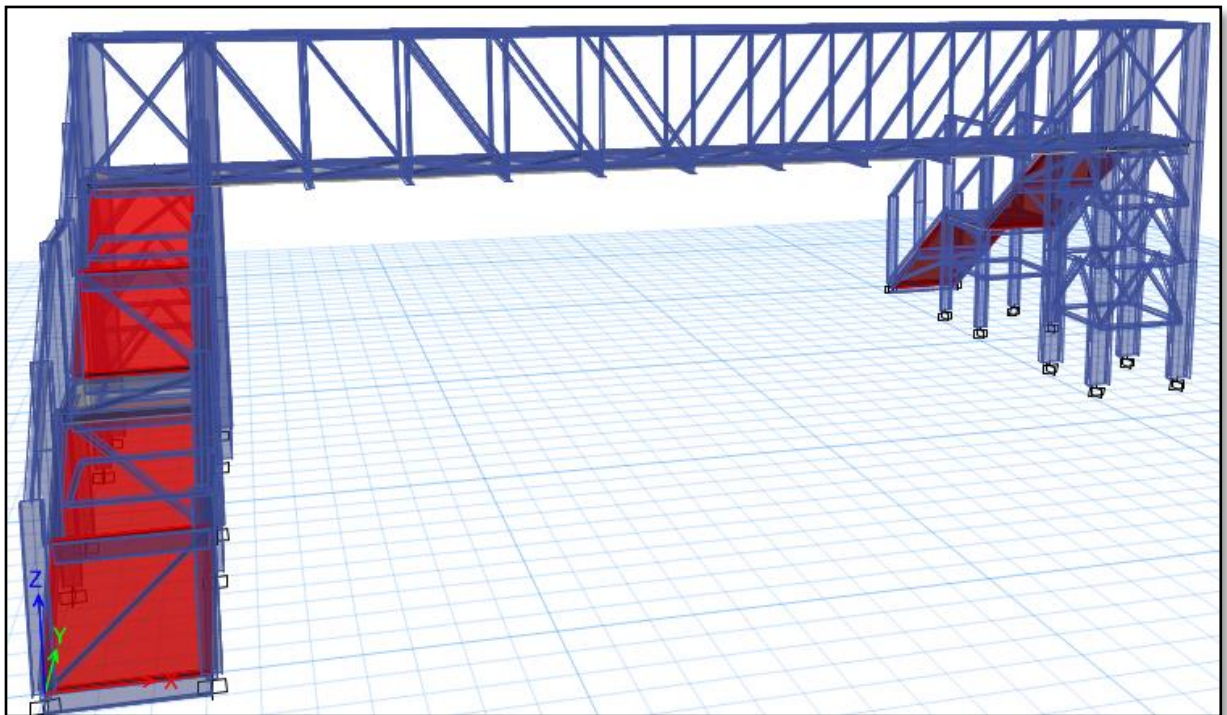
**Fig: 1.10** Numerical Modeling of Khairtabad Railway station FOB (Developed from the Visual inspection)

- Three-dimensional numerical model has been developed from the dimensions obtained by visual inspection and loads considered for foot over bridge is  $5 \text{ kN/m}^2$ . Obtained model and results are shown below.

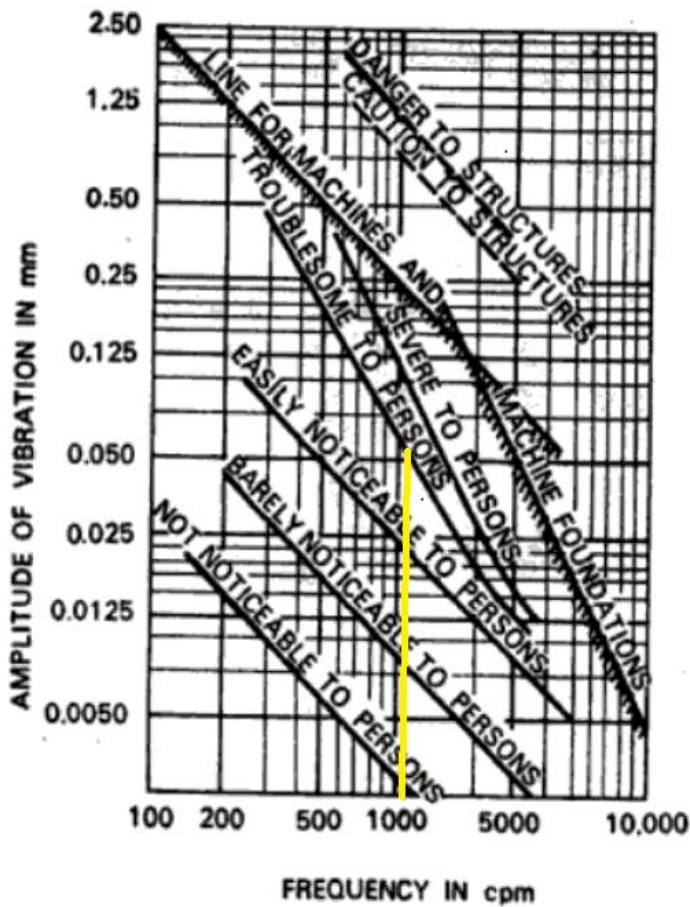
**Fig. 1.4:** Allowable Limits for Vertical Vibration Amplitudes (After Richart, F. E., Jr. *et al.*, *Vibration of Soils and Foundations*, Prentice-Hall Inc., New Jersey, USA, 1970; with permission).

Based on the vibration analysis carried out the structure is undergoing more vibrations than permissible. (Frequency observed is 1134 cpm and maximum amplitude observed during the test time of complete 3hrs is 0.0652 mm).
