# Third Party Audit of ROB's and FOB's of SCR

**INSPECTION OF FOB AT BIBINAGAR RAILWAY STATION**

**Final Report**  
SEPTEMBER | 2020

| <b>Name of the Project</b> | : | VISUAL INSPECTION OF FOB/ PF-1 - PF-2 AT BIBINAGAR RAILWAY STATION |

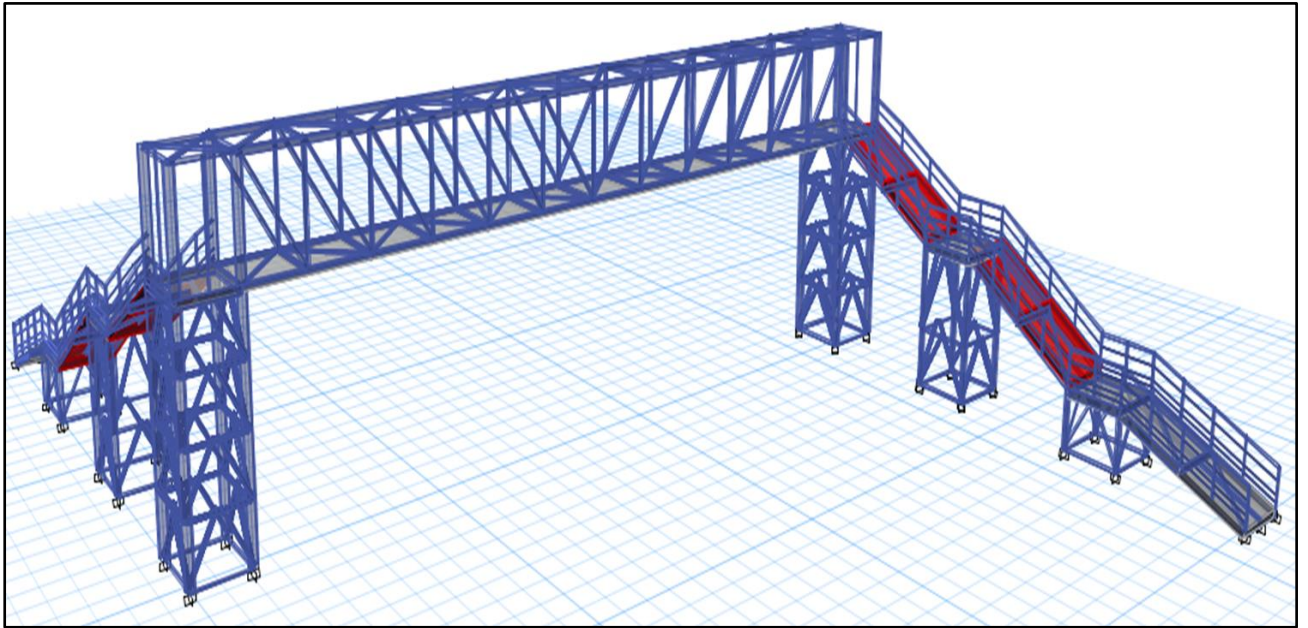
**Fig: 1.9.** Numerical Modelling of Bibinagar Railway station FOB  
(Developed from the Visual inspection)

- Three-dimensional numerical model has been developed from the dimensions obtained by visual inspection and loads considered for foot over bridge is  $5\text{kN/m}^2$  obtained model and results are shown below.
