## Third Party Audit of ROB's and FOB's of SCR

### INSPECTION OF FOB AT LAKDIKAPUL RAILWAY STATION

**Final Report**

| <b>Name of the Project</b> | : | VISUAL INSPECTION OF FOB/ PF-1 - PF-2 AT LAKDIKAPUL RAILWAY STATION |

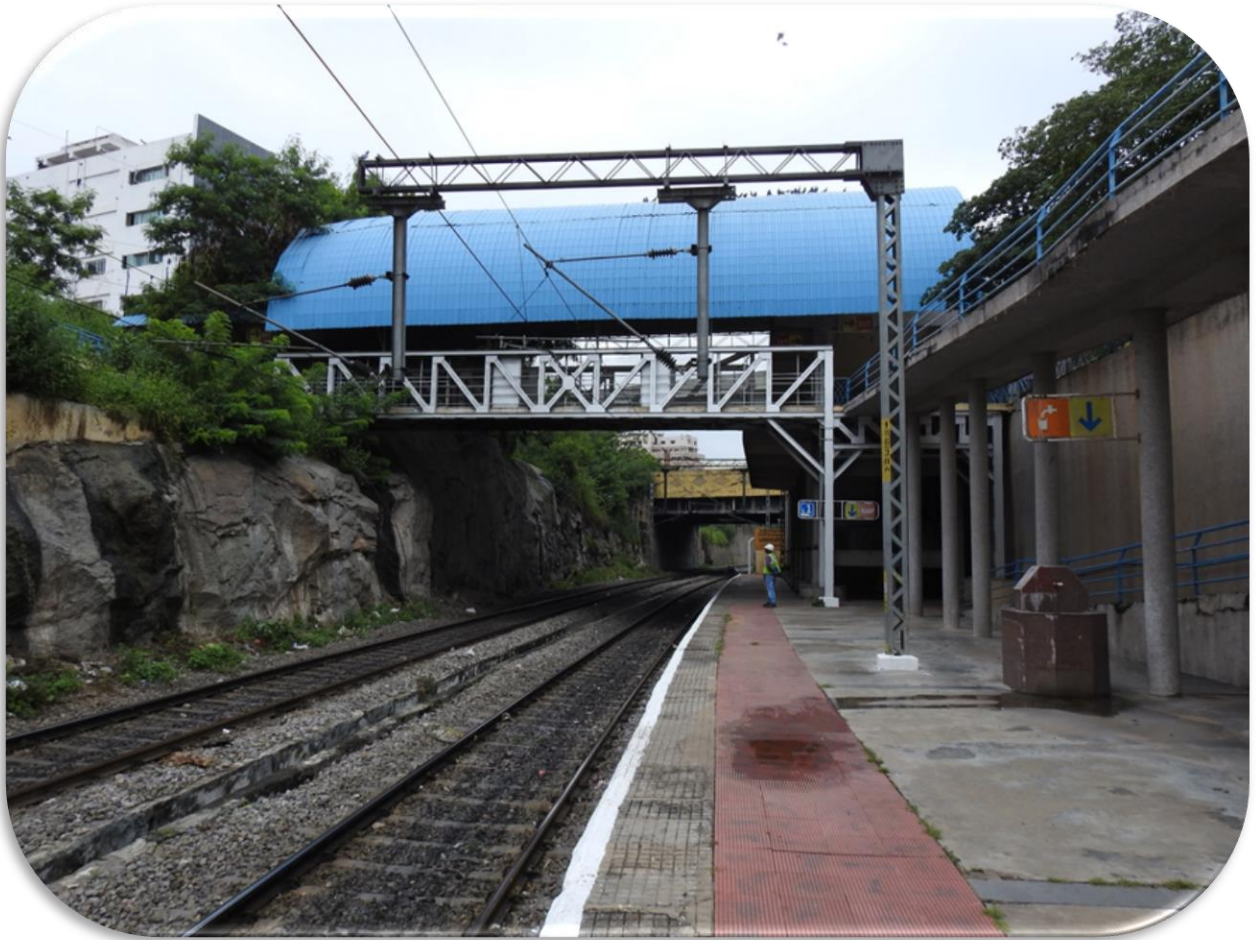
- From visual inspection, slight corrosion is observed at the bottom of sacrificial plate.
- Mild Corrosion is observed at Trestles (Double channel section) at PF-2.
- Corrosion of gusset plate at bottom chord members.
