## Third Party Audit of ROB's and FOB's of SCR

**INSPECTION OF FOB AT MAHABUBABAD RAILWAY STATION**

**Final Report**  
**SEPTEMBER | 2020**

| <b>Name of the Project</b> | <b>:</b> | VISUAL INSPECTION OF FOB/ PF-1 - PF-2 AT MAHABUBABAD RAILWAY STATION |

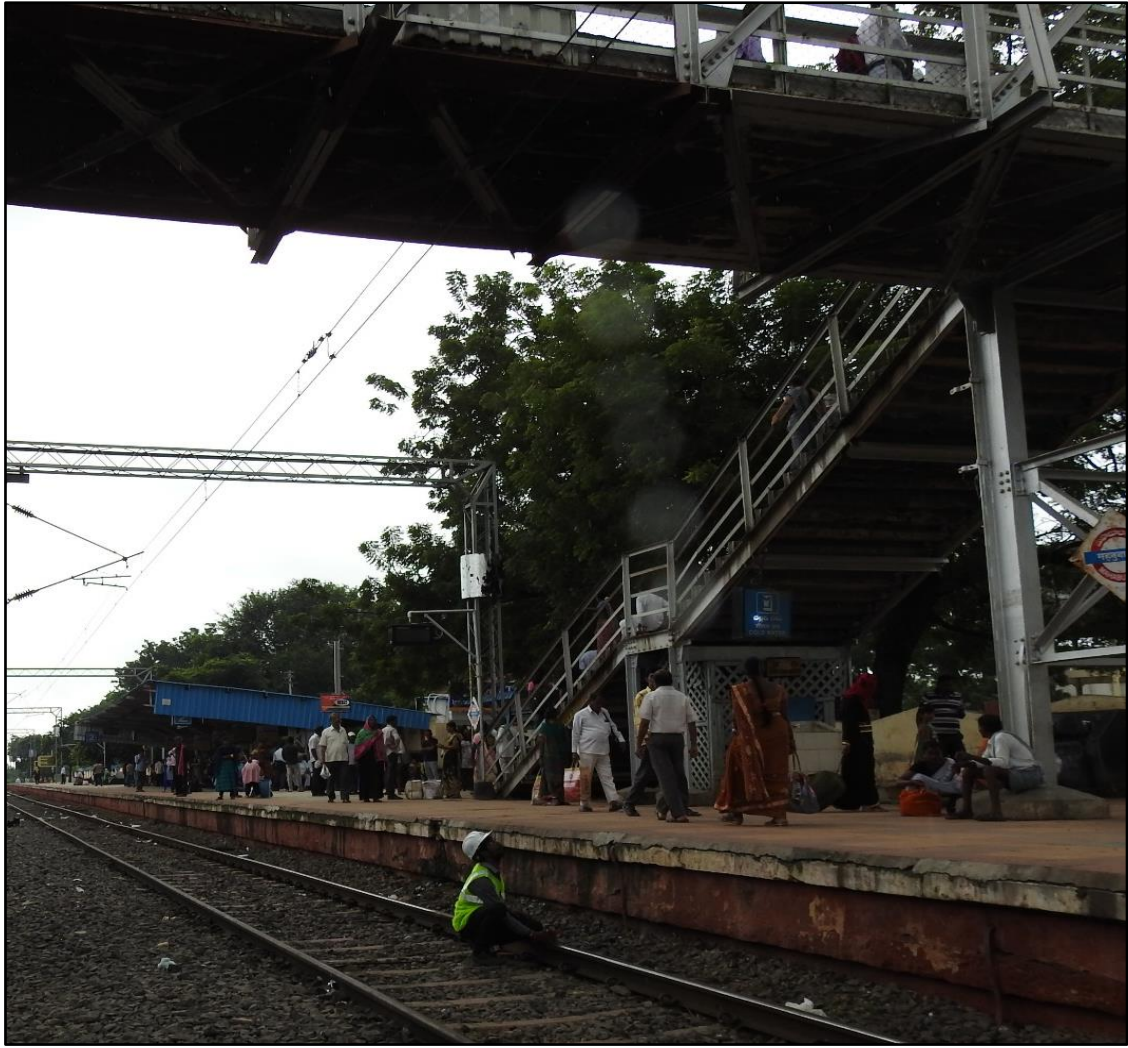
**Fig 1.4:** Measuring Vertical Clearance using laser meter (from rail top to girder bottom)

- Bottom chord and bottom lateral bracing members are severely corroded. (Photographs of the same can be seen in **fig: 1.4-1.7, 2.3**)
- Staircase stringer beams are having moderate corrosion. (Photographs of the same can be seen in **fig 2.4**)
- Algae and Vegetation is observed along steel concrete joint on outer surface at deck level. Carryout removal and cleaning as per Annexure 1a. (Photographs of the same can be seen in **fig 2.1**)
- In Majority of RCC Pre-cast slab panels spalling of concrete cover, cracking and reinforcement exposure is higher. (Photographs of the same can be seen in **fig 1.6-1.8, 2.4**)

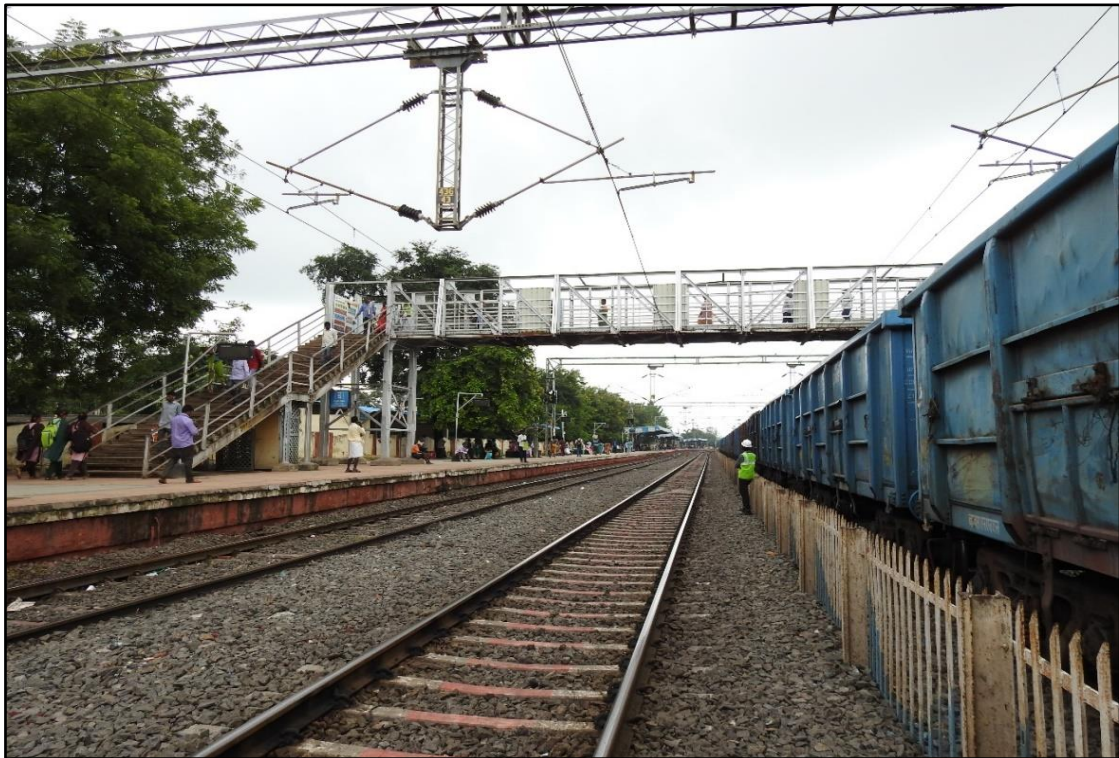
**Fig 1.5:** FOB view from platform 2 with staircase

| | Shape of Column section | I – Section | FOB is Supported on Vertical Built up Column of 4 - ISMB 350 and 2 of 200 x 10 mm plates are welded to both flanges up to bottom of Truss, 75 x 75 x 8 mm Angle Lacing members connected using Gusset plates and bolts. (Refer <b>fig: 1.5</b> ) |
