## Third Party Audit of ROB's and FOB's of SCR

### INSPECTION OF FOB AT MANCHIRYAL RAILWAY STATION

**Final Report**

SEPTEMBER | 2020

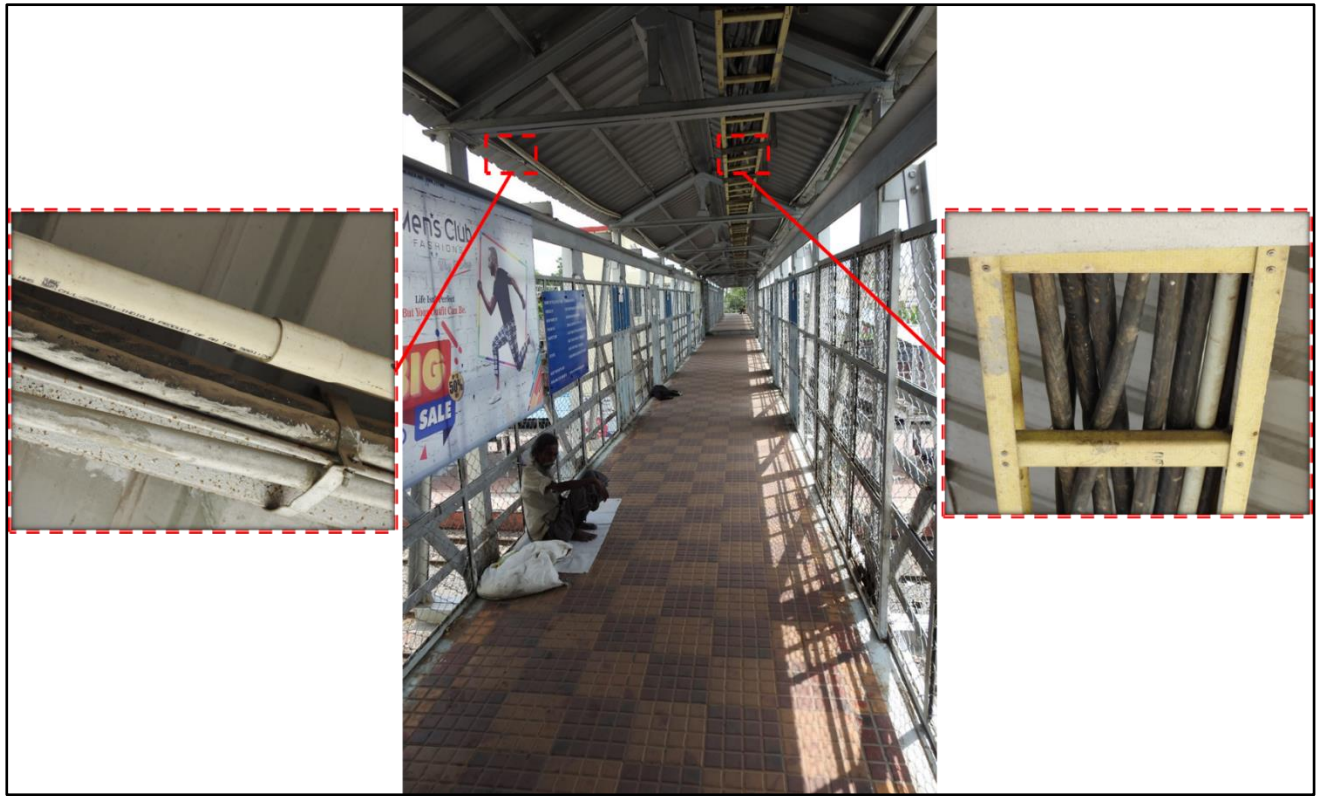
**Fig 1.1:** Cables, Roof truss, load of advertising hoarding, Flooring and protective screen

| PART 1.2 IDENTIFICATION OF LOADS ON BRIDGE | | | |
|---|---|---|---|
| | e) load of advertising hoarding | Yes | Advertising boards are provided. (Refer <b>fig :1.1</b> ) |
| | a) Additional wearing coat on Floor | No | Only Chequered tiles are used for flooring (Refer <b>fig :1.1</b> ) |
| | b) Provision of protective screen for passengers | Yes | Chain link fence made of galvanized wire of 2 mm gauge and 2mm galvanized sheet is used above OHE line on both side of gangway is used for protection (Refer <b>fig :1.1</b> ) |

| PART 1.3 STRUCTURAL SYSTEM OF THE BRIDGE | | | |
|---|---|---|---|
| | Element of roof truss section | Angle sections | 1 <sup>st</sup> span and 2 <sup>nd</sup> span roof truss is supported with 65 x 65 x 6 mm angle section and supported on 150 x 150 x 12 mm Double angle Top chord members (Refer <b>fig :1.1</b> ) |

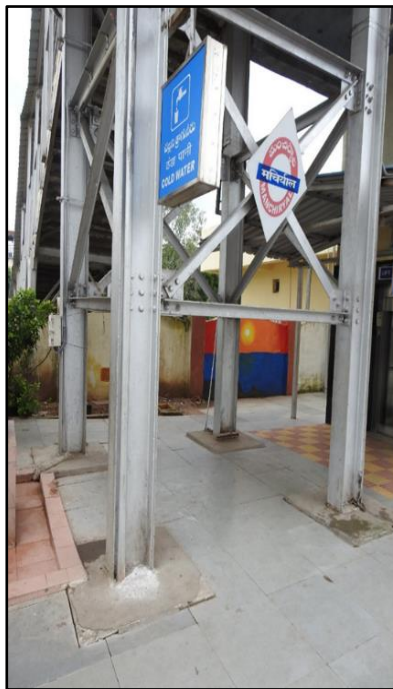
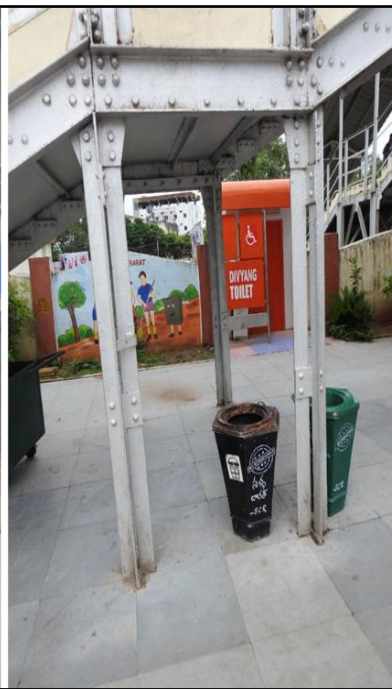
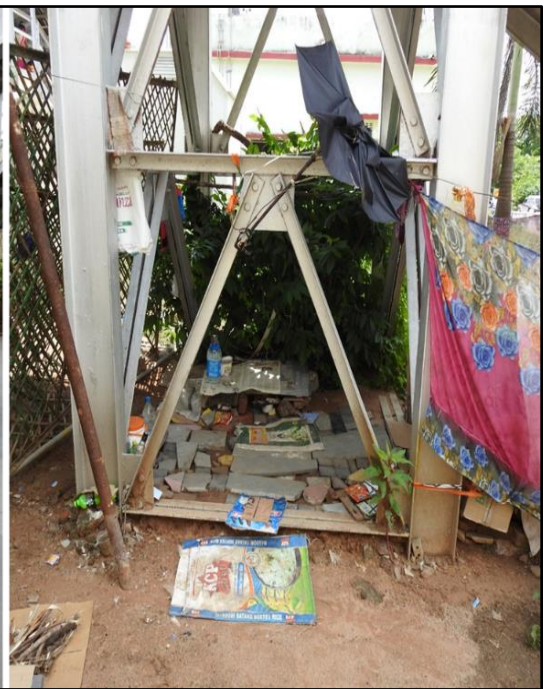
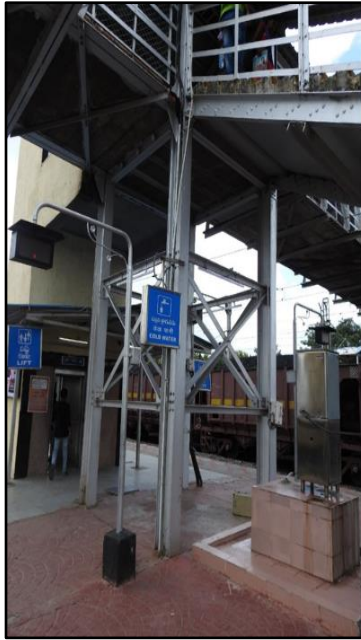
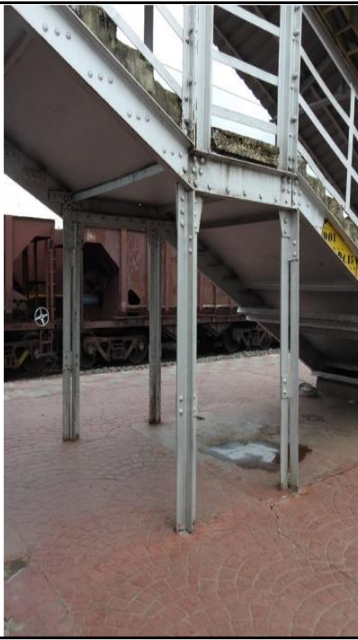
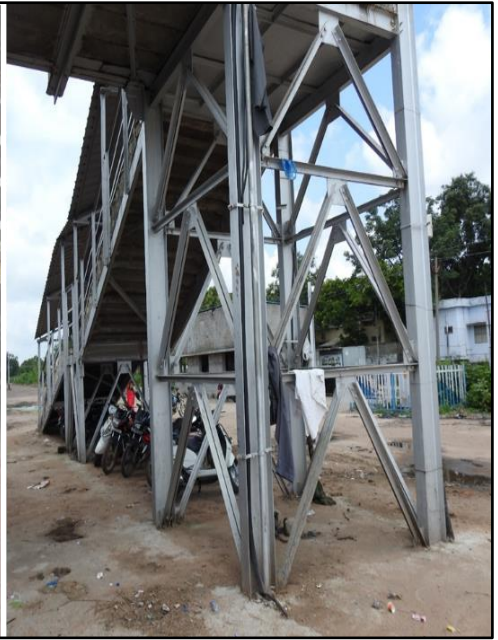
**Fig 1.2:** Trestles details

| PART 1.3 STRUCTURAL SYSTEM OF THE BRIDGE | | | |
|---|---|---|---|
| | Column – Trestles Connection Details | | a. Concrete encasement is observed below vertical supports.<br>b. Elevator Roof truss is supported on trestles on PF-1 and PF-2. (Refer <b>fig :1.2 and 1.3</b> ) |

| | Dimensions of Column | 300x150 mm | c. Staircase landing is supported ISMB 300 at 2 <sup>nd</sup> span circulating area. (Refer <b>fig :1.2</b> ) |

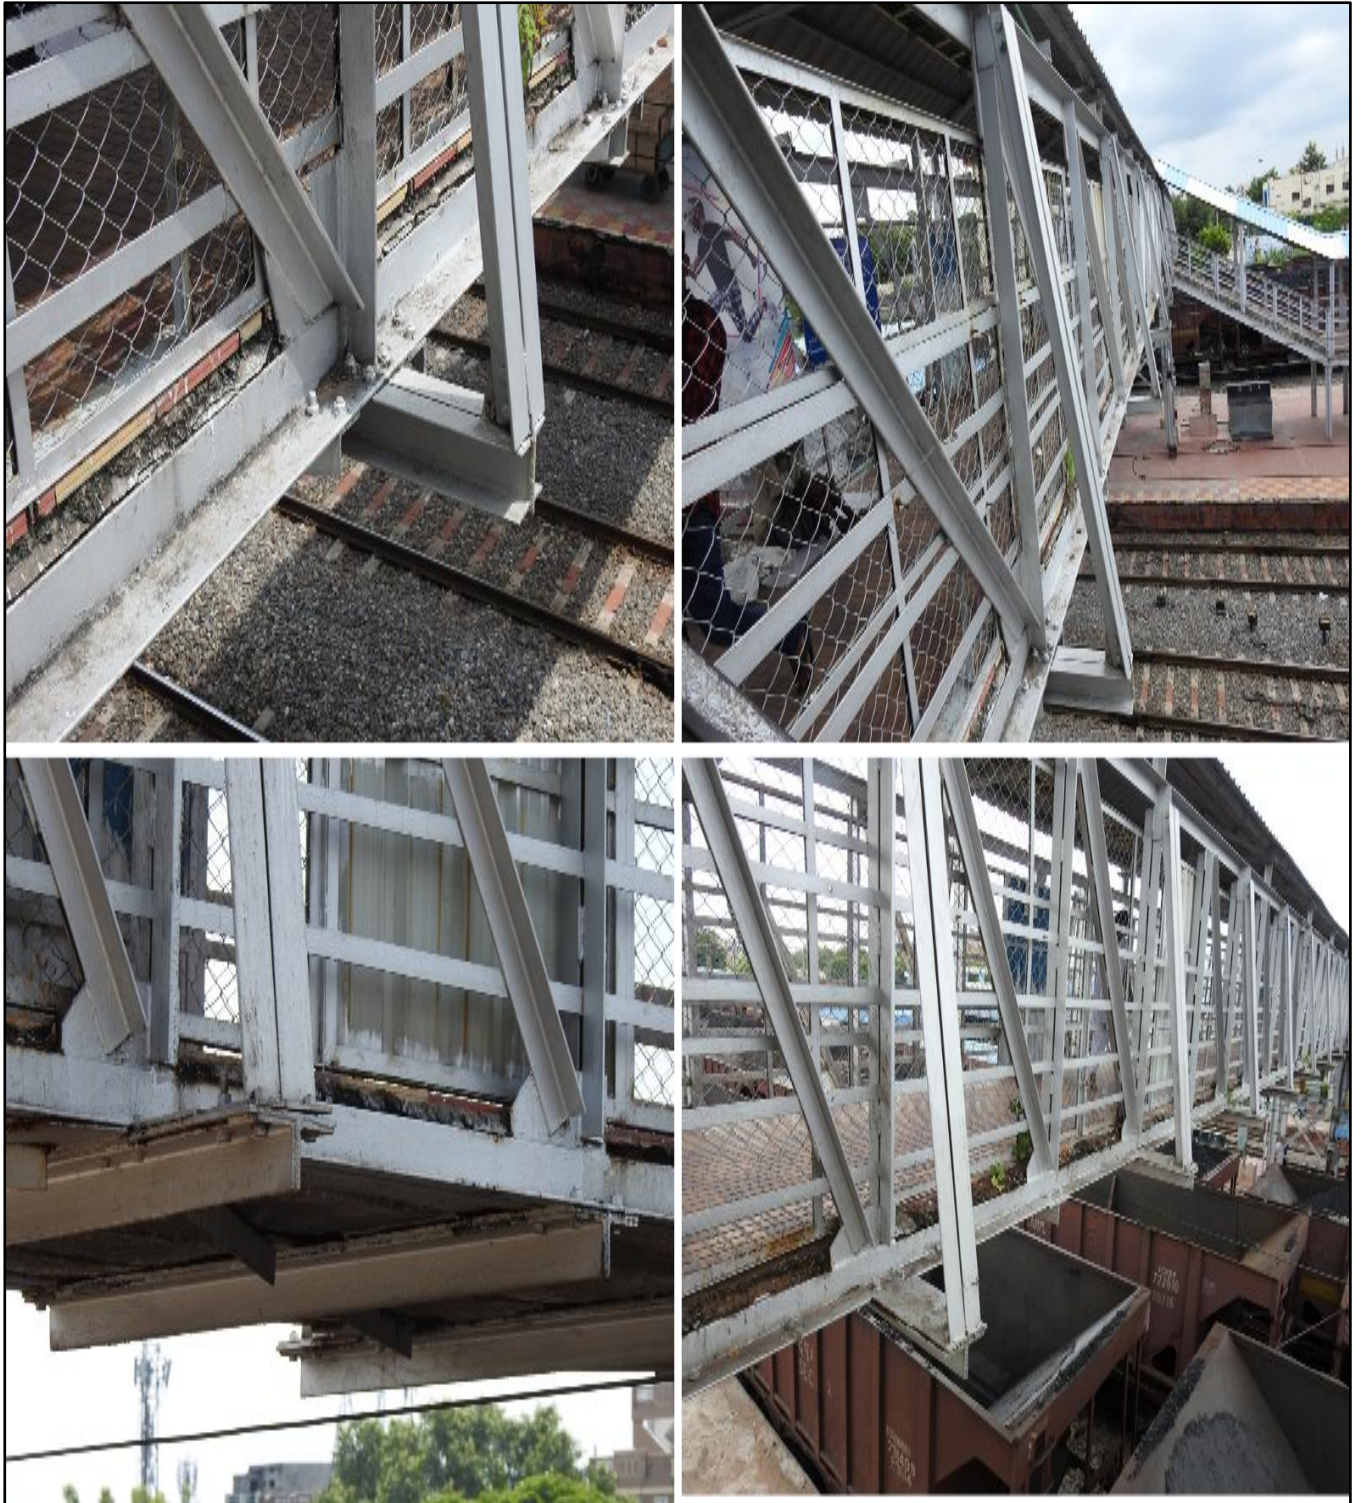
**Fig 1.4:** Main chord members, Floor beams, vertical and diagonal bracings for 1<sup>st</sup> span and 2<sup>nd</sup> span

| | Arrangement of Bracings | Diagonal | e. For 2 <sup>nd</sup> span 100x100x12 mm Double angle section are used for floor beams supported with 100x 100 x10 mm angle section connected to bottom main chord member using gusset plate and bolts (Refer <b>fig :1.4</b> ) |

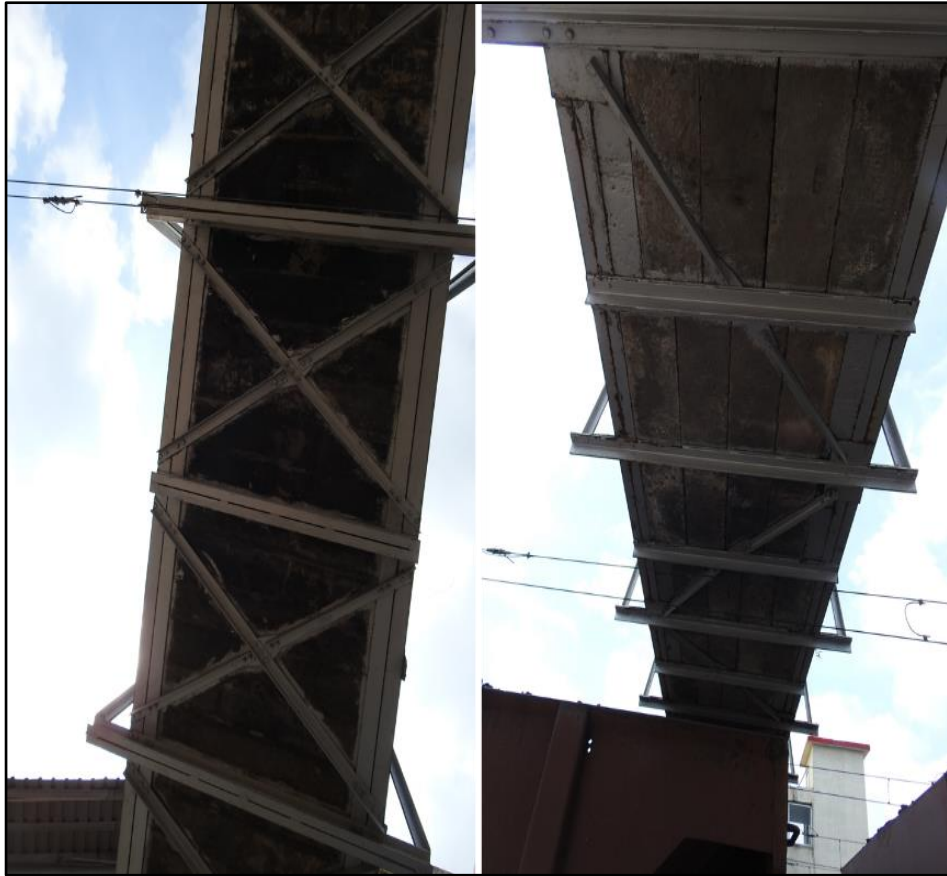
**Fig 1.5:** Bottom view of 1<sup>st</sup> and 2<sup>nd</sup> span of FOB

| | Thickness of Slab | 125 mm | b. Chequered tile flooring is laid on the top of the slab panels (Refer <b>fig : 1.1 and 1.5</b> ) |
| | Condition of Slab from Bottom | Leaching effect near 1 <sup>st</sup> span and for 2 <sup>nd</sup> span | |
