## Third Party Audit of ROB's and FOB's of SCR

### INSPECTION OF FOB AT KAZIPET RAILWAY STATION

**Final Report**  
SEPTEMBER | 2020

| <b>Name of the Project</b> | <b>:</b> | VISUAL INSPECTION OF FOB/ PF-1 - PF-3 AT KAZIPET RAILWAY STATION |

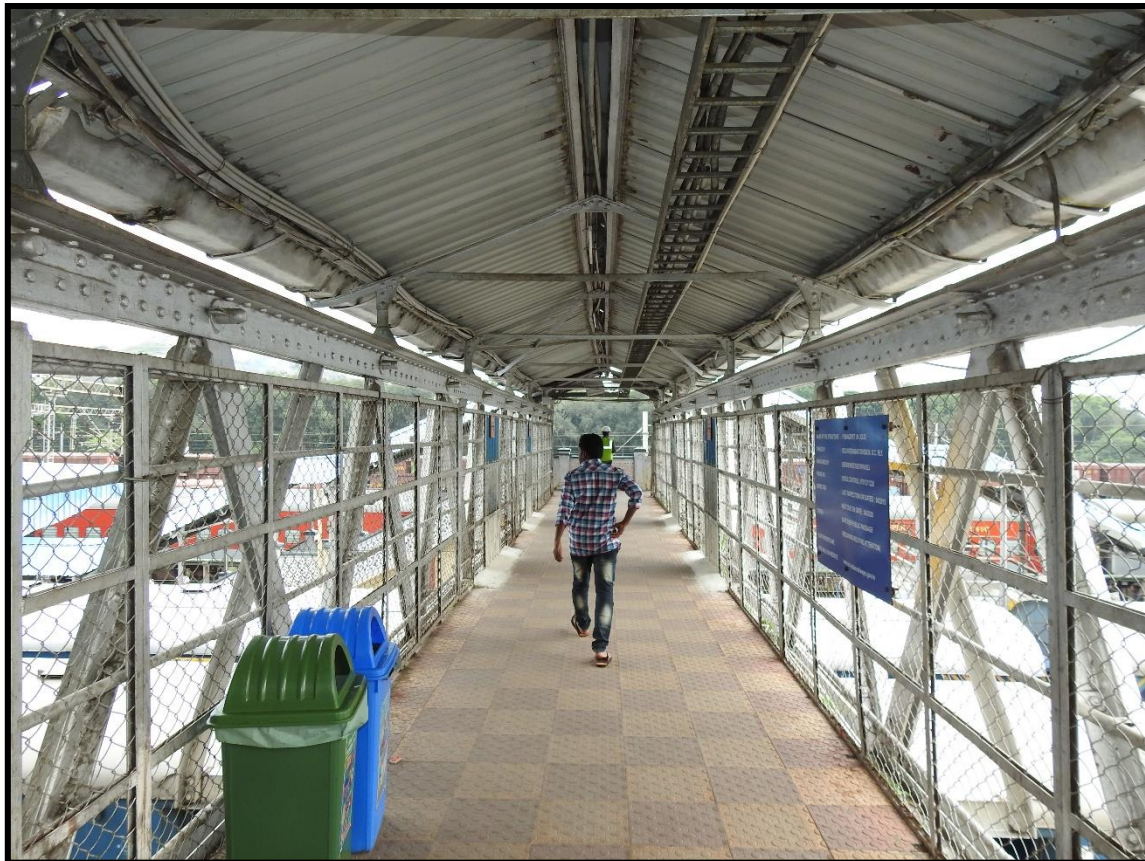
**Fig 1.2:** Set of cables running along the length of FOB

| PART 1.2 IDENTIFICATION OF LOADS ON BRIDGE | | | |
|---|---|---|---|
| | b) Cables | Yes | Set of Cables are running along the length of FOB, Approximate circumference of cables is 500 mm (Refer <b>fig : 1.2</b> ) |
| | c) Roof Truss | Yes | 2/65 x 65 x 8 mm Angles are used (Refer <b>fig :1.2</b> ) |
| | d) Roof Sheet | Yes | Corrugated metal Sheet is used for Roof (Refer <b>fig :1.2</b> ) |

| PART 1.3 STRUCTURAL SYSTEM OF THE BRIDGE | | | |
|---|---|---|---|
| | Element of roof truss section | King post angular section | King post angular truss with 65x65x8 mm section is used. Supported on Main tie members using welded joints (Refer <b>fig:1.2</b> ). |

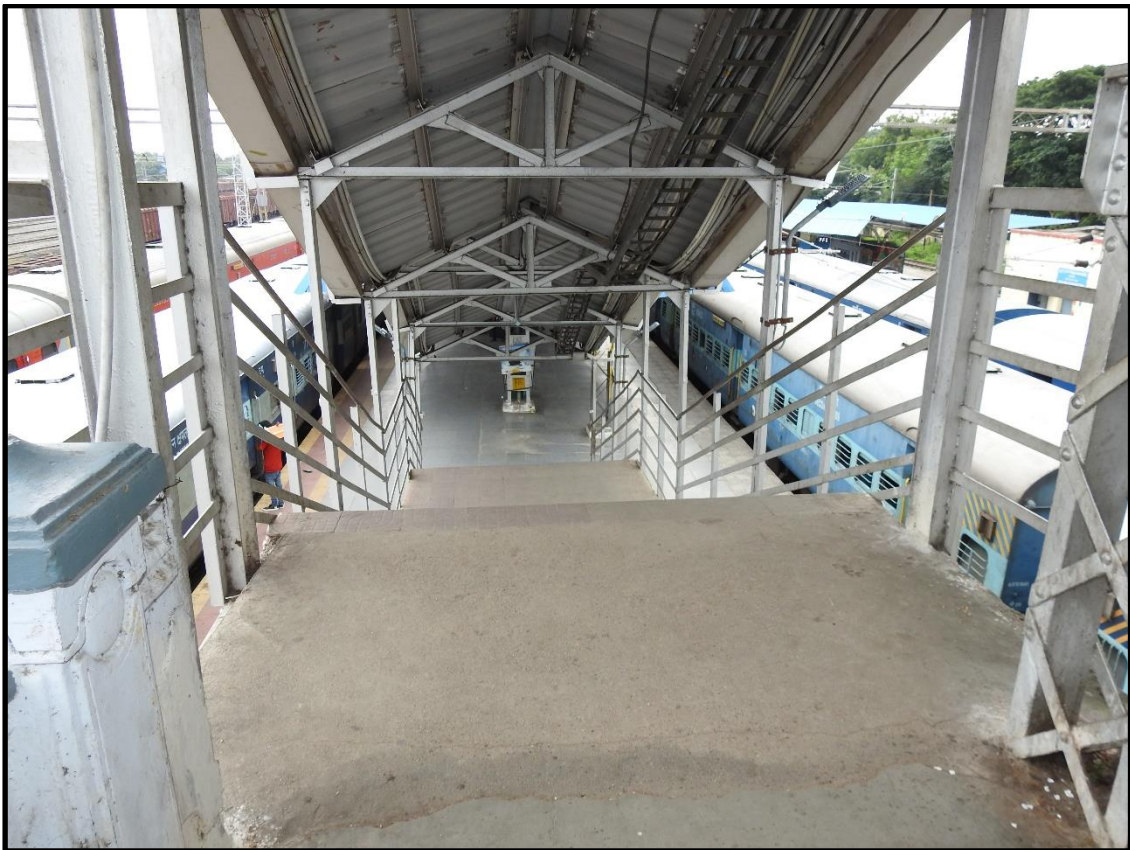
***Fig 1.4:*** Staircase 3 view from FOB

| | Number of Staircase | 3 No's | Staircase steps are observed as RCC slab is supported with sacrificial plate for staircase 3. Steps are supported on ISMC 250 Channel using cleat Angles. Staircase Landing of 2 m wide is supported on Vertical and Horizontal Angular Members. (Refer <b>fig :1.4</b> )<br>Staircase 3 Sacrificial plate is corroded at landing from bottom. (Refer <b>fig : 1.11</b> ) |

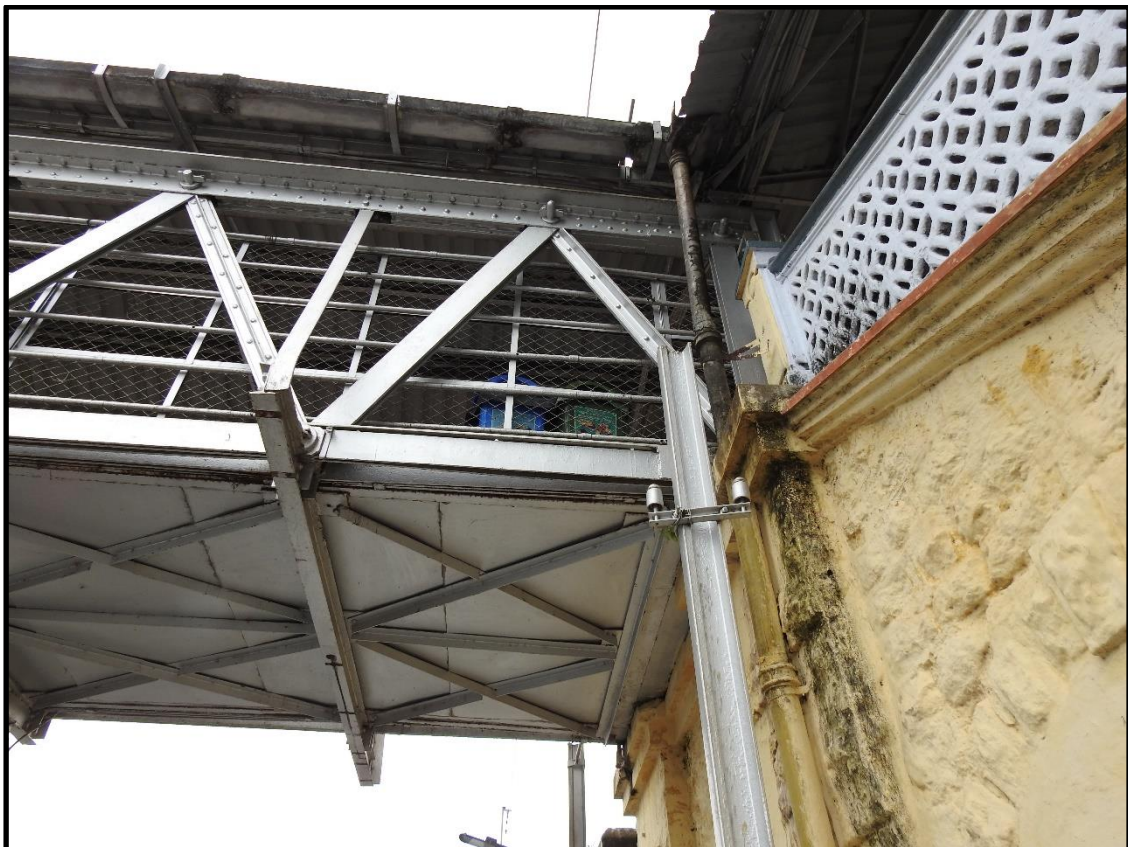
**Fig 1.10:** Bottom view of FOB near platform 1

| | Material of Slab | RCC Slab | Reinforced Concrete Slab is used as floor slab of 100 mm thick supported with Sacrificial plate, RCC slab is resting on Angular chord members supported on Secondary Girders and Bracings from bottom. Chequered tile (25 mm thick) flooring is laid on the top of the Pre-cast slab panels. (Refer <b>fig : 1.10</b> ) |
| | Type of Parapet Railing | Steel Railing | Stair case is provided with Railing on both sides of one-meter height using masonry wall ( <b>Refer fig :1.10</b> ) |
