# Third Party Audit of ROB's and FOB's of SCR

## INSPECTION OF FOB AT ELURU RAILWAY STATION

**Final Report**  
SEPTEMBER | 2020

| <b>Name of the Project</b> | : | VISUAL INSPECTION OF FOB/ PF-1 - PF-2<br>AT ELURU RAILWAY STATION |

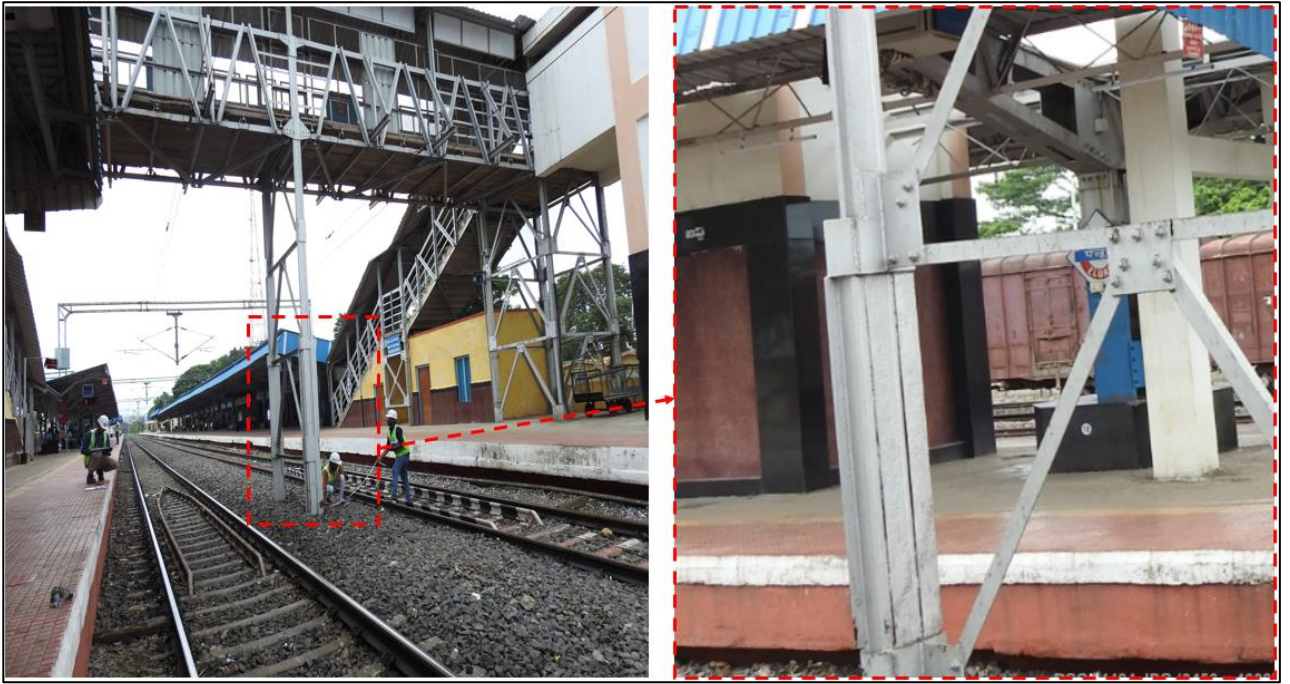
**Fig 1.4:** Stanchion Rail sections details

| | Type/Shape of Column section | Bull-headed Rail Section | a. FOB is supported on vertical column of 2 Rail section 70 x 140 x 135, with bracings of 75 x 75 x 6 mm angle section<br>b. Trestles 1 and 3 have 4 columns where as Trestles 2 (Stanchion) have only 2 columns. (Refer <b>4.3 b</b> ).<br>c. Stanchion column has built up section of 4 flat bottom rail sections 70 x 140 x 135mm up to a height of 2.8m and continued with 2 rails (Refer <b>fig : 1.4</b> )<br>d. Staircase landing is supported by 2 Rail section of 70 x 140 x 135mm, with bracings of 75 x 75 x 6 mm angle section (Refer <b>fig :1.6</b> ) |

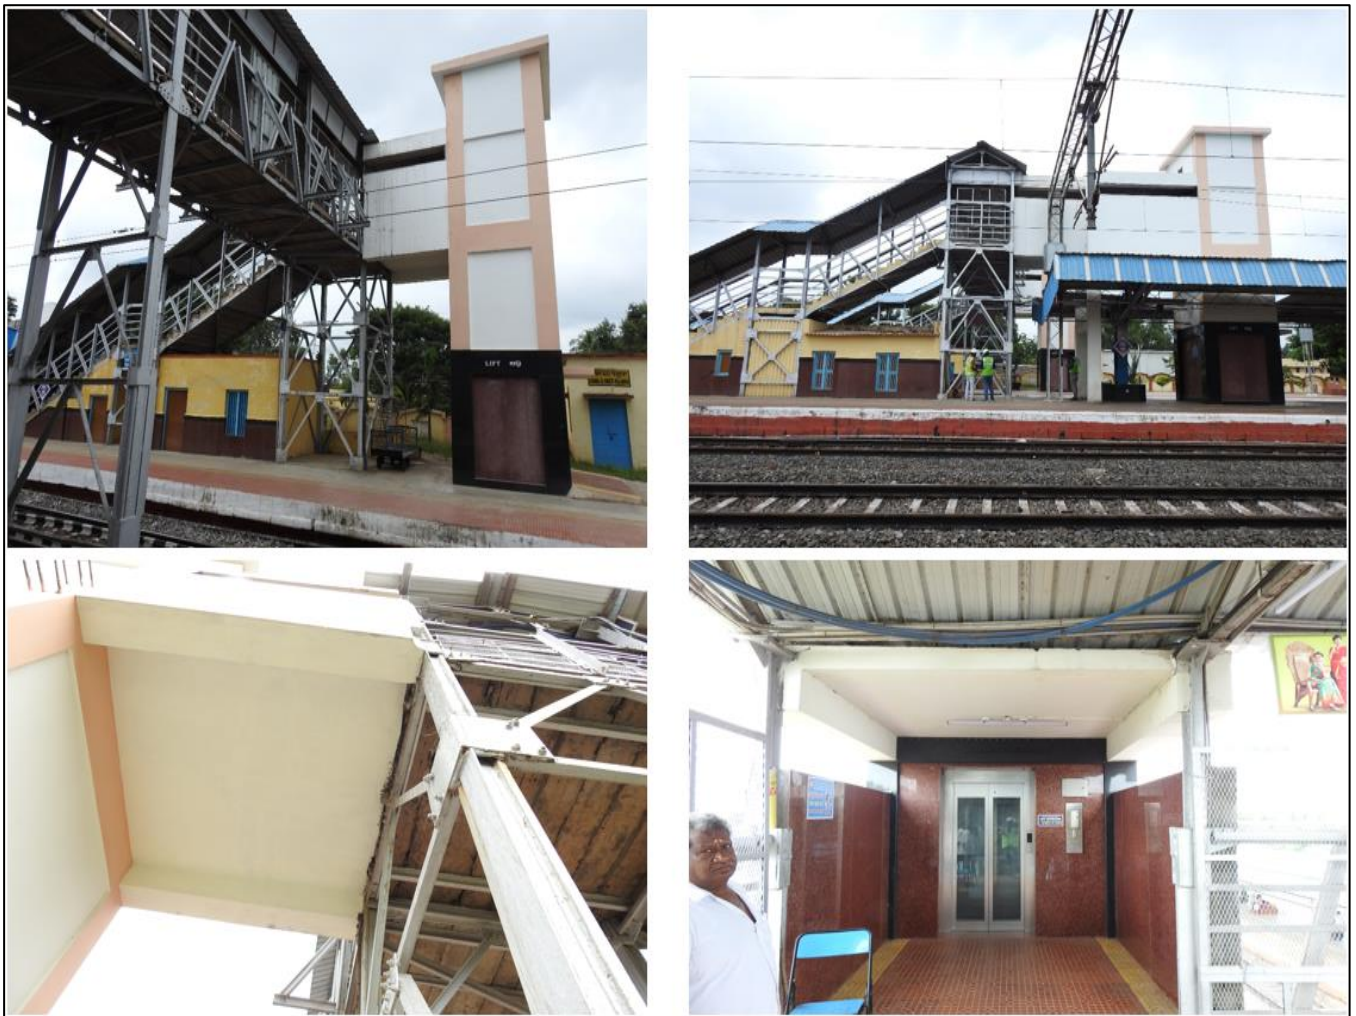
**Fig 1.5:** Lift is connected to staircase landing in both platforms

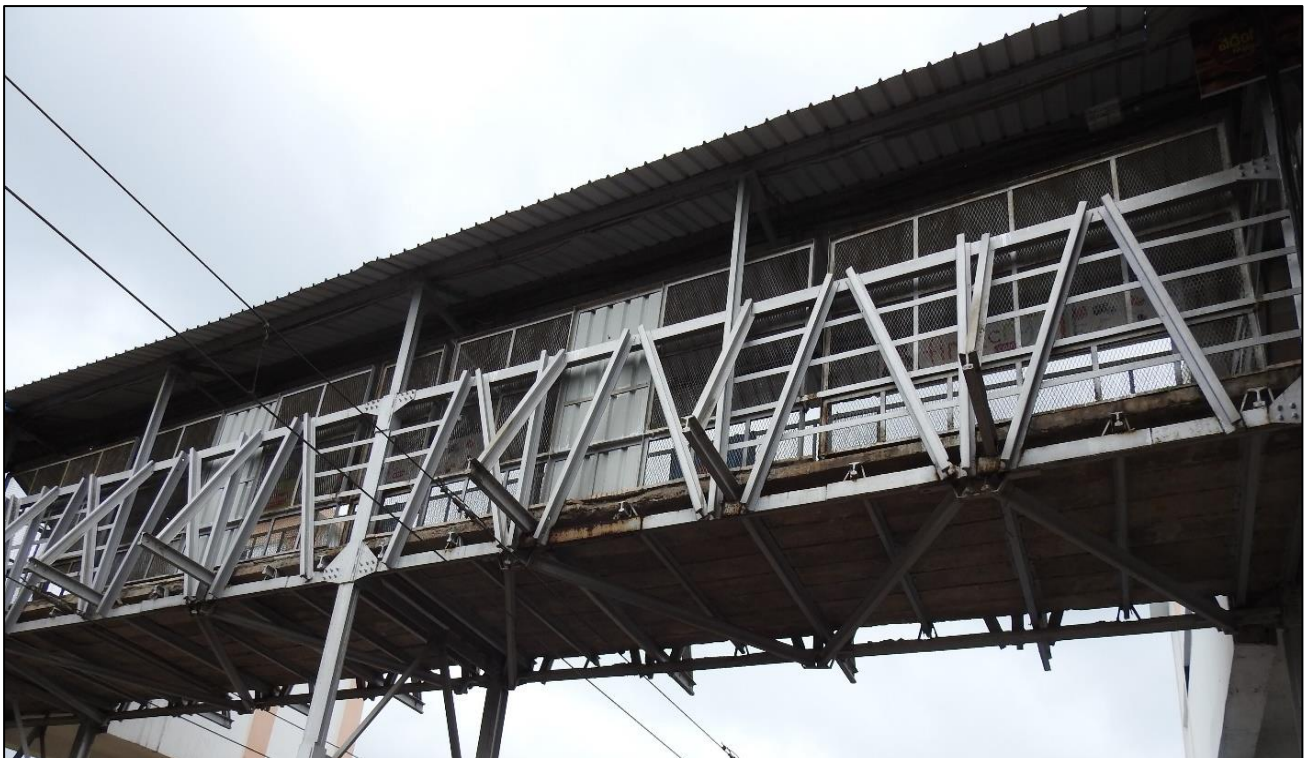
**Fig 1.7:** Bottom view of FOB

| PART 1.3 STRUCTURAL SYSTEM OF THE BRIDGE | | | |
|---|---|---|---|
| | Type /Shape of Truss Section | Warren Truss (with Rail section) | a) Top and bottom Chord members are 60 x 110 x 110 (Head x Web x Foot) Flat-bottom Rail section (Refer <b>fig: 1.7</b> ) |

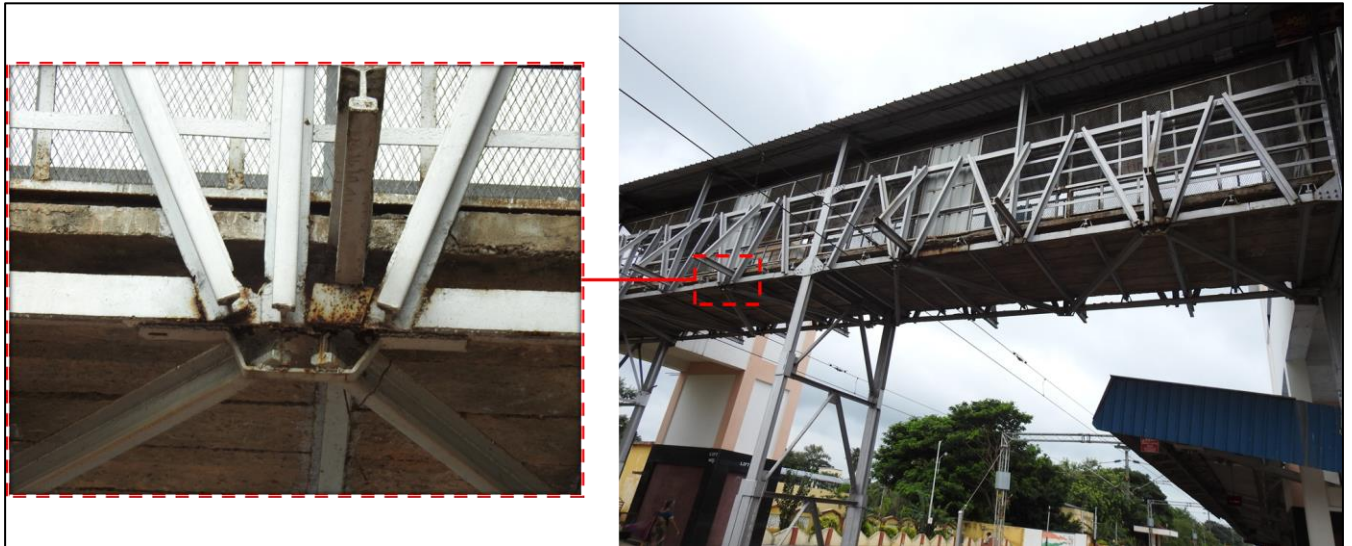
**Fig 1.9:** Bottom view of FOB and details of floor slab

| | Material of Slab | Pre-cast slab panels | a. Pre-cast Reinforced concrete slab panels are used for floor slab of 80 mm thick, RCC slab panels are resting on Floor beams, which are supported on Bottom chord member and bottom lateral bracings. (Refer <b>fig :1.9</b> ) |
