# Third Party Audit of ROB's and FOB's of SCR

## INSPECTION OF FOB AT KRISHNA CANAL RAILWAY STATION

**Final Report**  
SEPTEMBER | 2020

| <b>Name of the Project</b> | : | VISUAL INSPECTION OF FOB/ PF-1 - PF-4 AT KRISHNA CANAL RAILWAY STATION |

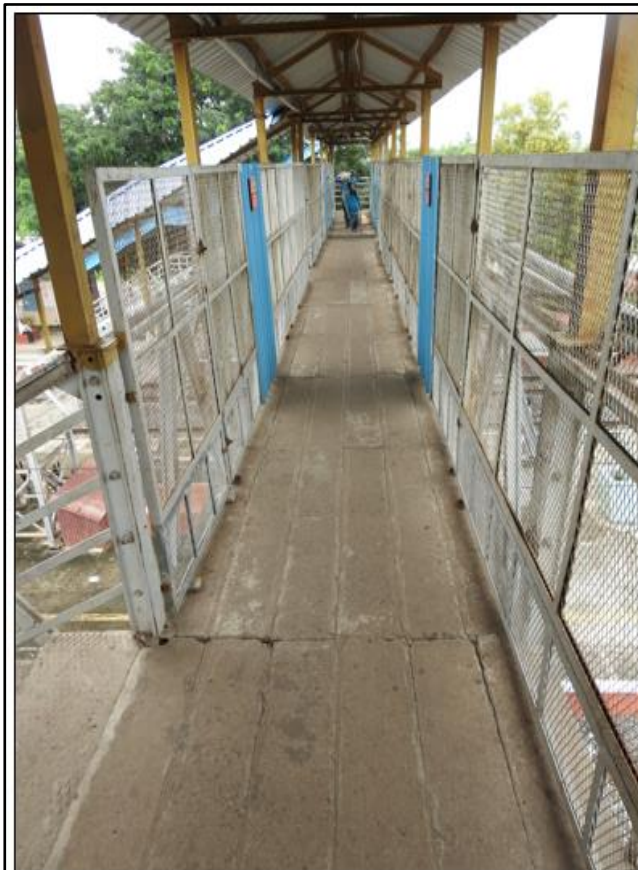
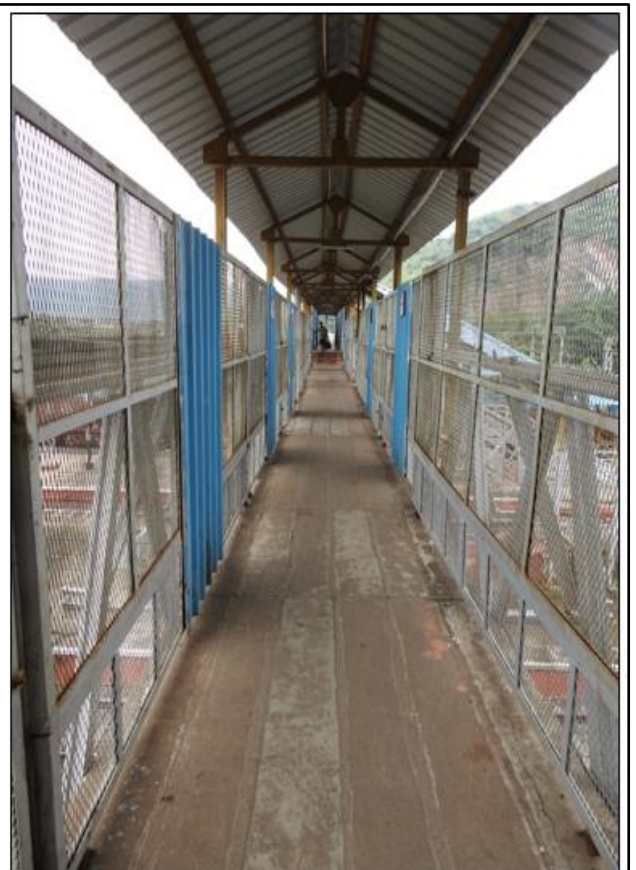
**Fig 1.2:** FOB span 1, 2 & 3 pathway, protective screen & Hoardings

| 1.2 IDENTIFICATION OF LOADS ON BRIDGE | | | |
|---|---|---|---|
| | Provision of protective screen for passengers | Yes | Fence made of galvanized wire of 2 mm gauge and 2 mm galvanized sheet is used above OHE Line on both side of pathway is used for passengers Protection. (Refer <b>fig :1.2</b> ) |

Span -1 & 2 Pathway

Span-3 Pathway

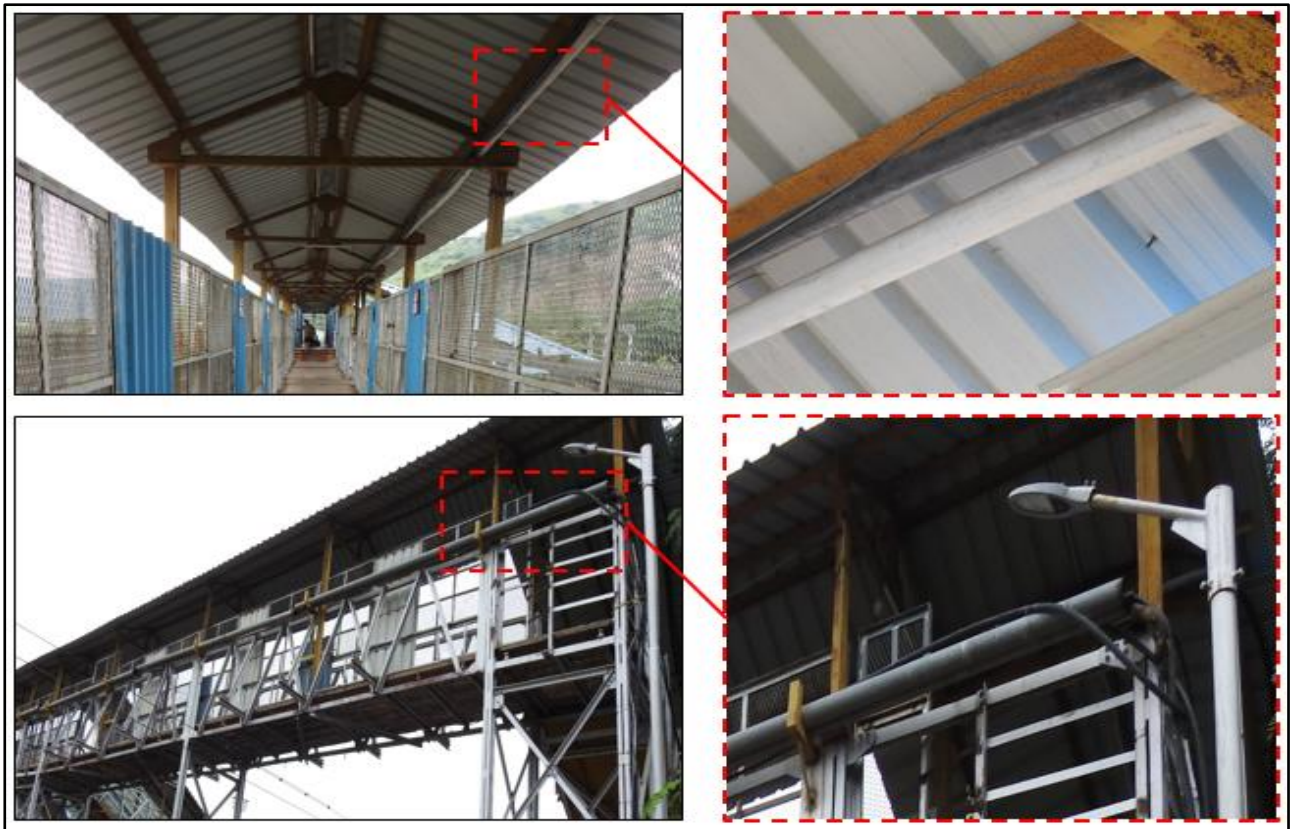
**Fig 1.3:** Additional loads of GI, HDPE, PVC pipes

| 1.2 IDENTIFICATION OF LOADS ON BRIDGE | | | |
|---|---|---|---|
| | a) Pipeline - Utilities | Yes | 2 inch GI Pipe supported on Truss<br><br>a. Cables are protected with 1-inch HDPE pipe of 2 No's, 1.5-inch HDPE pipe of 2 No's, 0.7-inch HDPE pipe of 2 No's, 2-inch PVC pipe of 1 No's, 2.5-inch GI pipe of 1 No's and 4 inch GI pipe of 1 No's supported on Roof Truss. (Refer <b>fig :1.2</b> )<br>b. King post of 65 x 65 x 12 mm Angles are used as Roof truss (Refer <b>fig :1.2</b> )<br>c. Steel Metal Sheet is used for Roof (Refer <b>fig : 1.2</b> ) |

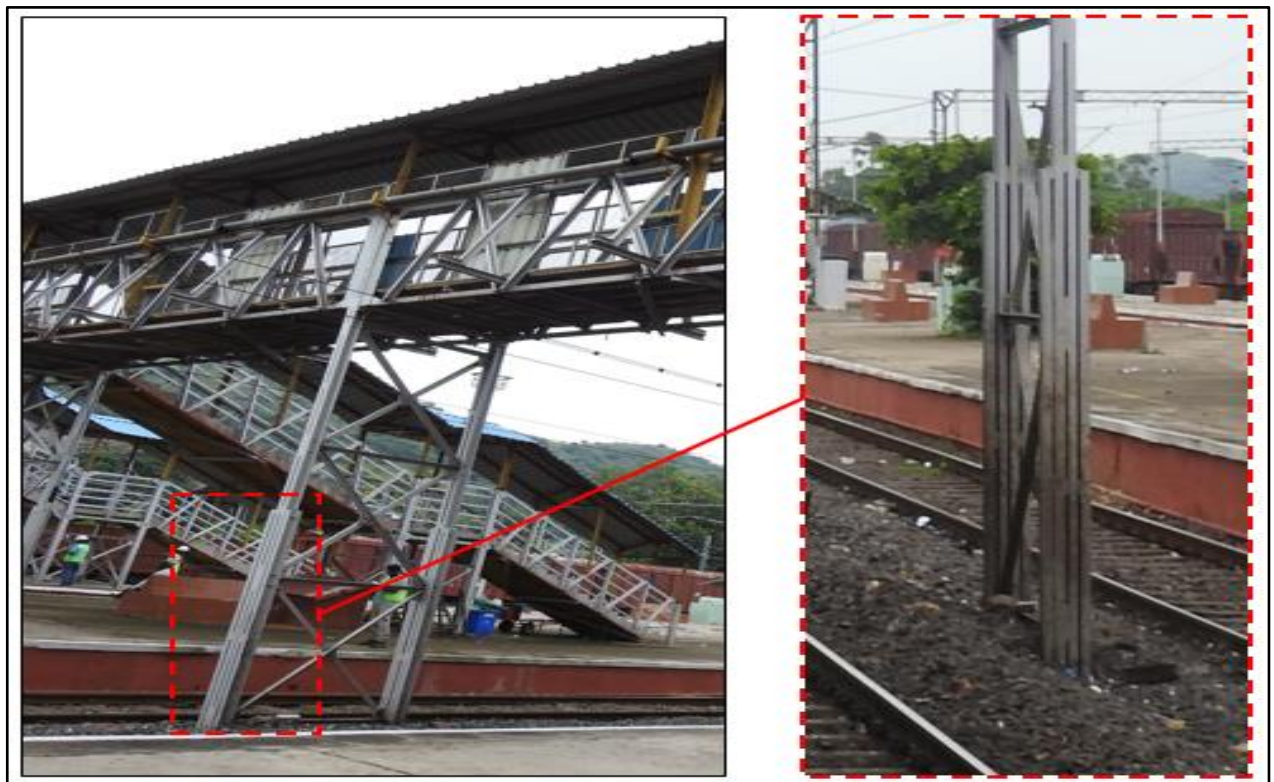
**Fig 1.4:** Stanchion column Rail sections details

| | Type/Shape of Column section | Built up Rail Section | a. FOB is supported on vertical column of 2 Rail section 65 x 130 x 65, with bracings of 65 x 65 x 10 mm angle section<br>b. Trestles 1 ,3 and 4 have 4 columns whereas Trestles 2 (Stanchion) have only 2 columns.<br>c. Trestle 2 (Stanchion column) and Trestle 3 has built up section of 4 rail sections 65 x 130 x 65mm up to a height of 2.94 and 2.25 m respectively and continued with 2 rails (Refer <b>fig: 1.4, 1.5</b> )<br>d. Staircase landing is supported by 2 Rail section of 65 x 130 x 65mm. |

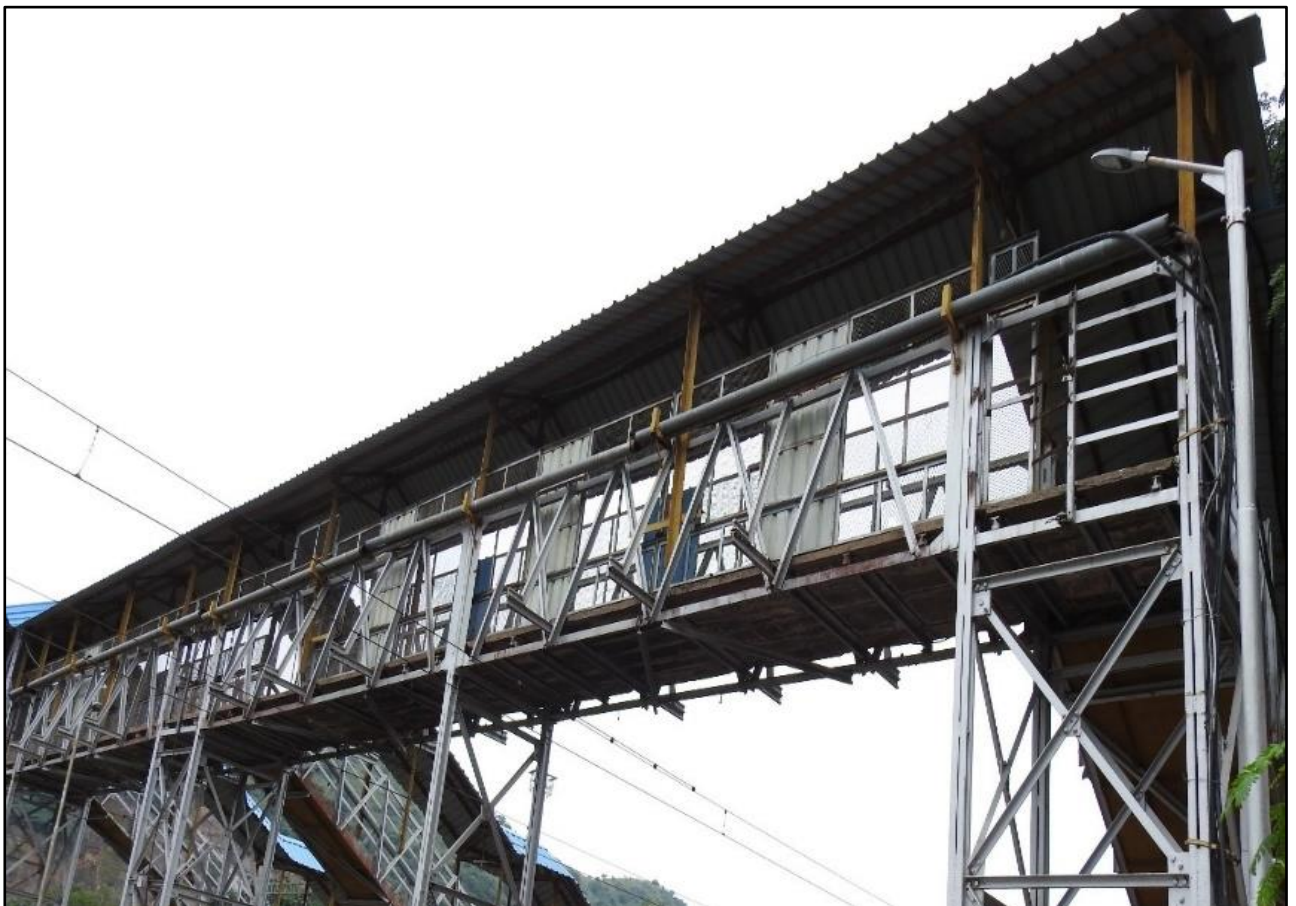
***Fig 1.6:*** Bottom view of FOB

| 1.3 STRUCTURAL SYSTEM OF THE BRIDGE | | | |
|---|---|---|---|
| | Shape of Truss Section | Rail section | a) Top and bottom Chord members are 45 x 100 x 100 (Head x Height x Base) Rail section (Refer <b>fig: 1.6</b> ) |

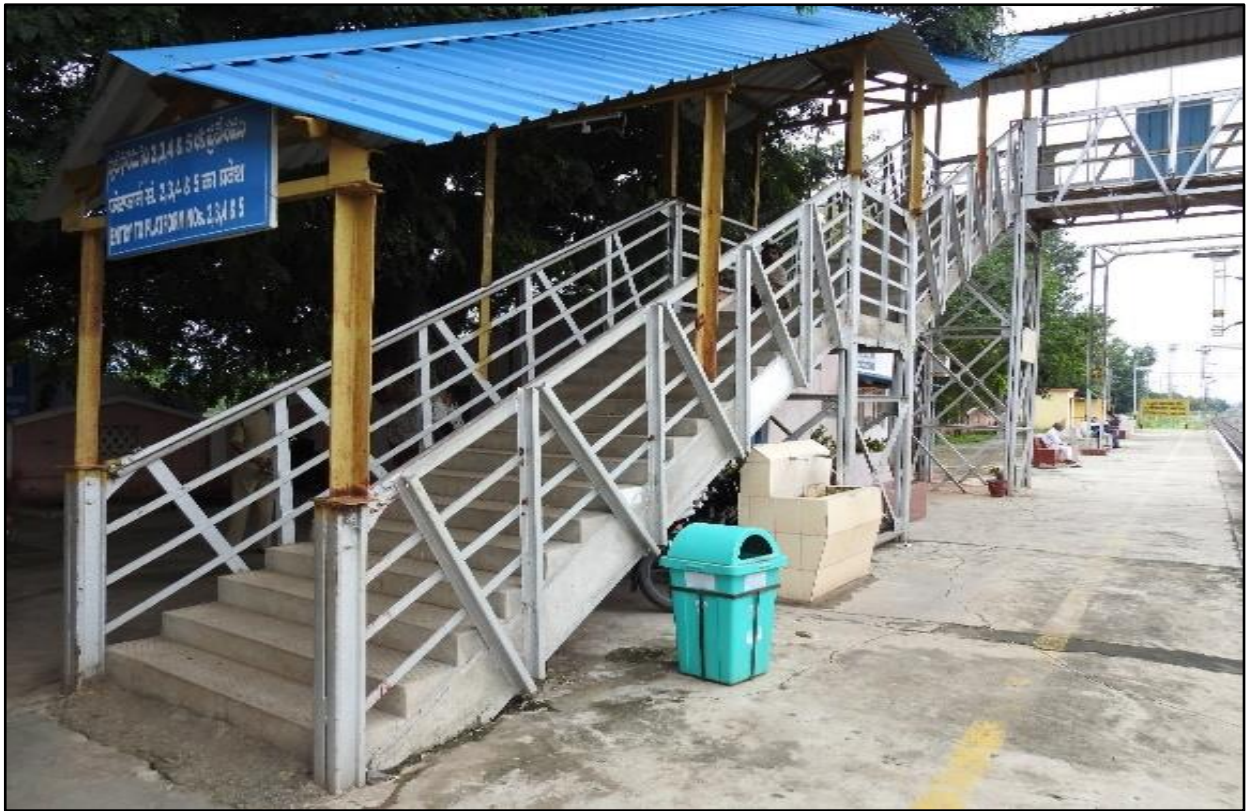
**Fig 1.7:** Staircase side view of FOB

| | Number of Staircase | 3 No's | Staircase is observed as In-situ RCC Slab supported on 50 x 90 x 90mm Rail tie beam and Rail Stringer beam on both sides of stair case. (Refer <b>fig : 1.7</b> ) |
