# Third Party Audit of ROB's and FOB's of SCR

## INSPECTION OF FOB AT PEDDAVATLAPUDI RAILWAY STATION

**Final Report**  
SEPTEMBER | 2020

| <b>Name of the Project</b> | : | VISUAL INSPECTION OF FOB AT PEDDAVATLAPUDI RAILWAY STATION |

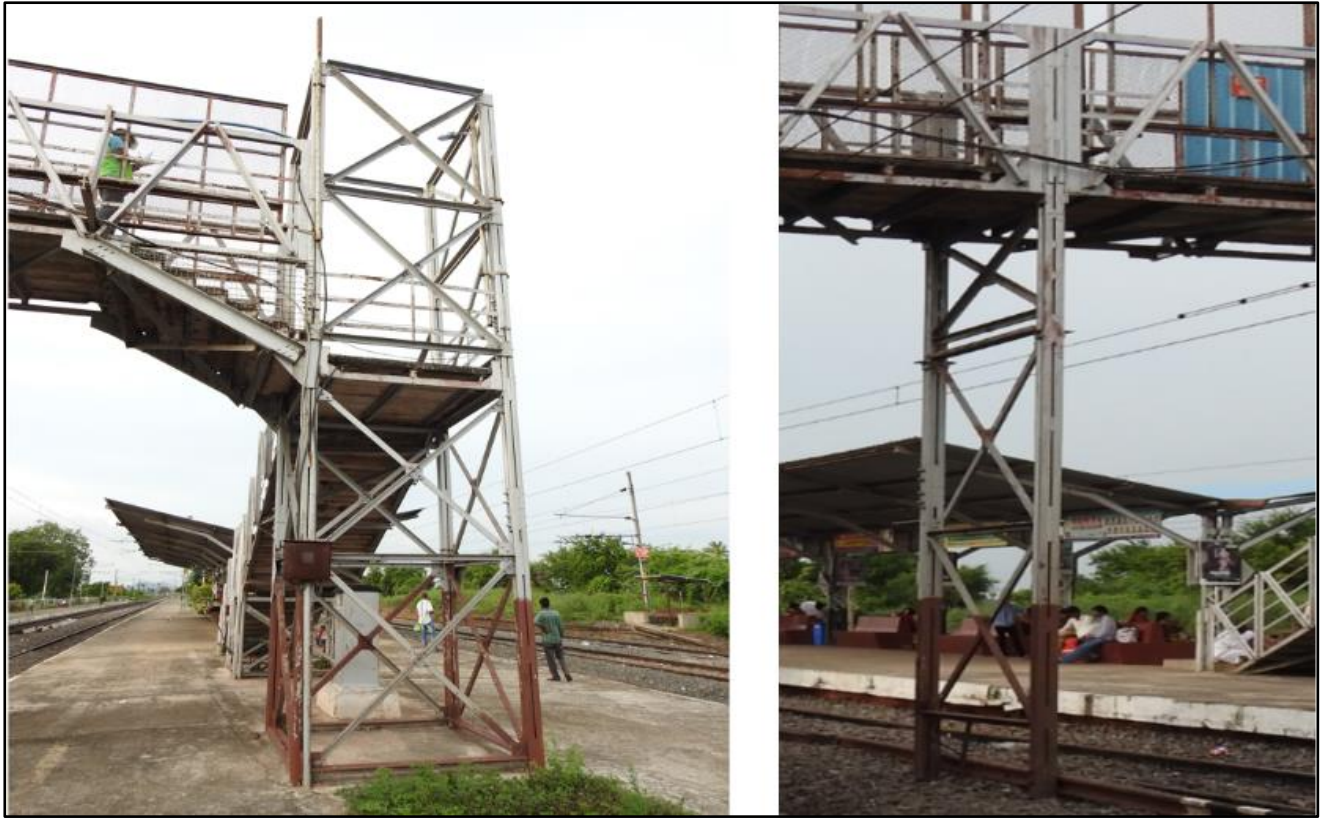
**Fig 1.9:** Trestle and Stanchion of FOB

| | Type/Shape of Column section | Double Rail Section | a. FOB is supported on vertical column of 2 Rail section 65 x 130 x 65, with bracings of 65 x 65 x 10 mm angle section(Refer <b>fig :1.9</b> ) |
