# Third Party Audit of ROB's and FOB's of SCR

## INSPECTION OF FOB AT TSUNDURU RAILWAY STATION

**Final Report**  
SEPTEMBER | 2020

| <b>Name of the Project</b> | : | VISUAL INSPECTION OF FOB/ PF-1 – PF-2 AT TSUNDURU RAILWAY STATION |

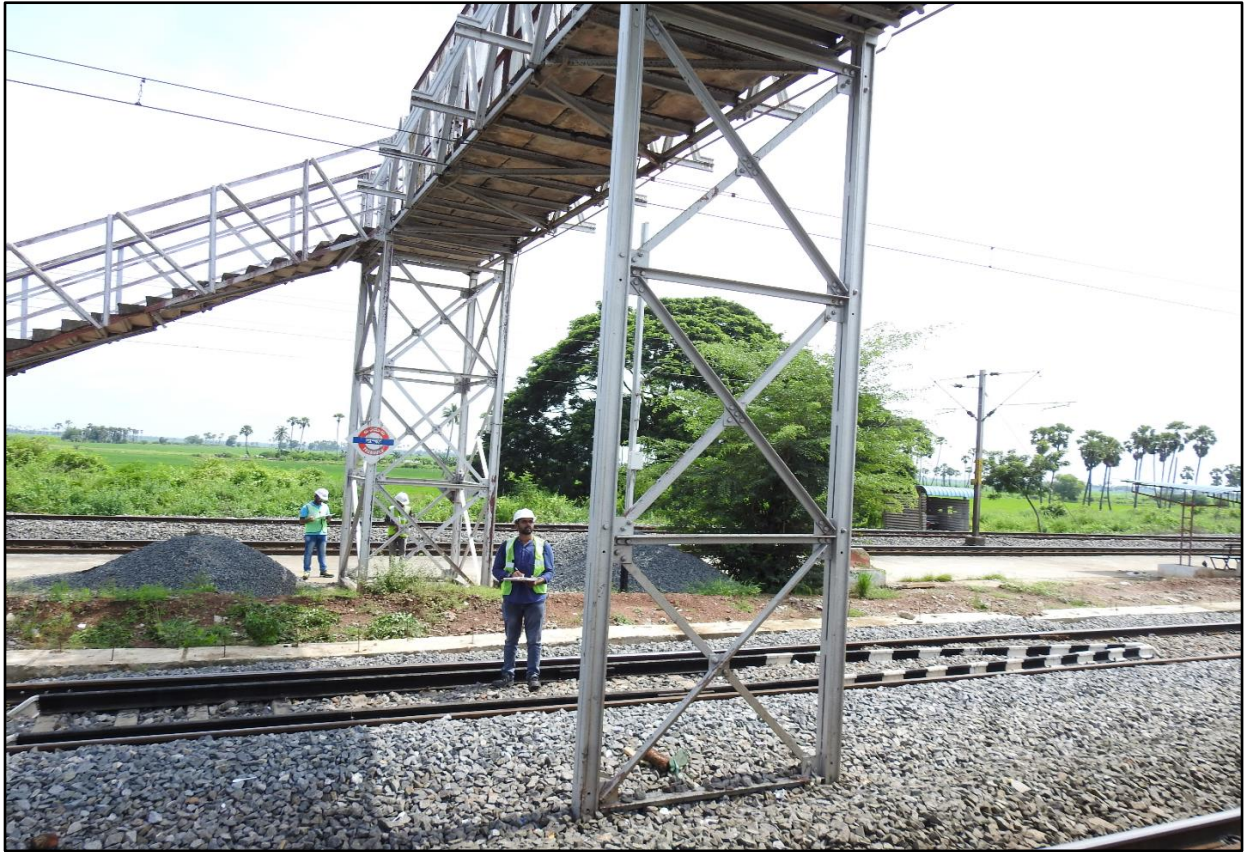
**Fig 1.9:** Trestle and Stanchion

| | Type/Shape of Column section | Built up Rail Section | a. FOB is supported on vertical column of 2 Rail section 65 x 135 x 65, with bracings of 65 x 65 x 10 mm angle section (Refer <b>fig :1.9</b> )<br>b. Trestles 1 and 3 have 4 columns whereas Trestles 2 (Stanchion) have only 2 columns. (Refer <b>fig :1.9</b> )<br>c. Staircase landing is 2 Rail section 65 x 135 x 65, with bracings of 65 x 65 x 10 mm angle section (Refer <b>fig :1.10</b> ) |

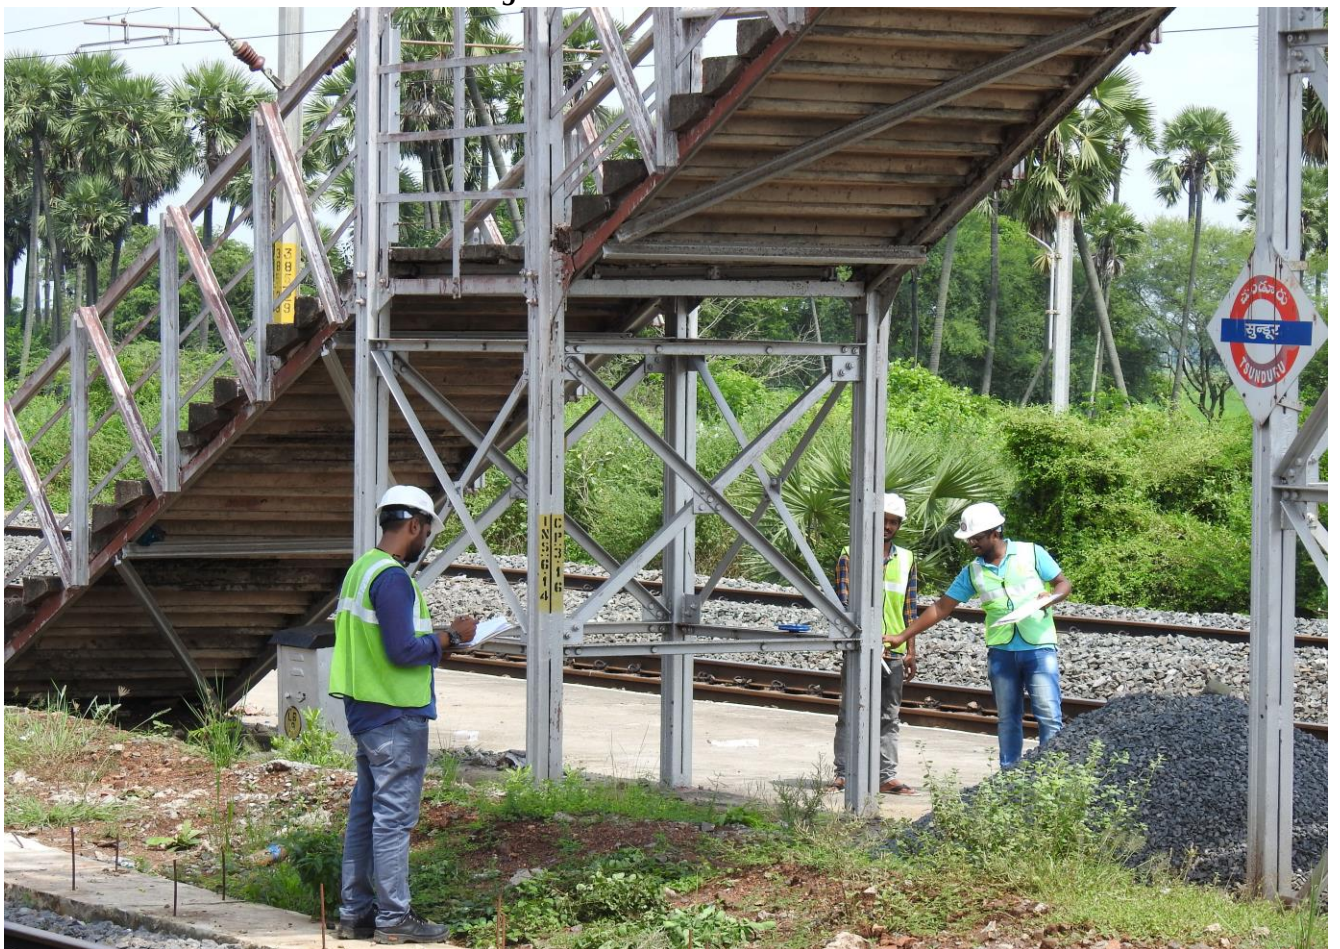
**Fig 1.10:** Staircase Mid-landing

e) Spalling, Exposed Reinforcement and leaching observed in staircase 2 (Mid landing)
