# Third Party Audit of ROB's and FOB's of SCR

## INSPECTION OF FOB AT MUSTABAD RAILWAY STATION

**Final Report**  
SEPTEMBER | 2020

| <b>Name of the Project</b> | : | VISUAL INSPECTION OF FOB AT MUSTABADA RAILWAY STATION |

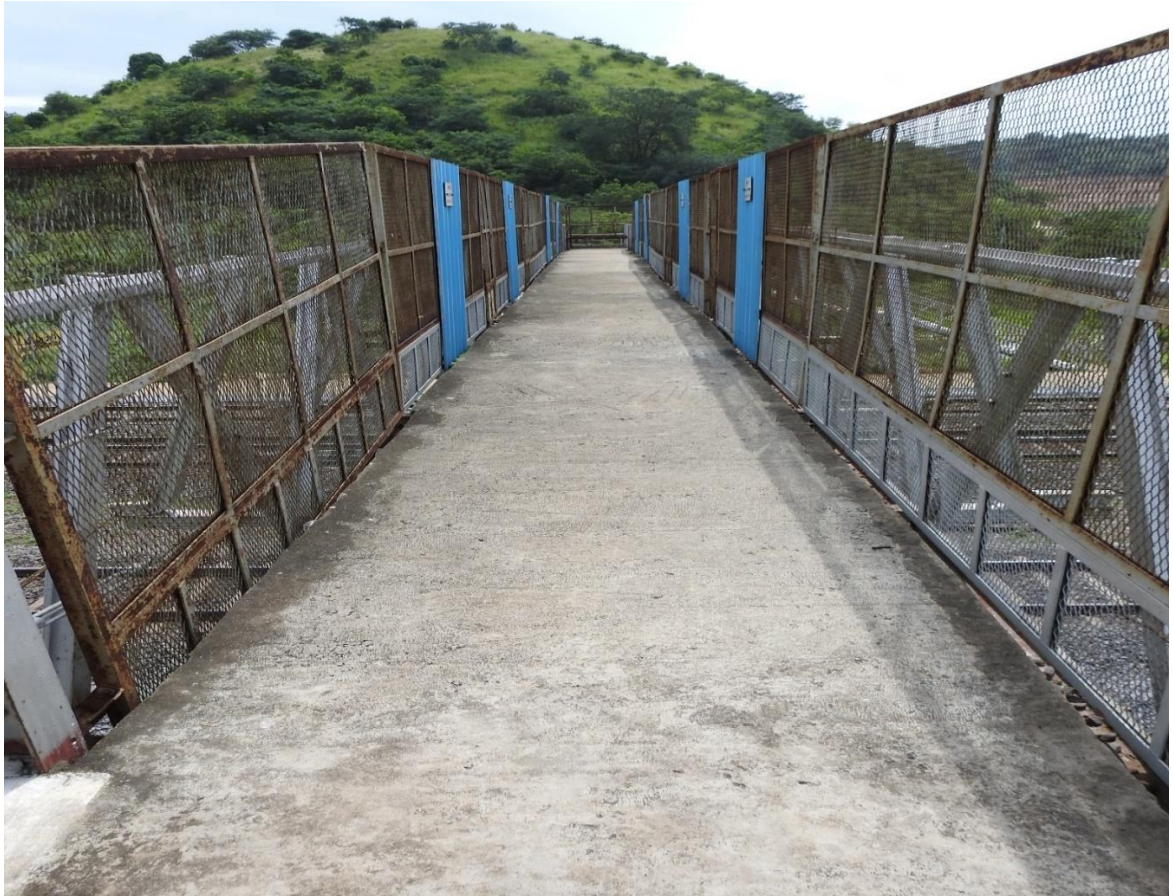
**Fig 1.2:** Pathway, Protective screen

| 1.2 IDENTIFICATION OF LOADS ON BRIDGE | | | |
|---|---|---|---|
| | b) Provision of protective screen for passengers | Yes | Fence made of galvanized wire of 2 mm gauge and 2 mm galvanized sheet is used above OHE Line on both side of pathway is used for passengers Protection.<br>(Refer <b>fig :1.2</b> ) |

| | Material of Slab | Cast In-Situ | <p>a. Pre-cast Reinforced concrete slab panels are used for floor slab of 150 mm thick, RCC slab panels are resting on Floor beams, which are supported by Bottom Lateral Bracings and Bottom chord member.</p> <p>b. Cement concrete layer is used for flooring. (Refer <b>fig : 1.2</b>)</p> |

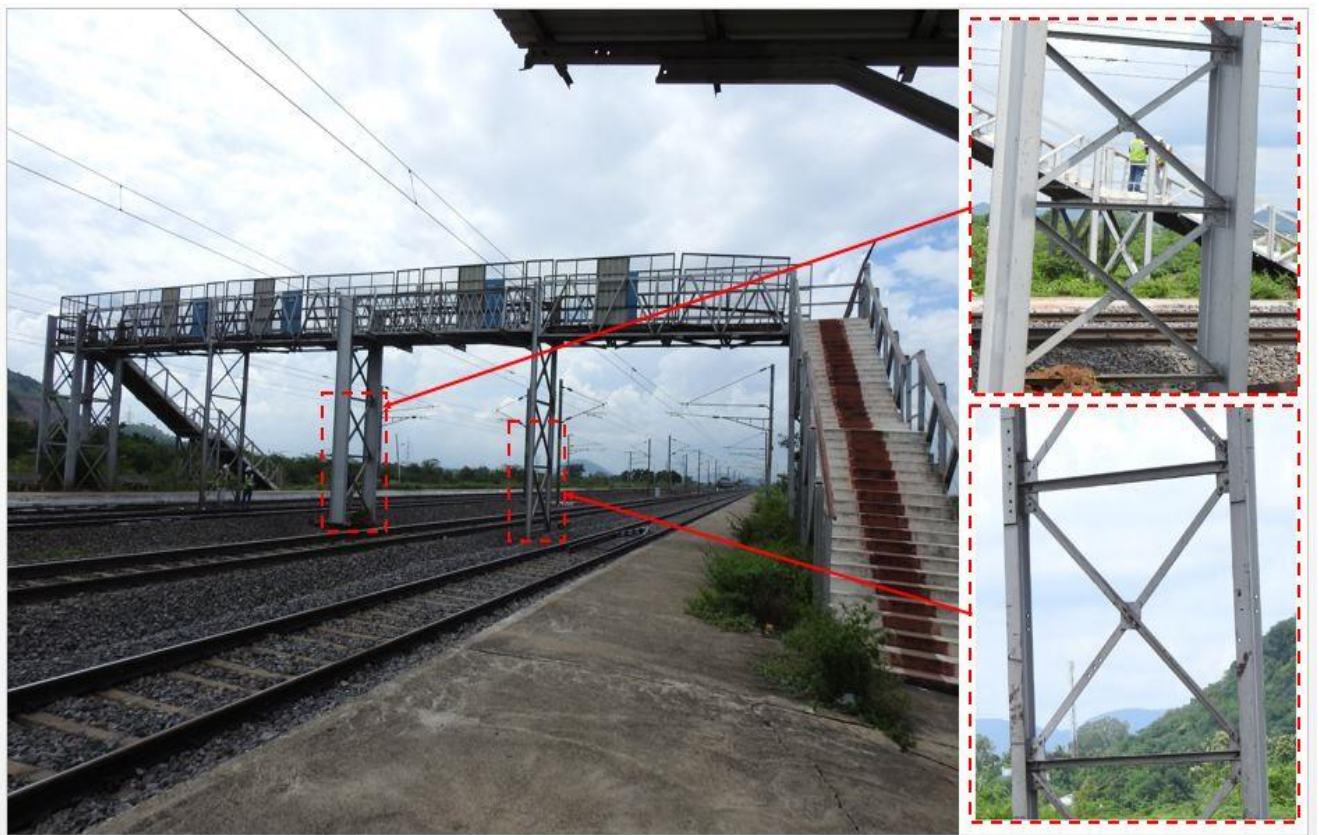
**Fig 1.3:** Stanchion details

| | Type/Shape of Column section | I- Section Railing | <p>a. FOB is supported on vertical column of ISMB 400, with bracings of 75 x 75 x 12 mm angle section.</p> <p>b. Trestles 1 and 5 have 4 columns whereas Trestles 2, 3 and 4 (Stanchions) have only 2 columns. (Refer <b>fig: 1.3</b>)</p> <p>c. Stanchion - 1 has ISMB 200 column section, Stanchion - 2 has ISMB 600 column section and Stanchion 3 2 has ISMB 150 column section</p> <p>d. Staircase landing is supported by ISMB 150, with bracings of 75 x 75 x 12 mm angle section (Refer <b>fig :1.6</b>)</p> |

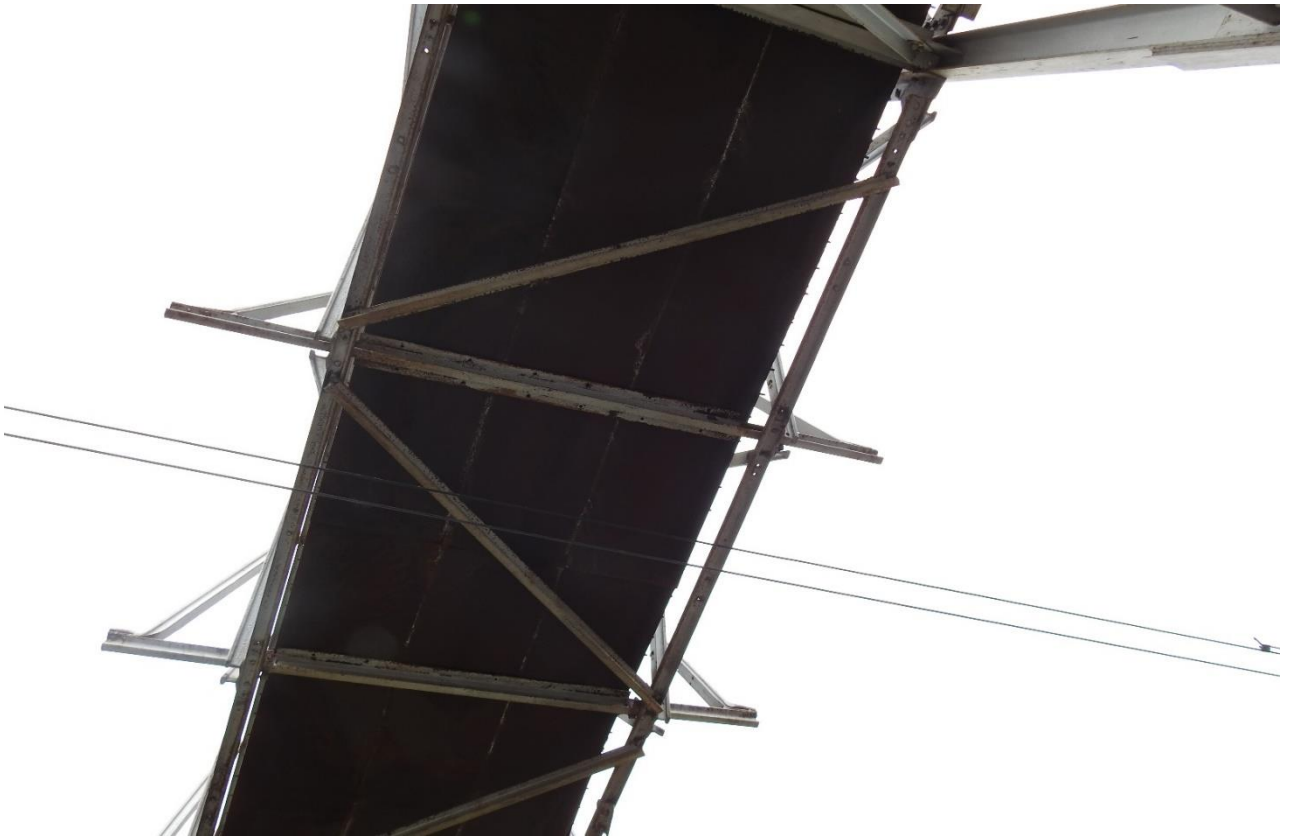
**Fig 1.4:** Bottom view of FOB

| 1.3 STRUCTURAL SYSTEM OF THE BRIDGE | | | |
|---|---|---|---|
| | Type /Shape of Truss Section | Warren Type (Span-1,3,4), Diamond Mesh (Span-2) | <b>Span – 1, 3 &amp; 4:</b><br>a) Top and bottom Chord members are 45 x 90 x 90mm (Head x Height x Base) Rail sections. (Refer <b>fig :1.4</b> )<br>b) 45 x 90 x 90mm Rail sections are used as Diagonal & Knee bracing members. |

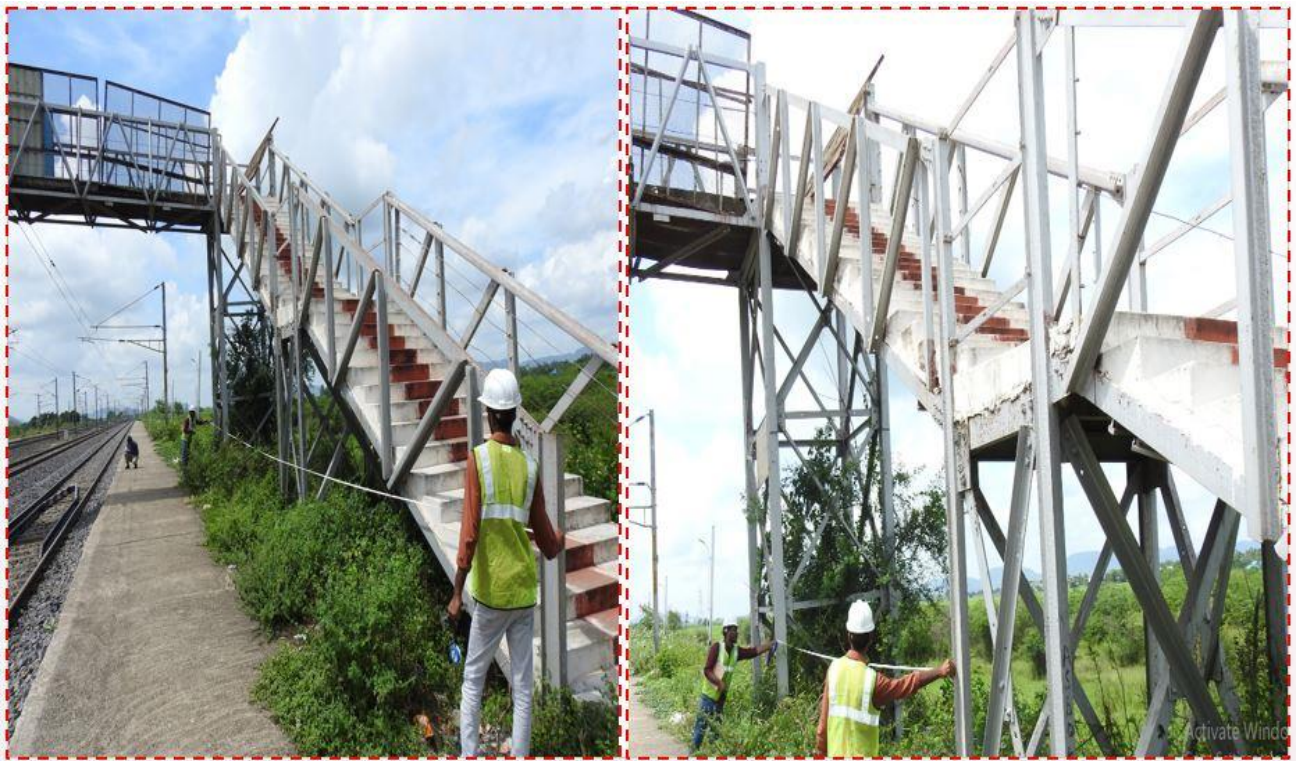
**Fig 1.5:** Stair Case Details

| | Number of Staircase | 2 No's | <p>Staircase is observed as Cast-In situ RCC Slab panels supported on 45 x 90 x 90mm Rail tie beam and 55 x 110 x 110mm Rail Stringer beam on both sides of stair case. (Refer <b>fig : 1.5</b>)</p> |
