## Third Party Audit of ROB's and FOB's of SCR

### INSPECTION OF FOB AT CHINNAGANJAM RAILWAY STATION

**Final Report**  
SEPTEMBER | 2020

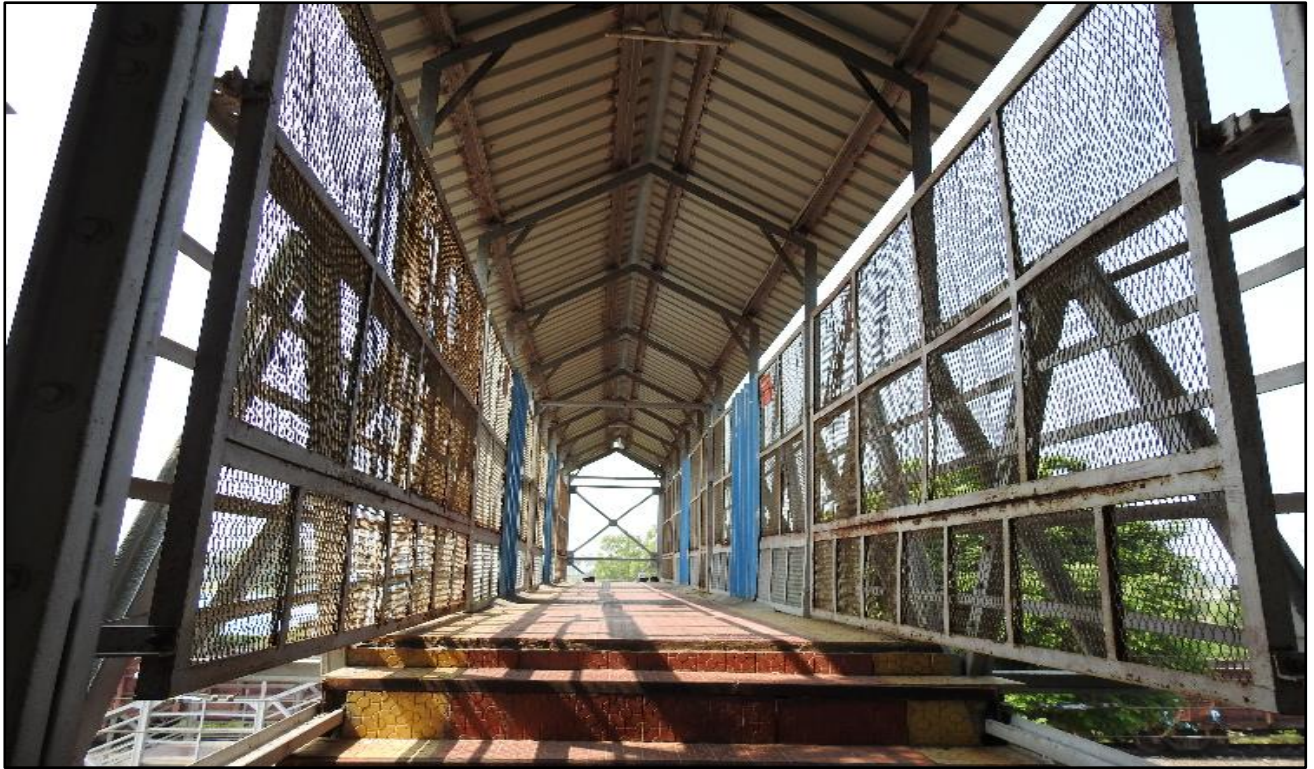
**Fig 1. 2:** FOB span 1 & 2 pathway, additional wearing coat, protective screen

| PART 1.2 IDENTIFICATION OF LOADS ON BRIDGE | | | |
|---|---|---|---|
| | a) Additional wearing coat on Floor | Yes | Only Chequered tiles used for Flooring (Refer <b>fig :1.2</b> ) |
| | b) Provision of protective screen for passengers | Yes | Fence made of galvanized wire of 2 mm gauge and 2 mm galvanized sheet is used above OHE Line on both side of pathway is used for passengers Protection. (Refer <b>fig :1.2</b> ) |

| PART 1.3 STRUCTURAL SYSTEM OF THE BRIDGE | | | |
|---|---|---|---|
| | Element of roof truss section | Angle section | Common Rafter Truss of 75 x 75 x 6 mm Angles are used as Roof truss supported on Vertical members of 75 x 75 x 6 mm Angle section (Refer <b>fig : 1.2</b> ) |

| | Material of Slab | RCC | a. Cast in-situ Reinforced concrete slab is used for floor slab of 75 mm thick, RCC slab covered by Sacrificial Plate is resting on Floor beams, which are supported by Bottom Lateral Bracings and Bottom chord member.<br>b. Chequered tile flooring is laid on the top of the Pre-cast slab panels.(Refer <b>fig : 1.2</b> ) |

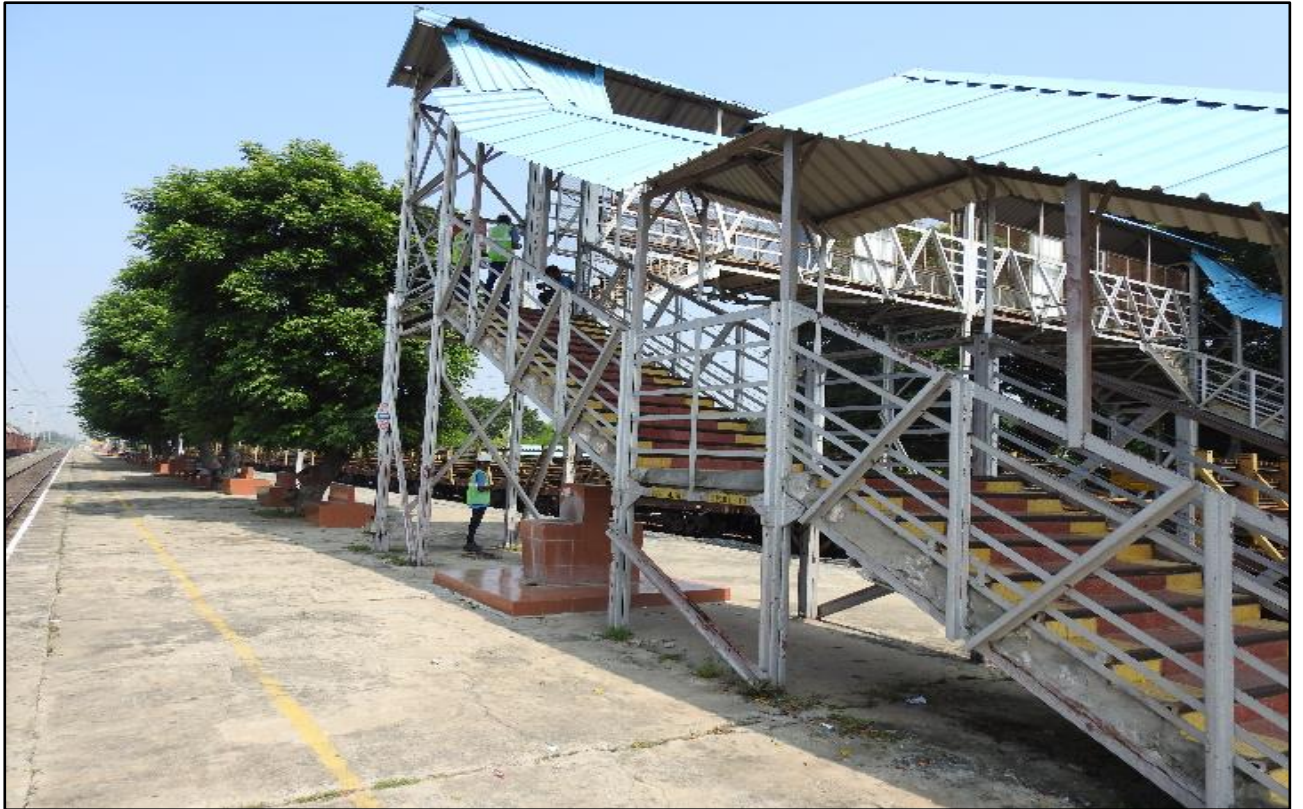
**Fig 1.6:** Railing Details

| | Type of Parapet Railing | Steel railing | Staircase is provided with railing on both sides using 50 x 80 x 80 Rail section and 50 x 6 mm M.S flats are used. (Refer <b>fig : 1.6</b> ) |
