# Third Party Audit of ROB's and FOB's of SCR

## INSPECTION OF FOB AT ANAKAPALLE RAILWAY STATION

**Final Report**  
SEPTEMBER | 2020

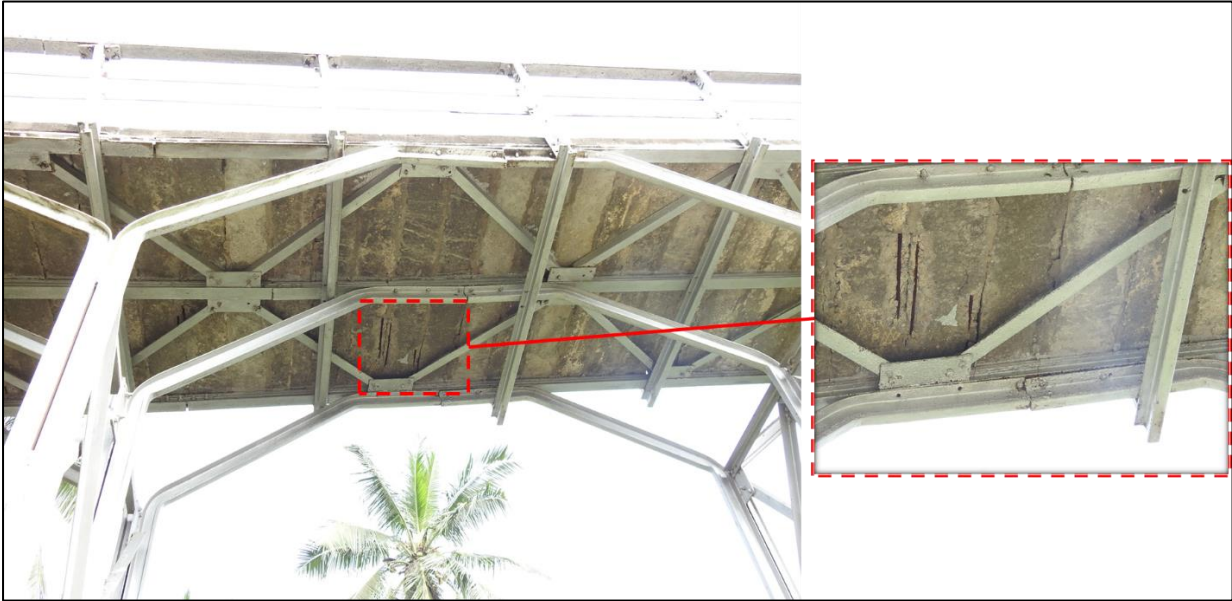
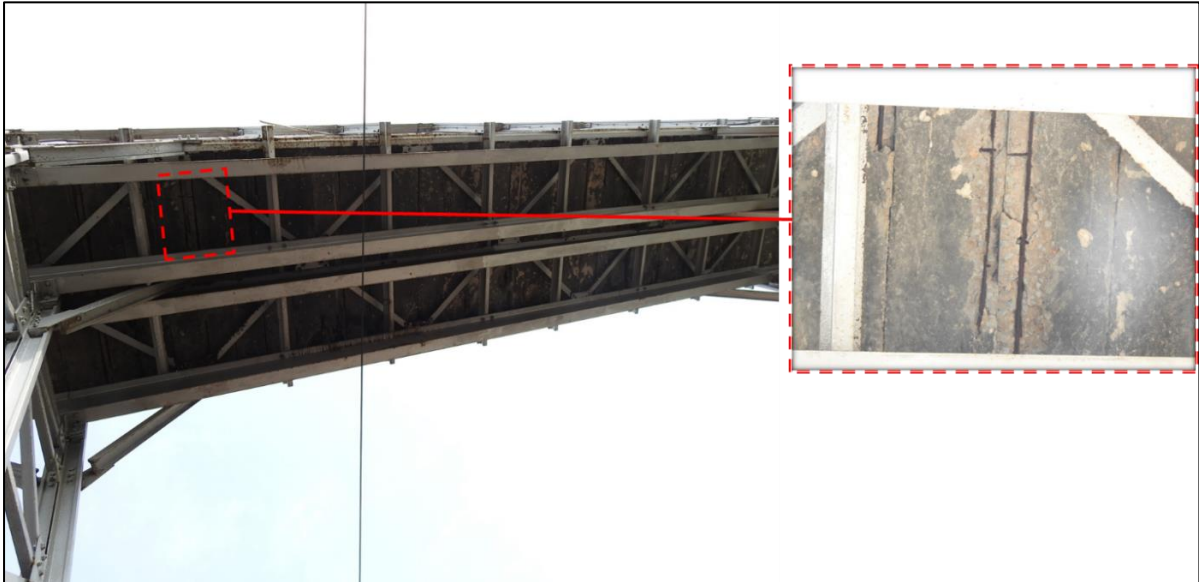
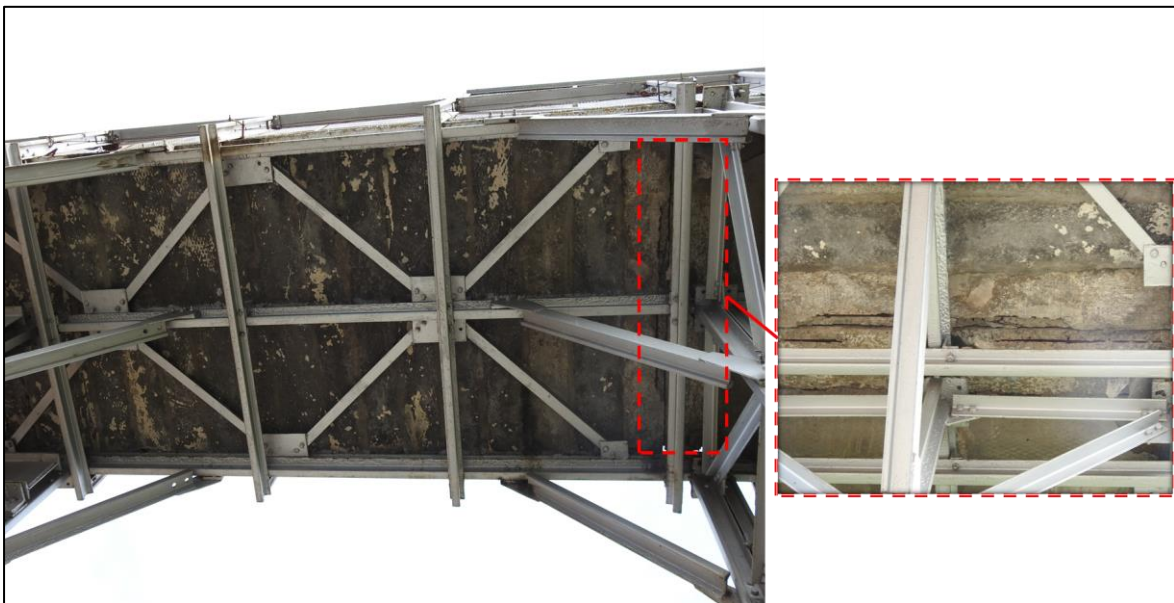
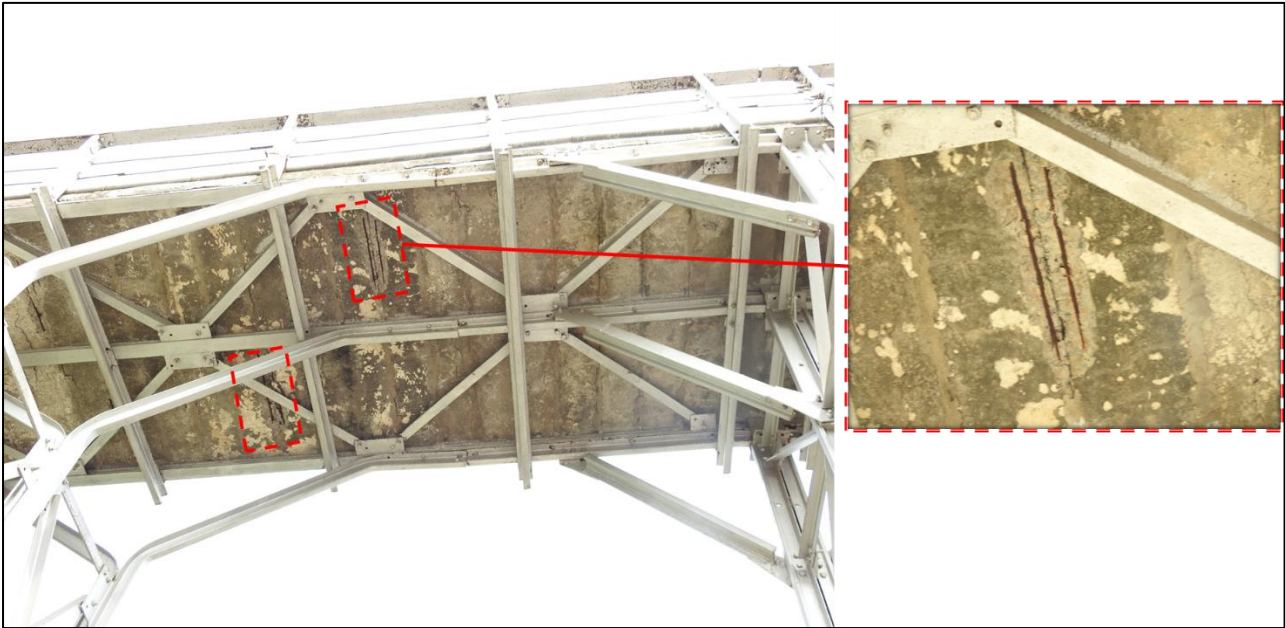
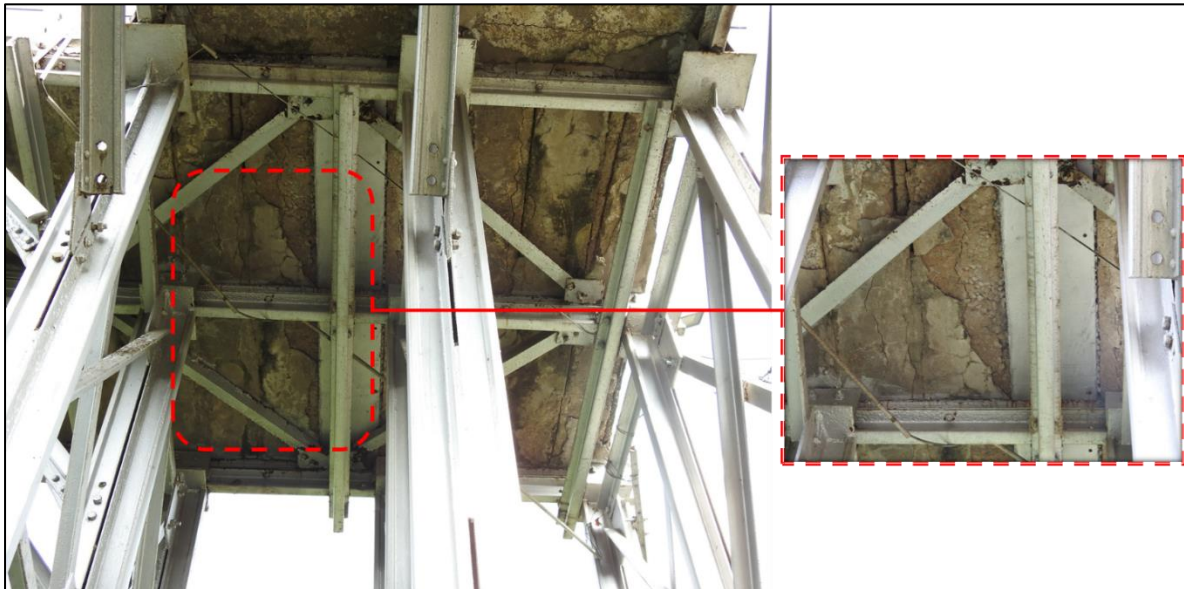
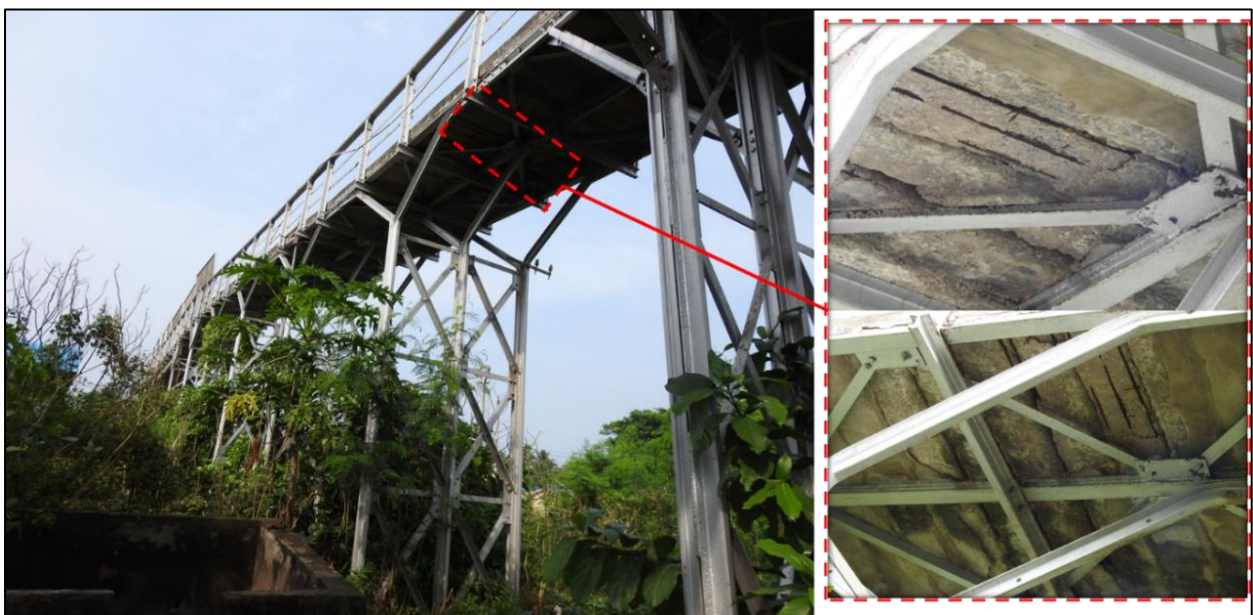
- i ✓ Exposed reinforcement is observed in span 1, 2, 3 and 7<sup>th</sup> span and spalling are observed ramp.

a) Reinforcement exposed slab panels

b) Spalling observed in ramp on both sides

| SIGNS OF DISTRESS, DEFORMATION IN BRIDGES | | | |
|---|---|---|---|
| | Cracking in RCC components | Slab panels | Cracks are observed in Pre-cast RCC slab panels of Ramps & Main Slab. (Refer: <b>Part 1.4, Fig- b</b> ). |
| | Spalling | Slab panels in ramp | Spalling is observed in ramp slab (Refer: <b>Part 1.4, Fig- b</b> ). |

Reinforced cement concrete Slab at Deck level and some precast panels in staircase are observed with exposed rebar in many locations. *(Photographs of the same can be seen in fig 2.4)*

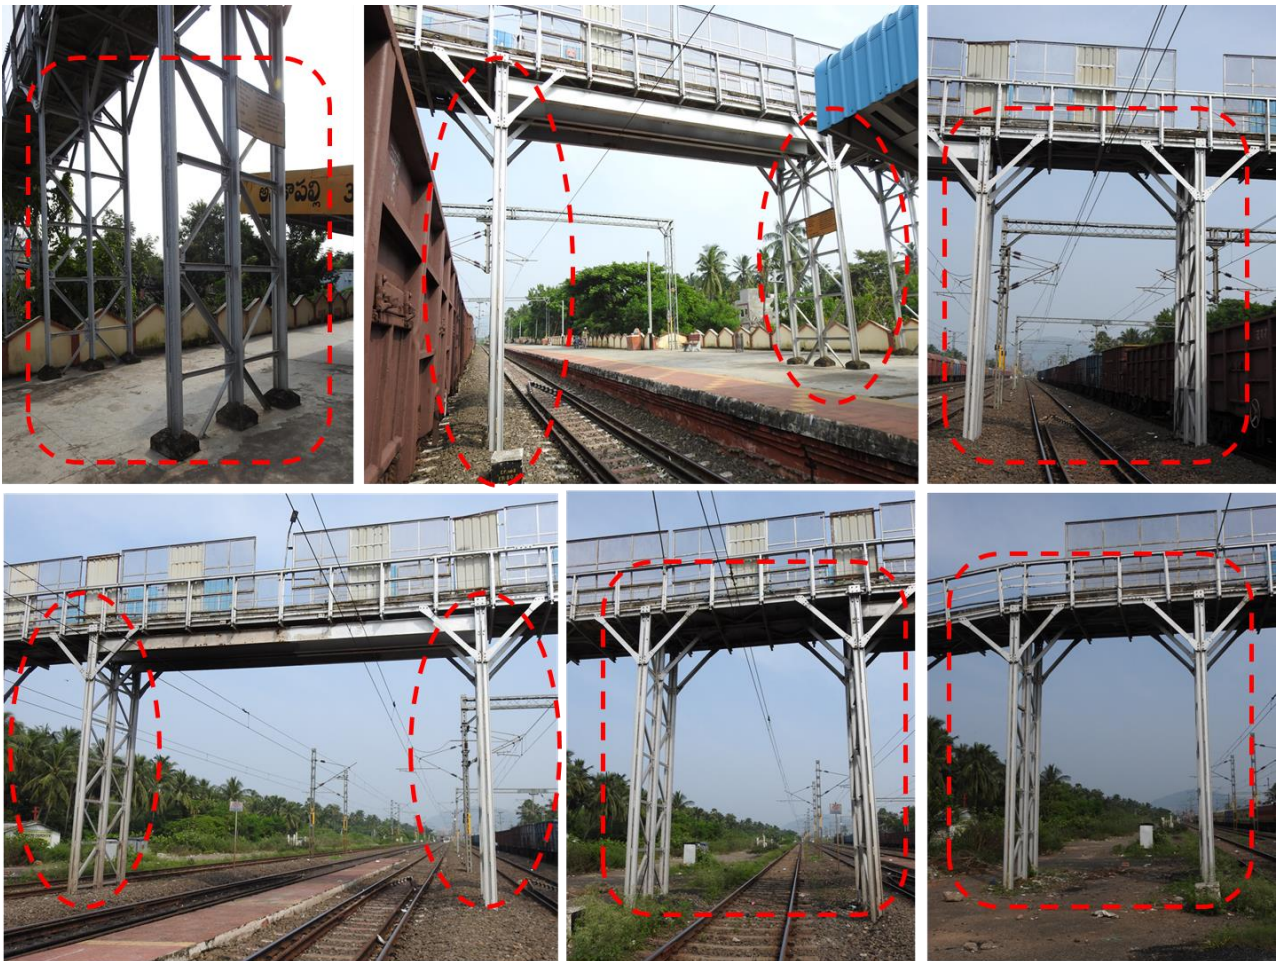
**Fig 1.3:** Stanchion column sections details

| | No of Columns/ support | 3 | b. Cross Bracings in Stanchions are 75 x 75 x 8 mm Angles are used. (Refer <b>fig :1.3</b> ) |

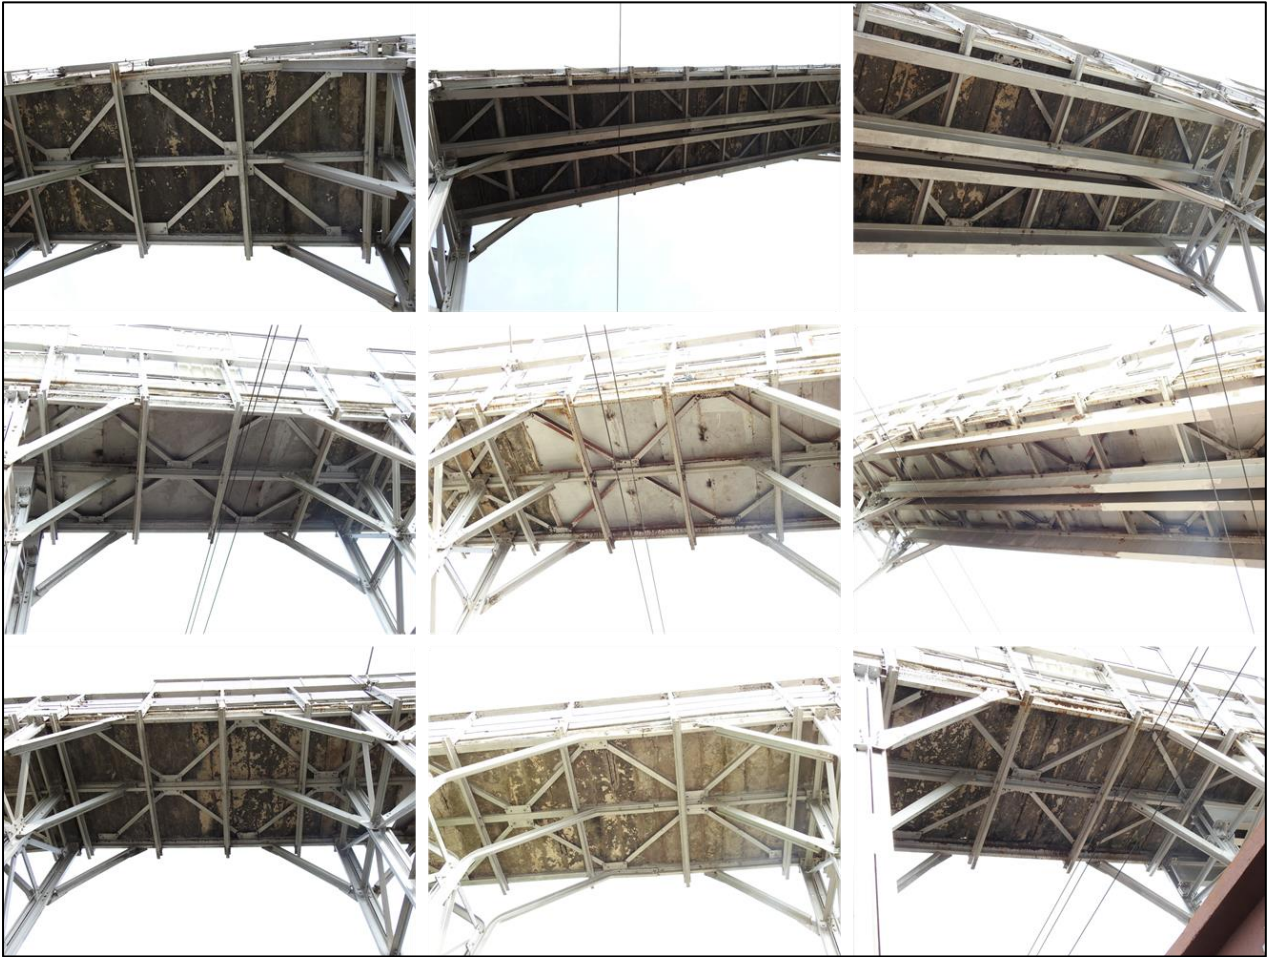
**Fig 1.4:** Bottom view of FOB

| 1.3 STRUCTURAL SYSTEM OF THE BRIDGE | | | |
|---|---|---|---|
| | Type /Shape of Truss Section | Rail sections | a) Top Chord members are 60 x 120 x 120 (Head x Height x Base) Rail sections<br>(Refer <b>fig :1.4</b> ) |
