# Third Party Audit of ROB's and FOB's of SCR

## INSPECTION OF FOB AT KACHIGUDA RAILWAY STATION

**Final Report**  
SEPTEMBER | 2020

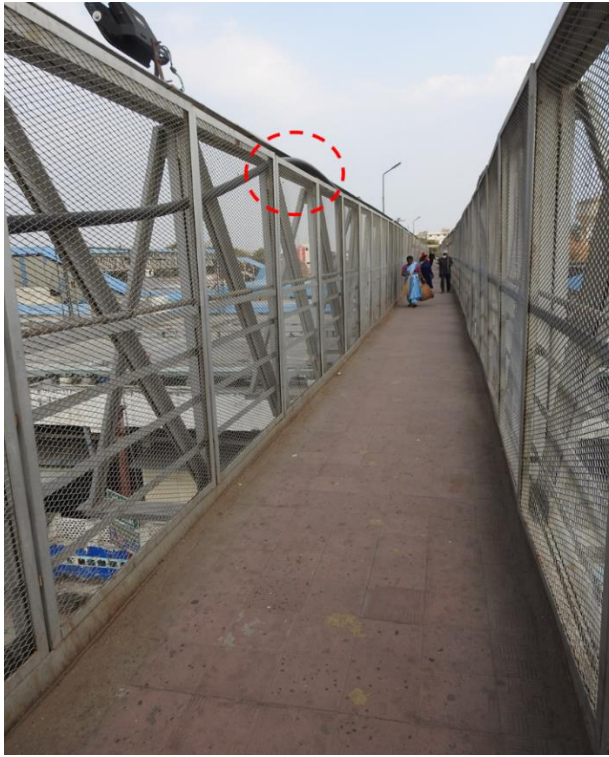
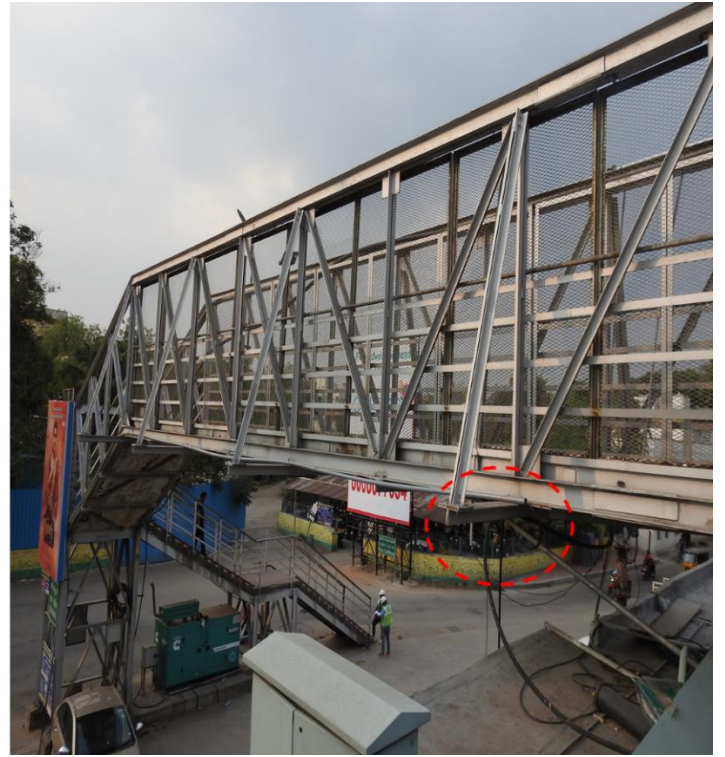
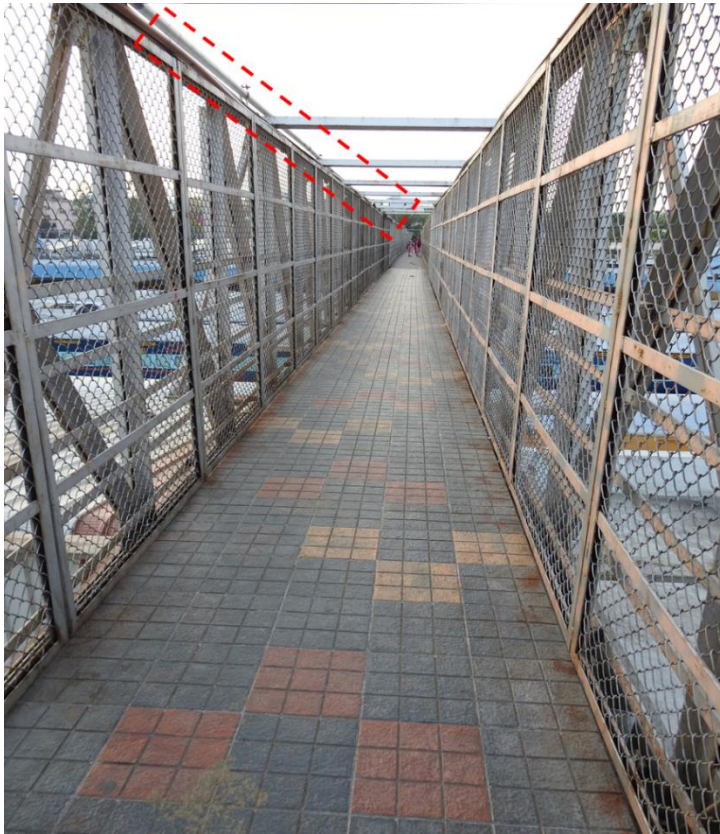
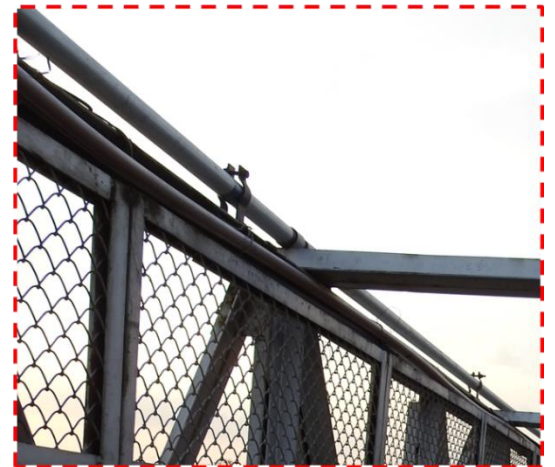
***Fig 1.1:*** Cables, Flooring and Protective screen

| 1.2 IDENTIFICATION OF LOADS ON BRIDGE | | | |
|---|---|---|---|
| | b) Cables | | Cables are protected with 1-inch and 1.5-inch dia HDPE pipe and 1-inch PVC pipes supported on top and bottom chord of span 1 and 2- inch GI pipe supported on top chord. (Refer <b>fig :1.1</b> ) |
| | b) Provision of protective screen for passengers | Yes | Chain link fence made of galvanized wire of 2 mm gauge and 2mm galvanized sheet is used above OHE line on both side of gangway is used for protection. (Refer <b>fig :1.1</b> ) |

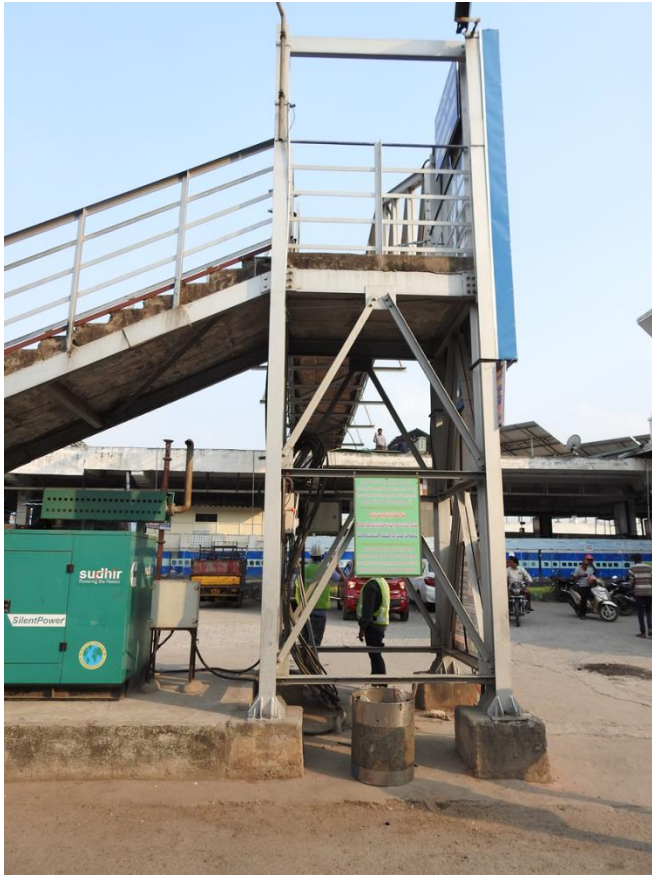
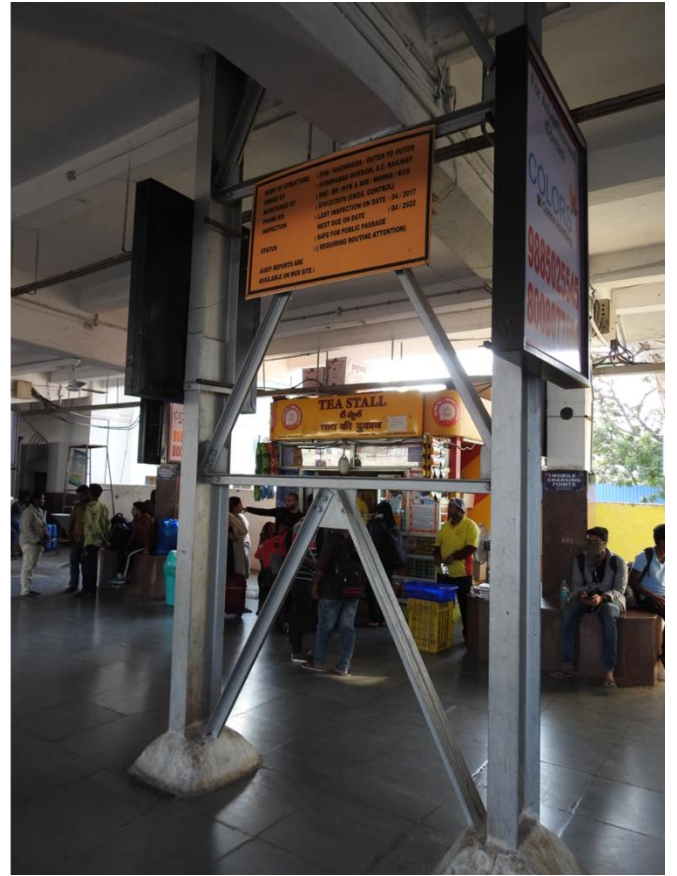
**Fig 1.2:** Trestles details

| | Type/Shape of Column section | I – Section | <p>FOB is supported on vertical column of ISMB 300 with bracings of 65 x 65 x 8mm double angle sections. (Refer <b>fig :1.2</b>)</p> |

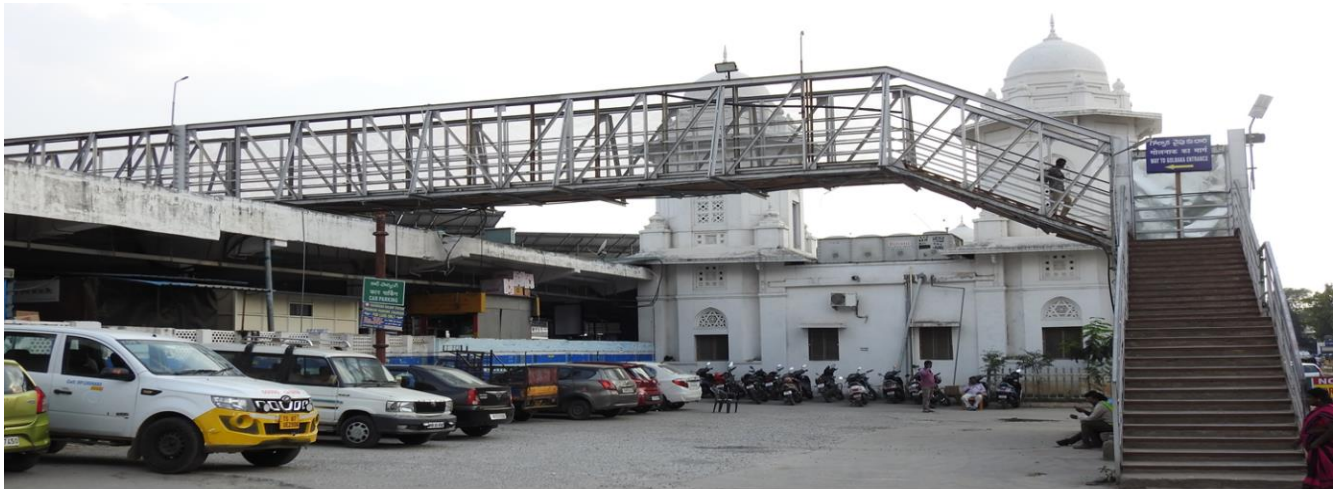
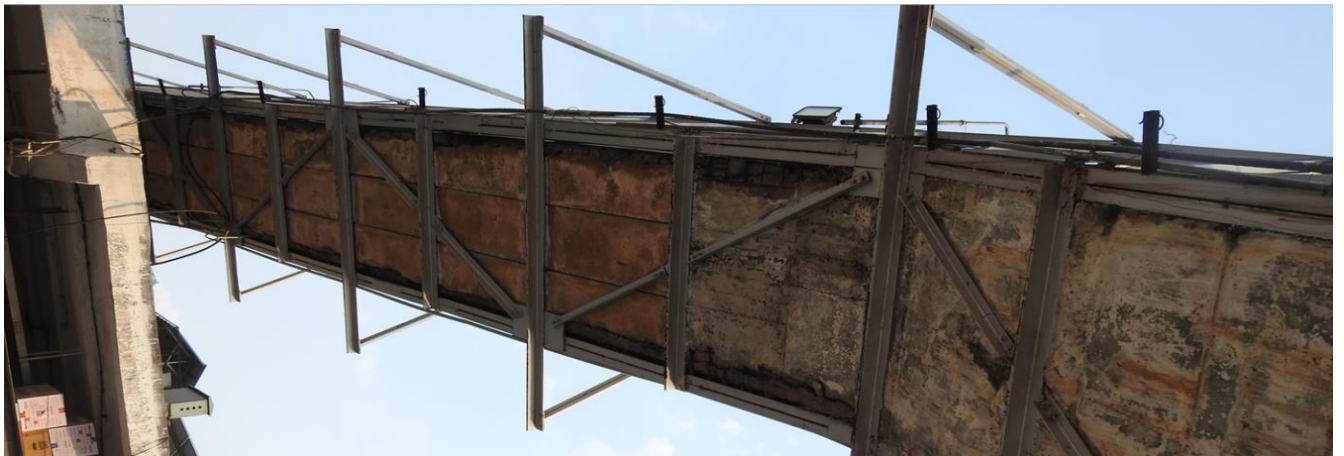
**Fig 1.3:** Front view and bottom view of span 1

| | Type/Shape of Secondary Girder /Bracings | Double angle sections | <p>c. 100 x100 x10mm of double angle sections are used as Floor beams supported by 75 x 75 x 8 mm angle sections to transfer load from slab to roof truss. (Refer <b>fig :1.3</b>)</p> <p>Span 2,3,4,5:</p> <p>d. Top and bottom chord members 100x100x10 double angle sections.</p> <p>e. 65 x 65 x 8 mm double angle sections are used as bracing members.</p> <p>f. 100 x100 x10mm of double angle sections are used as Floor beams supported by 75 x 75 x 8 mm angle sections to transfer load from slab to roof truss.</p> |

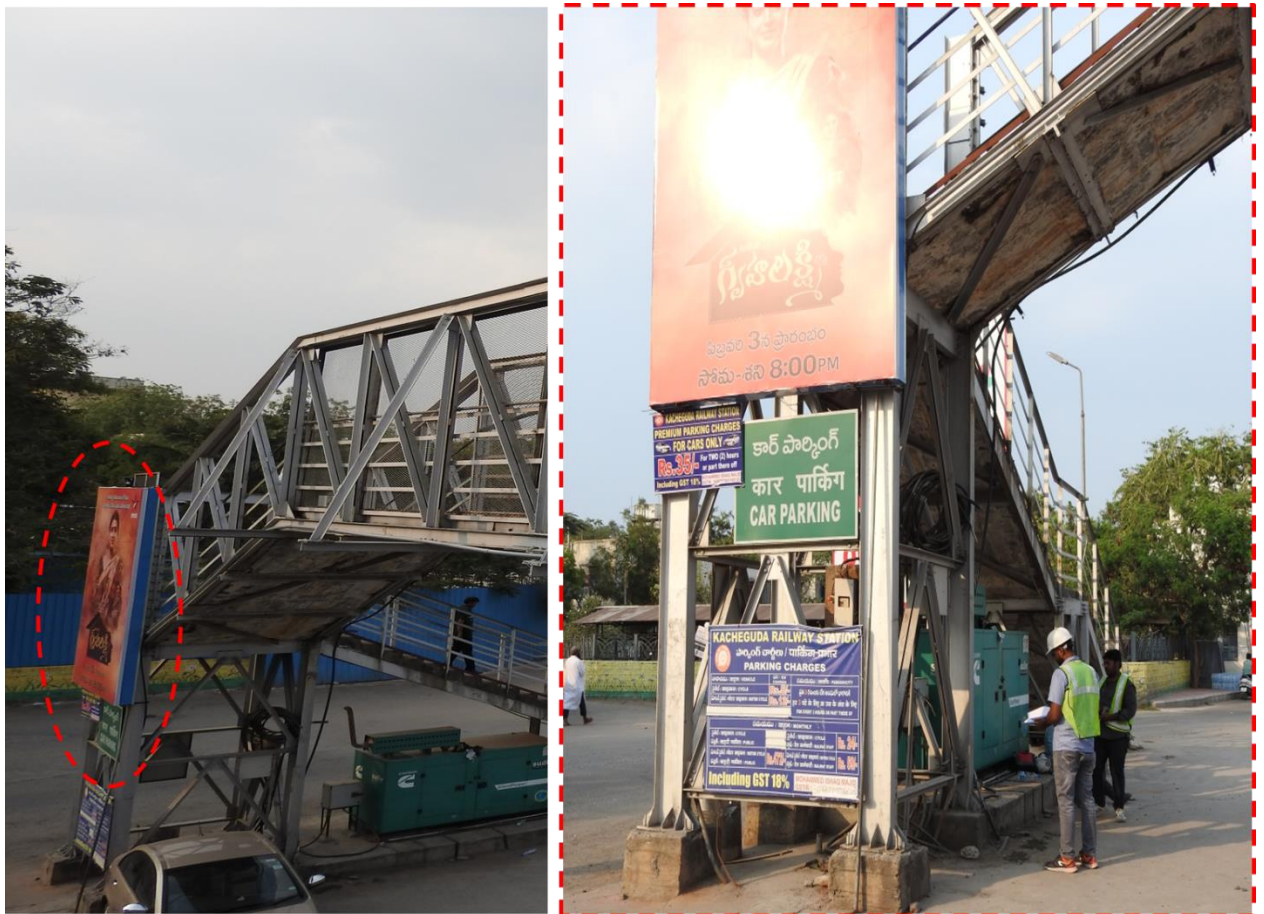
**Fig 1.9:** Advertise hoardings at Trestle 1

| 1.2 IDENTIFICATION OF LOADS ON BRIDGE | | | |
|---|---|---|---|
| | e) load of advertising hoarding | Yes | Advertising boards are provided at Trestle 1 (Refer <b>fig :1.9</b> ) |

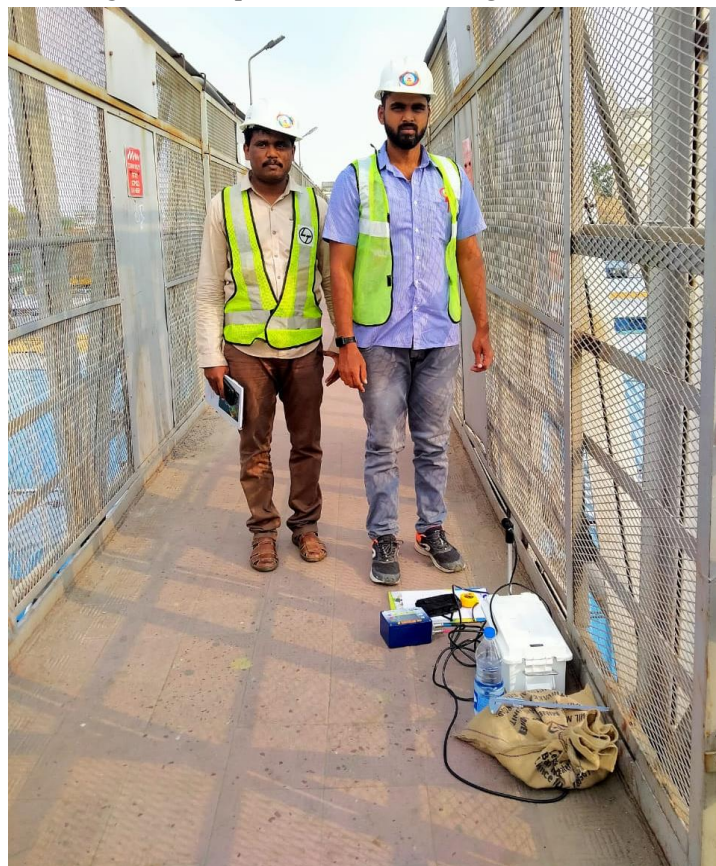
**Fig 1.11:** Vibration Test at Kachiguda FOB

Based on the vibration analysis carried out the structure is undergoing vibrations in permissible limit of vibrations. (Frequency observed is 366 cpm and maximum amplitude observed during the test time of complete 3hrs is 0.1425 mm)
