## Third Party Audit of ROB's and FOB's of SCR

### INSPECTION OF FOB AT MALKAJGIRI RAILWAY STATION

**Final Report**  
SEPTEMBER | 2020

| <b>Name of the Project</b> | : | VISUAL INSPECTION OF FOB AT MALKAJGIRI RAILWAY STATION |

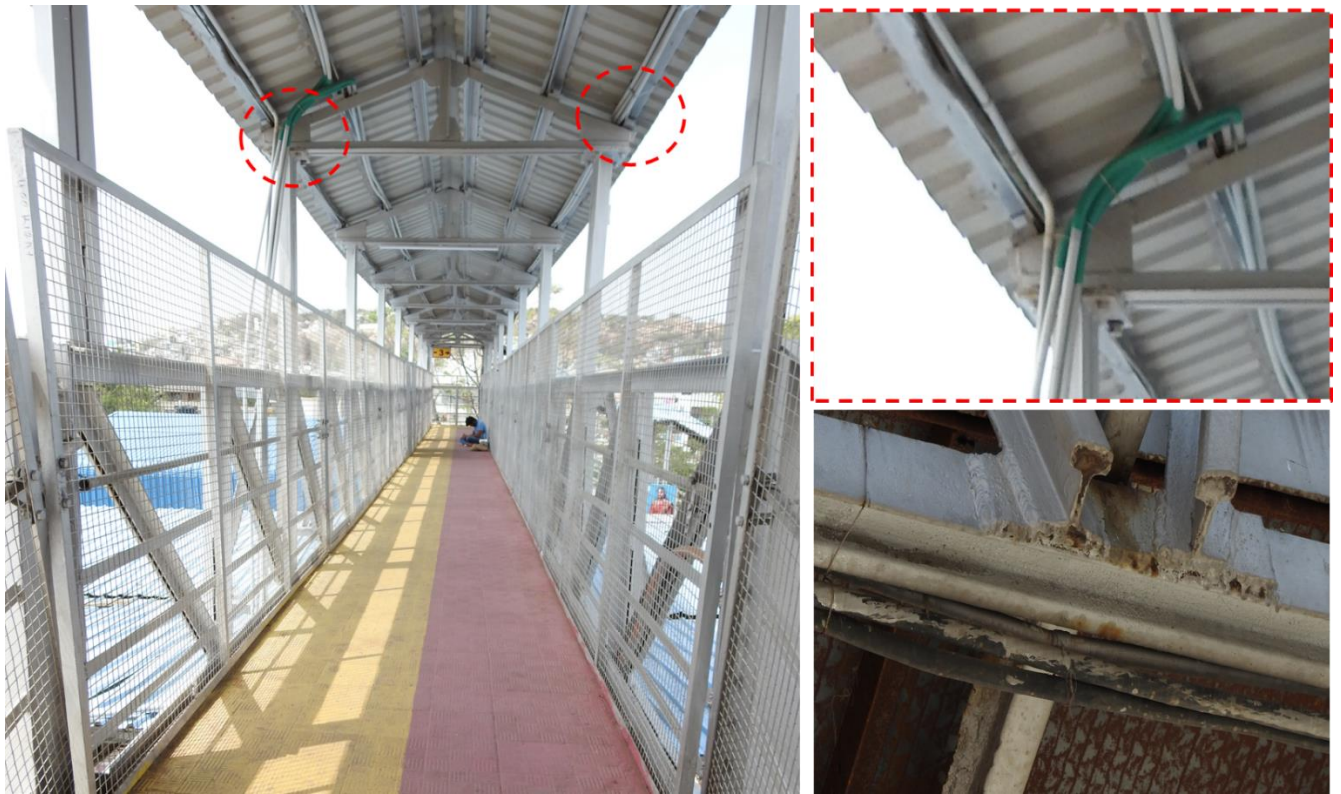
**Fig 1.1:** Cables, Roof truss, Flooring and Protective screen

| PART 1.2 IDENTIFICATION OF LOADS ON BRIDGE | | | |
|---|---|---|---|
| | b) Cables | Yes | Cables are protected with 1-inch dia HDPE pipe of 2 nos. and 1-inch PVC pipes of 5 nos. (Refer <b>fig :1.1</b> )<br>King post roof supported with 65 x 65 x 8 mm angles are used (Refer <b>fig: 1.1</b> ).<br>Steel Metal Sheet is used for Roof (Refer <b>fig :1.1</b> ) |
| | b) Provision of protective screen for passengers | Yes | Chain link fence made of galvanized wire of 2 mm gauge and 2mm galvanized sheet is used above OHE line on both side of gangway is used for protection. (Refer <b>fig :1.1</b> ) |

| PART 1.3 STRUCTURAL SYSTEM OF THE BRIDGE | | | |
|---|---|---|---|
| | Element of roof truss section | Angle sections | Span of roof truss is supported with 65 x 65 x 8 mm double angle sections which are rested on Top chord members. (Refer <b>fig :1.1</b> ) |

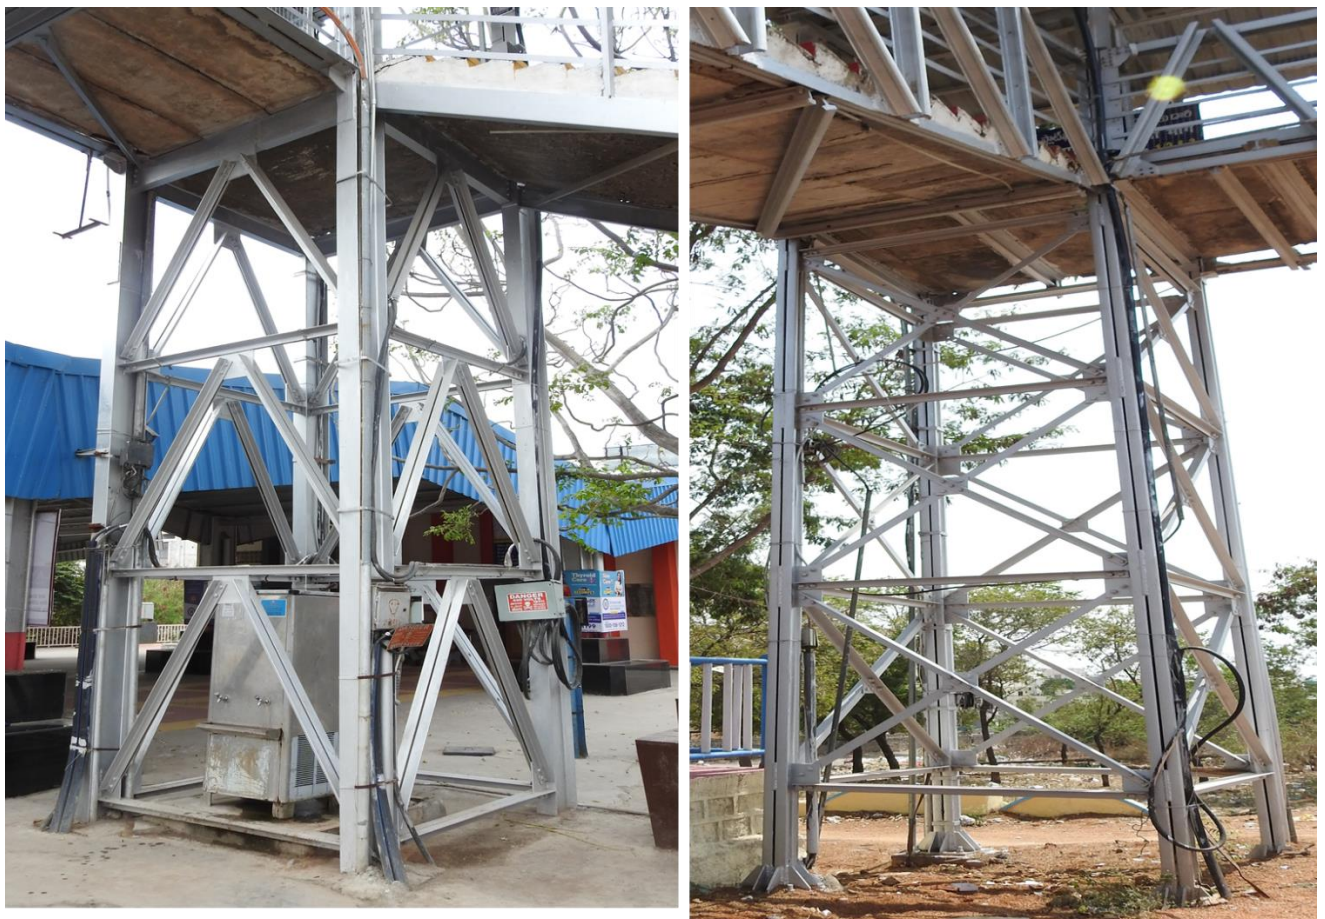
**Fig 1.2:** Trestles details

| | Type/Shape of Column section | I – Section, Rail section | Span 1:<br>FOB is supported on vertical column of ISMB 300 with bracings of 65 x 65 x 8mm double angle sections. (Refer <b>fig :1.2</b> ) |
| | Dimensions of Column | 300x150 mm, 130x130mm | FOB is supported on vertical column of Built up rail section of 130x130 mm with 2 Rail sections of 60 x 130 x 60 mm (Head x Height x Base) with bracings of 65 x 65 x 8mm angle sections (Refer <b>fig :1.2</b> ) |

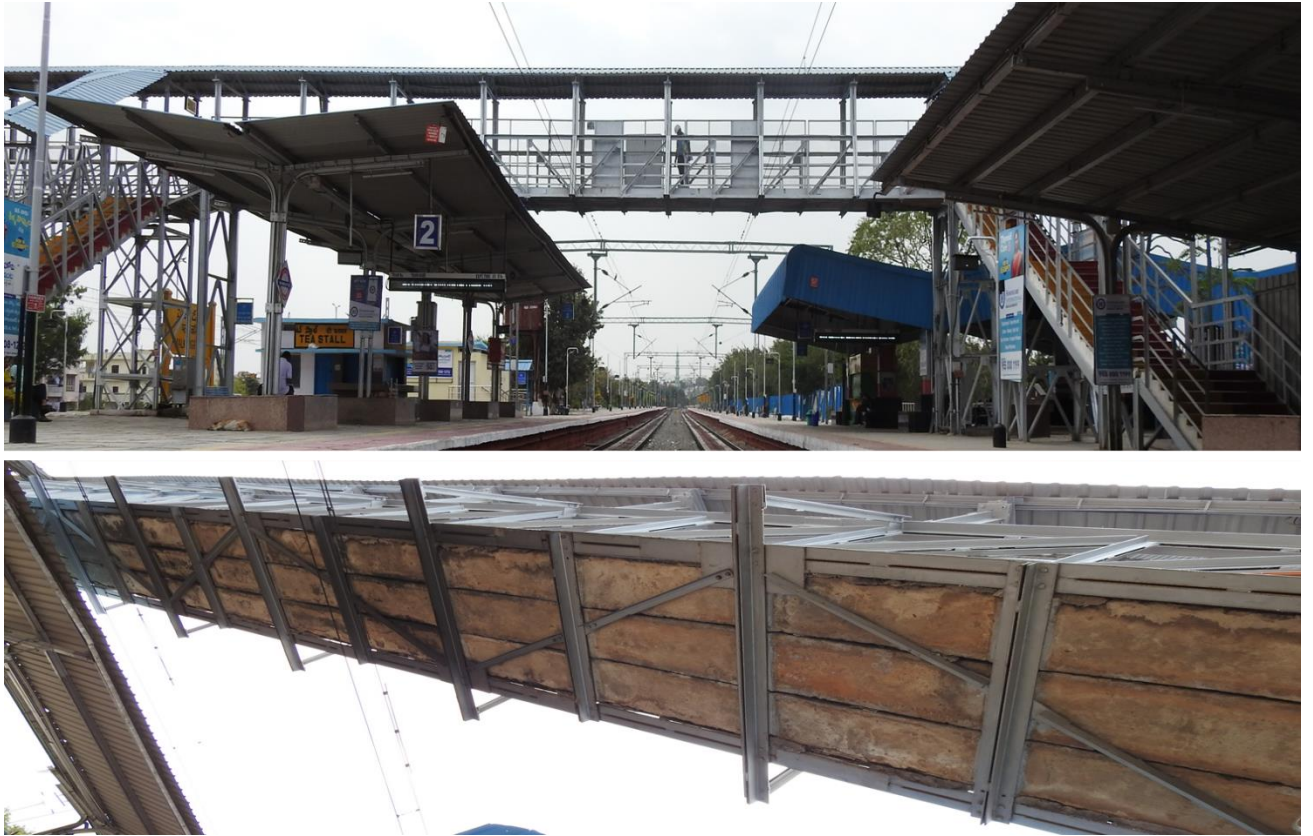
**Fig 1.3:** Front view and bottom view of span 1

| | Height of Truss (H) | 1.5 m | b. 65 x 65 x 8 mm double angle sections are used as bracing members<br>c. 100 x100 x10mm of double angle sections are used as Floor beams supported by 65 x 65 x 8 mm angle sections to transfer load from slab to roof truss. (Refer <b>fig :1.3</b> ) |

- a. ✓ Spalling and Reinforcement exposure of RCC slab observed along the 1<sup>st</sup> span of FOB

Reinforced cement concrete Slab at Deck level and some precast panels in staircase are observed with exposed rebar in many locations. (*Photographs of the same can be see in fig*)

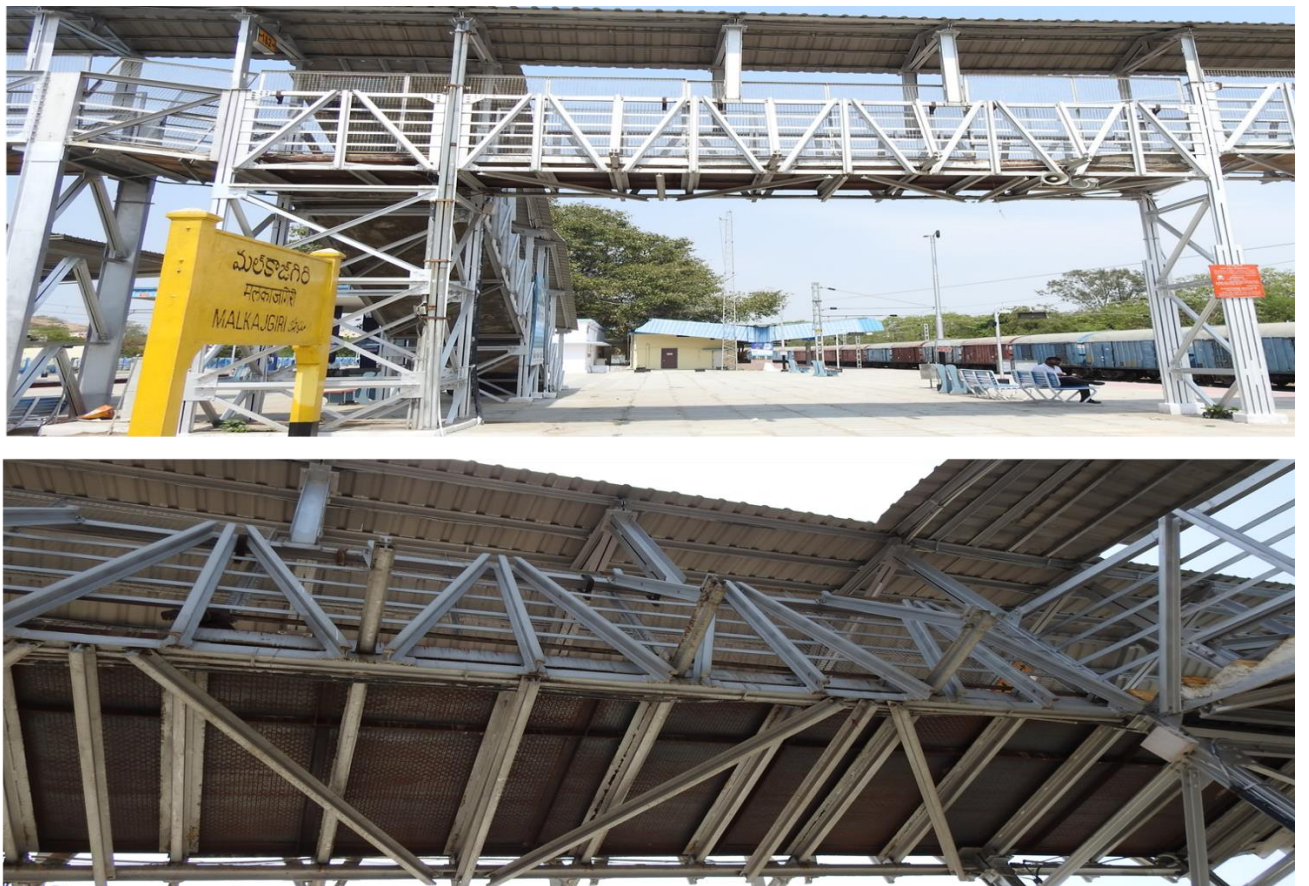
**Fig 1.4:** Front view and bottom view of span 2

b. ✓ Corrosion is observed floor beams of span 2

| SURVEY OF SIGNS OF DISTRESS, DEFORMATION IN BRIDGES | | | |
|---|---|---|---|
| | Extent of Corrosion | Floor beams | Slight corrosion is observed at floor beams of span 2 (Refer <b>Part 1.4 – 1.4(b)</b> ) |

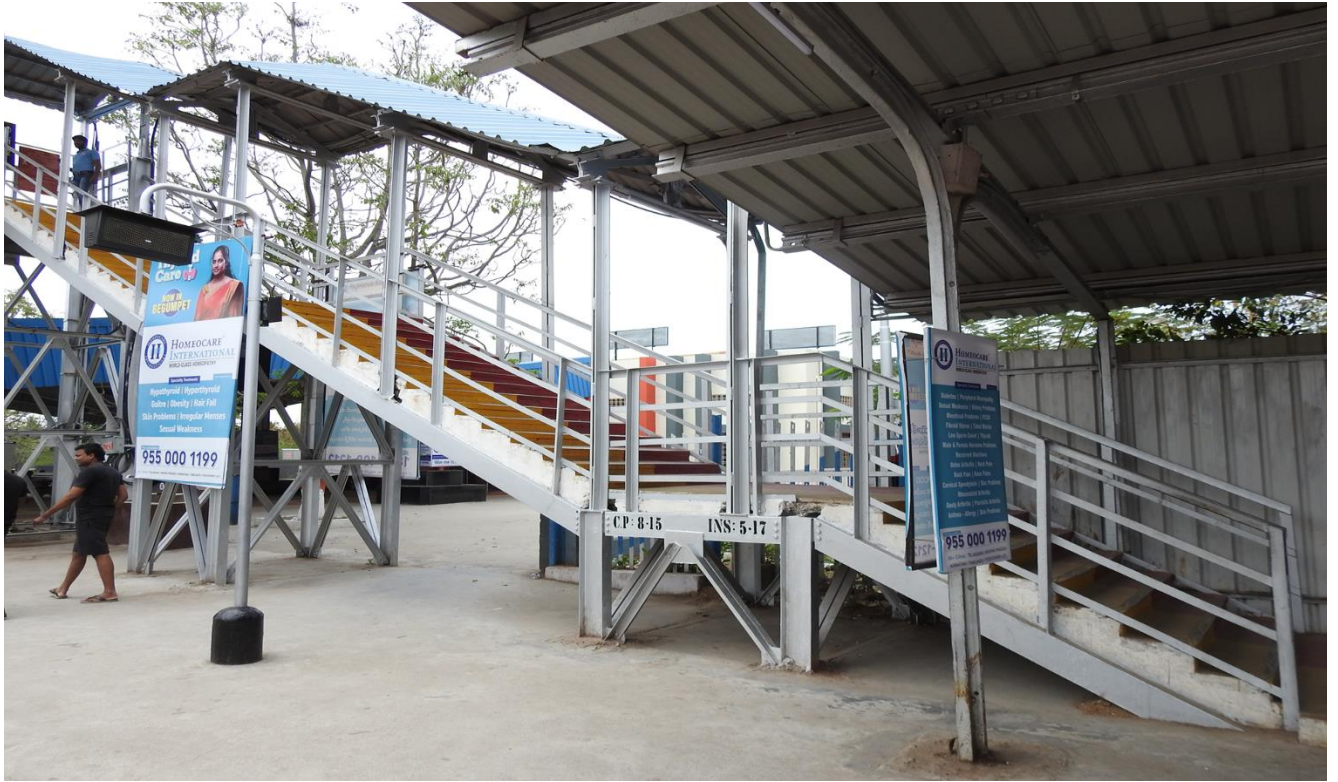
**Fig 1.7:** Staircase details

| | Number of Staircase | 3 no's | Staircase steps are observed as RCC slab, Steps are supported on stringer beams of ISMB 250 section, horizontal members of ISMB 150 and diagonal bracings with 65 x 65 x 8mm angle sections. (Refer <b>fig :1.7</b> ) |
| | Type of Parapet Railing | Steel railing | Staircase is provided with railing on both sides of 1.2m height using 75 x 75 x 8 mm double angle sections and 50 x 6 mm MS flats are used. (Refer <b>fig :1.7</b> ) |

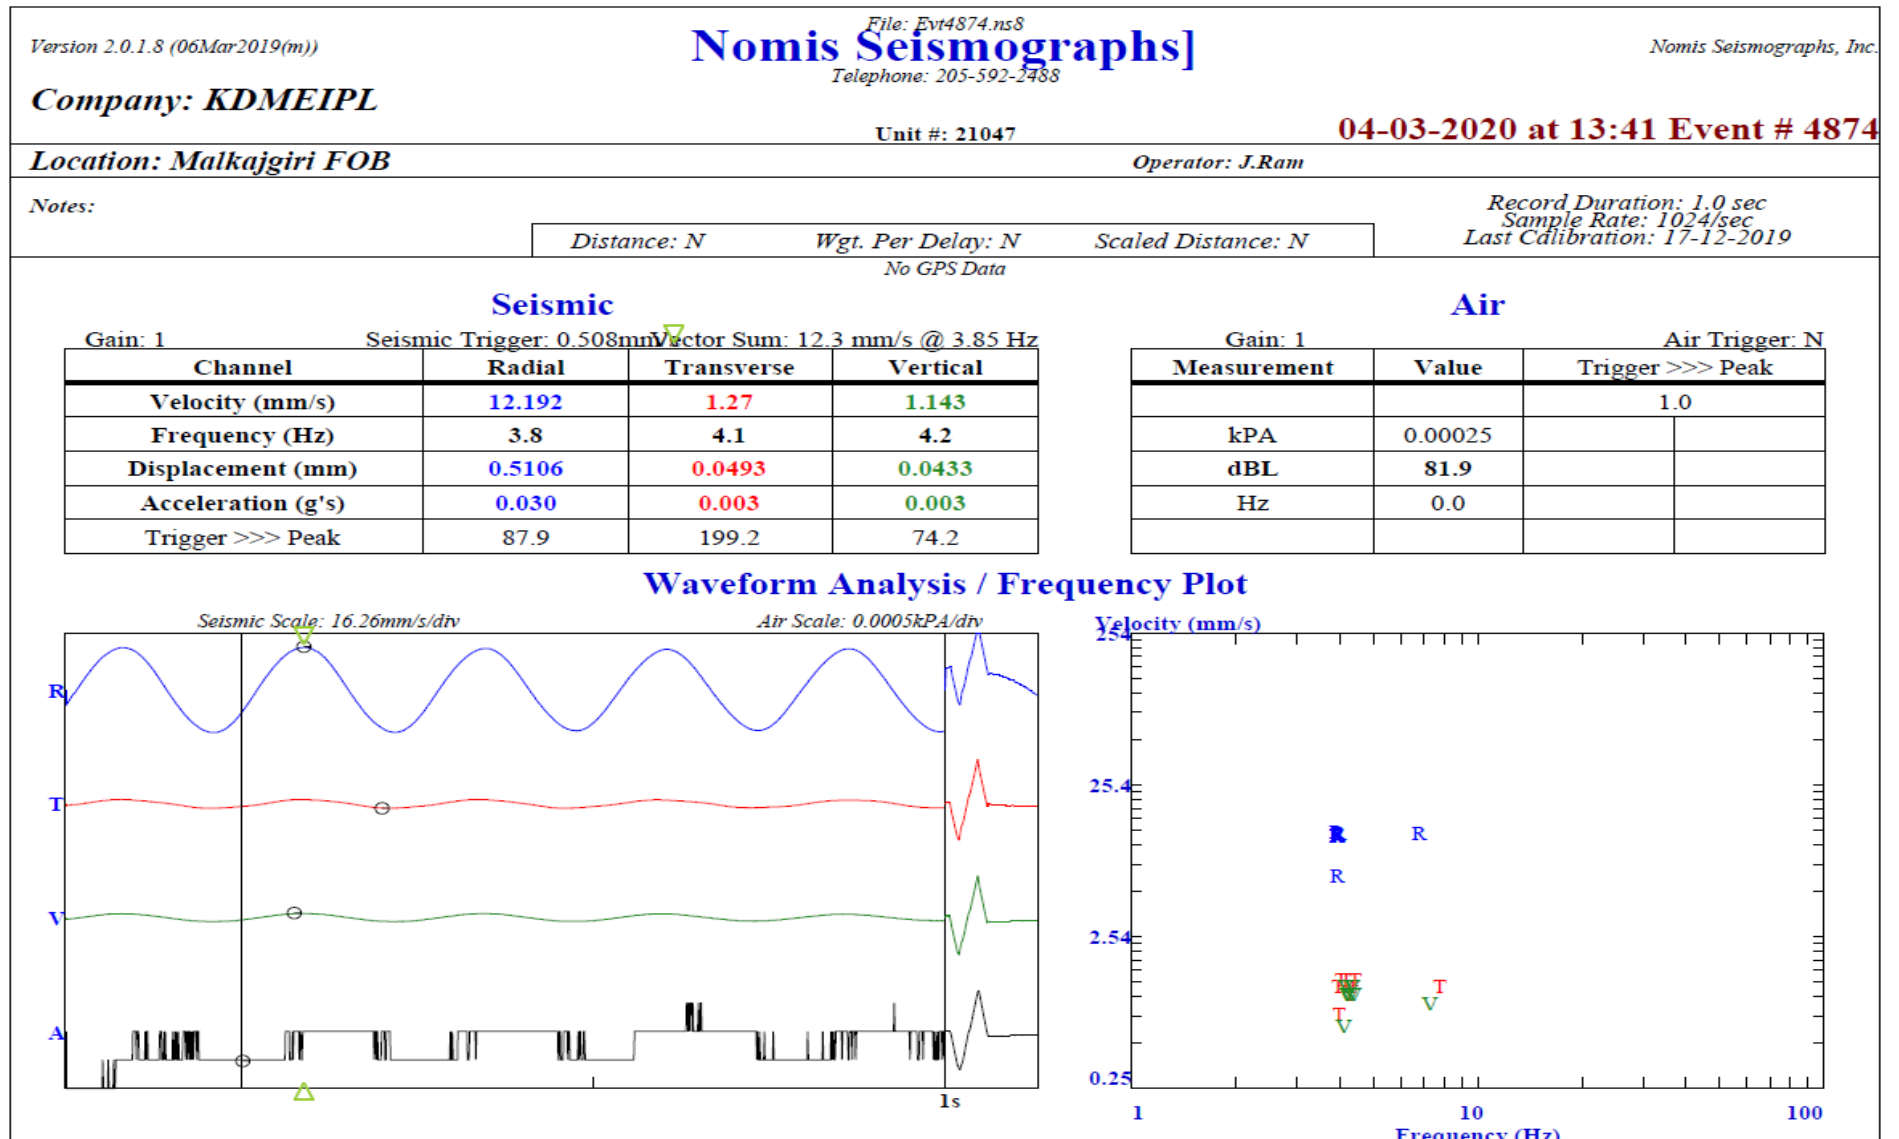
**Fig 1.10:** Vibration Test at Malkajgiri FOB

Based on the vibration analysis carried out the structure is undergoing vibrations in permissible limit of vibrations. (Frequency observed is 252 cpm and maximum amplitude observed during the test time of complete 2hrs is 0.5106 mm)
