## Third Party Audit of ROB's and FOB's of SCR

### INSPECTION OF FOB AT FALAKNUMA RAILWAY STATION

**Final Report**  
SEPTEMBER | 2020

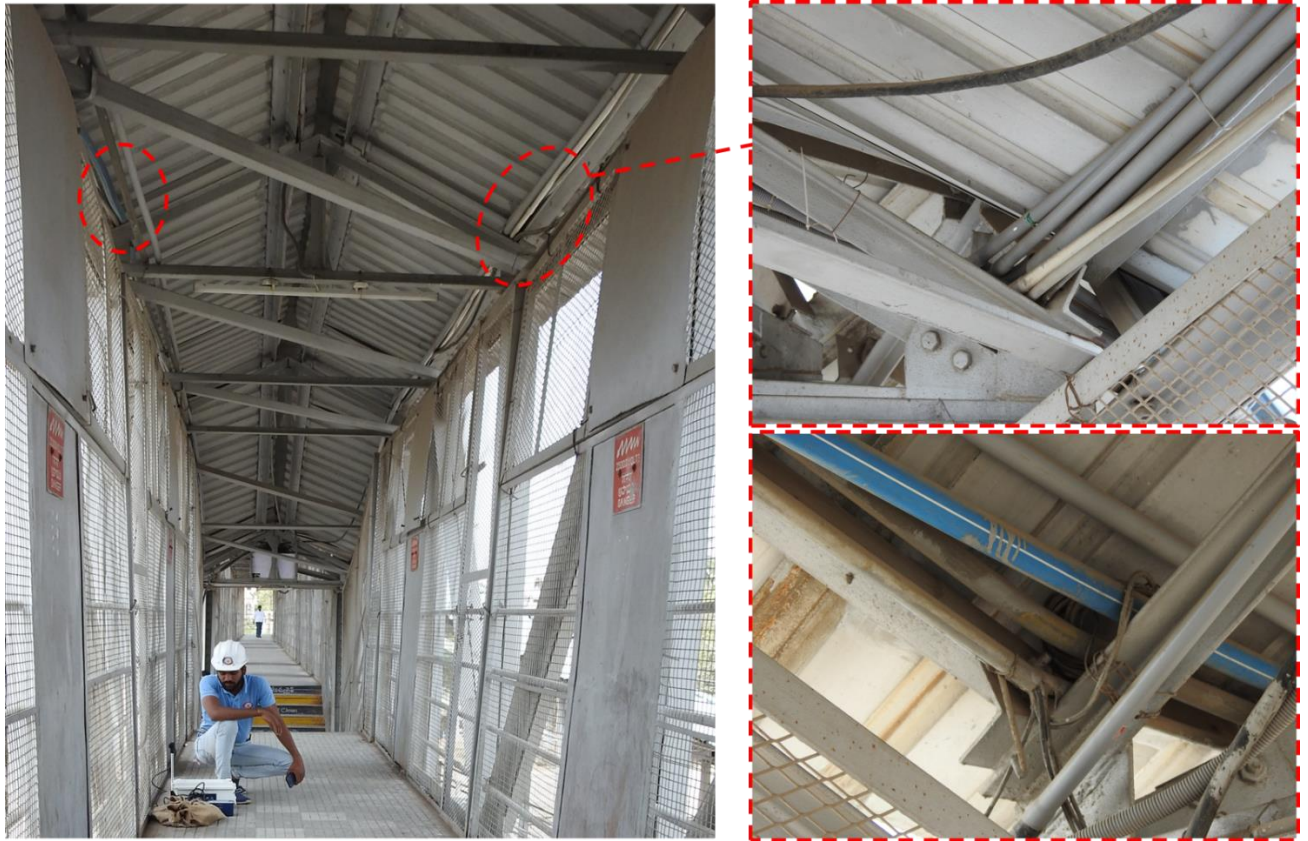
**Fig 1.1:** Cables, Roof truss, Flooring and Protective screen

| 1.2 IDENTIFICATION OF LOADS ON BRIDGE | | | |
|---|---|---|---|
| | b) Cables | Yes | Cables are protected with 1-inch and 2-inch dia HDPE pipe of 2 nos. and 1-inch PVC pipes of 6 no's and (Refer <b>fig :1.1</b> )<br>King post supported with 65 x 65 x 8 mm angles are used (Refer <b>fig: 1.1</b> ).<br>Steel Metal Sheet is used for Roof (Refer <b>fig :1.1</b> ) |
| | b) Provision of protective screen for passengers | Yes | Chain link fence made of galvanized wire of 2 mm gauge and 2mm galvanized sheet is used above OHE line on both side of gangway is used for protection. (Refer <b>fig :1.1</b> ) |

| 1.3 STRUCTURAL SYSTEM OF THE BRIDGE | | | |
|---|---|---|---|
| | Element of roof truss section | Angle sections | Span of roof truss is supported with 65 x 65 x 8 mm double angle sections which are rested on Top chord members. (Refer <b>fig :1.1</b> ) |

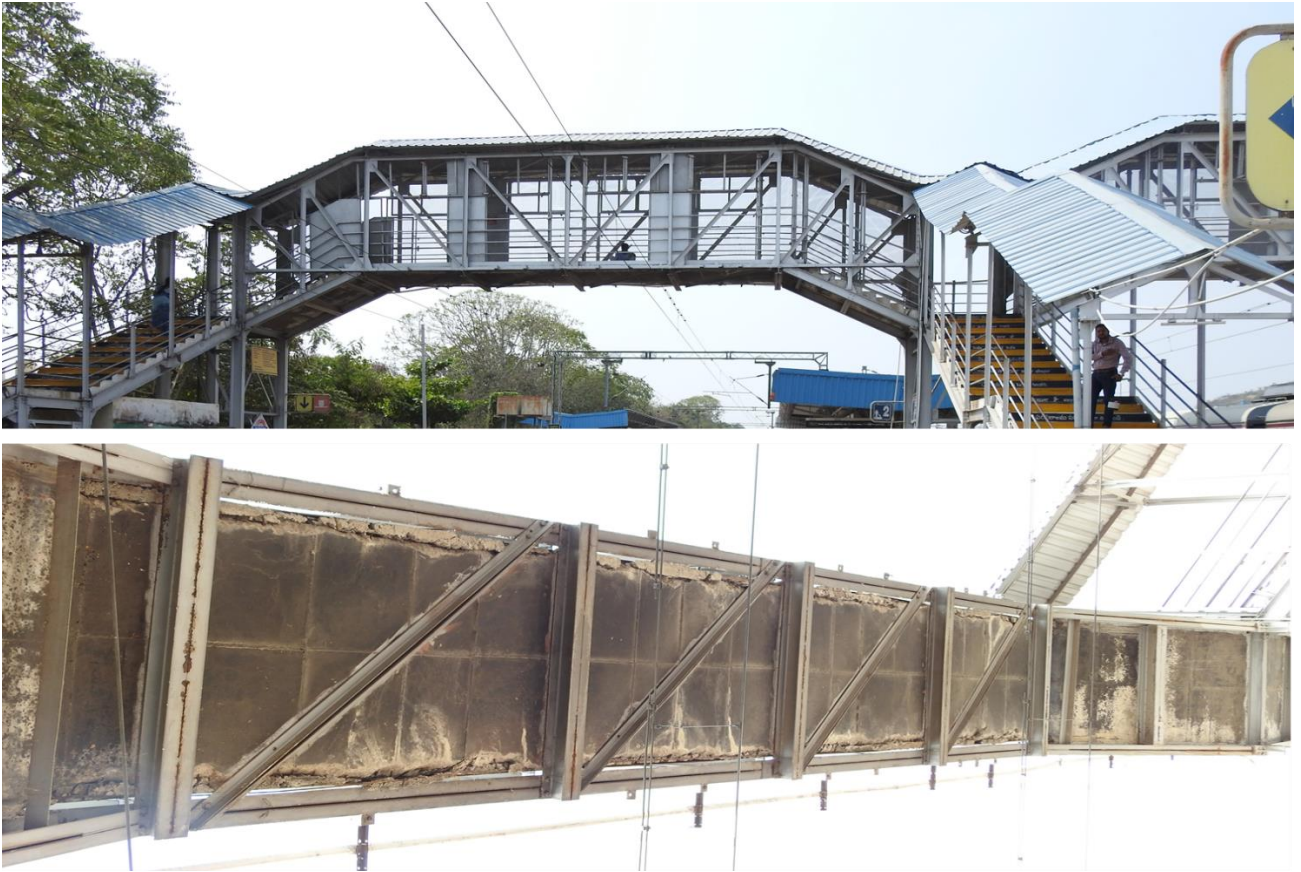
**Fig 1.3:** Front view and bottom view of span 1

| | Type of Beam-Column Joint<br>(shape of gusset plate if any) | Cleat angles | to transfer load from slab to roof<br>truss. (Refer <b>fig :1.3</b> ) |

- a. ✓ Spalling and Reinforcement exposure of RCC slab observed along the 1<sup>st</sup> span of FOB

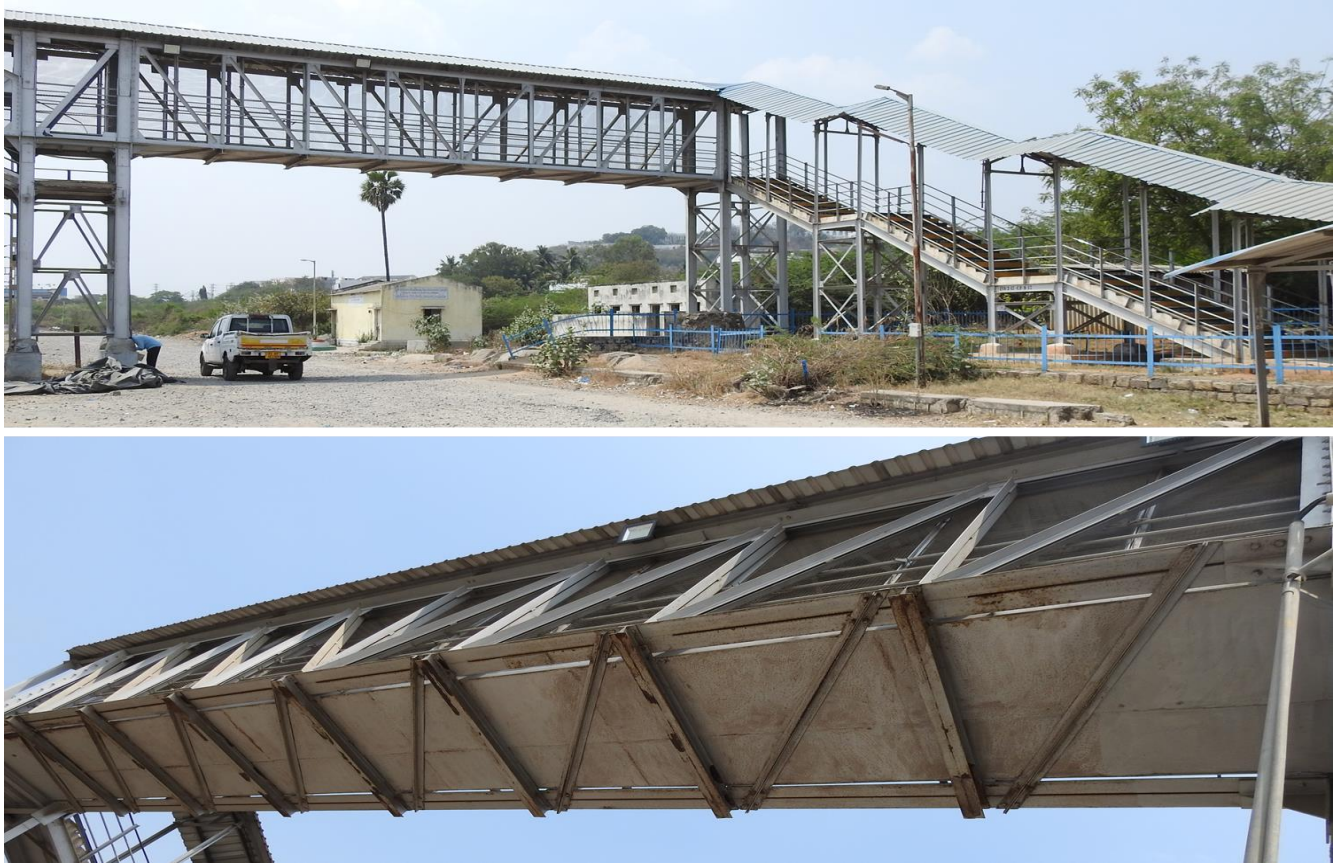
**Fig 1.5:** Front view and bottom view of span 3

Corrosion of floor beam joints of span 3

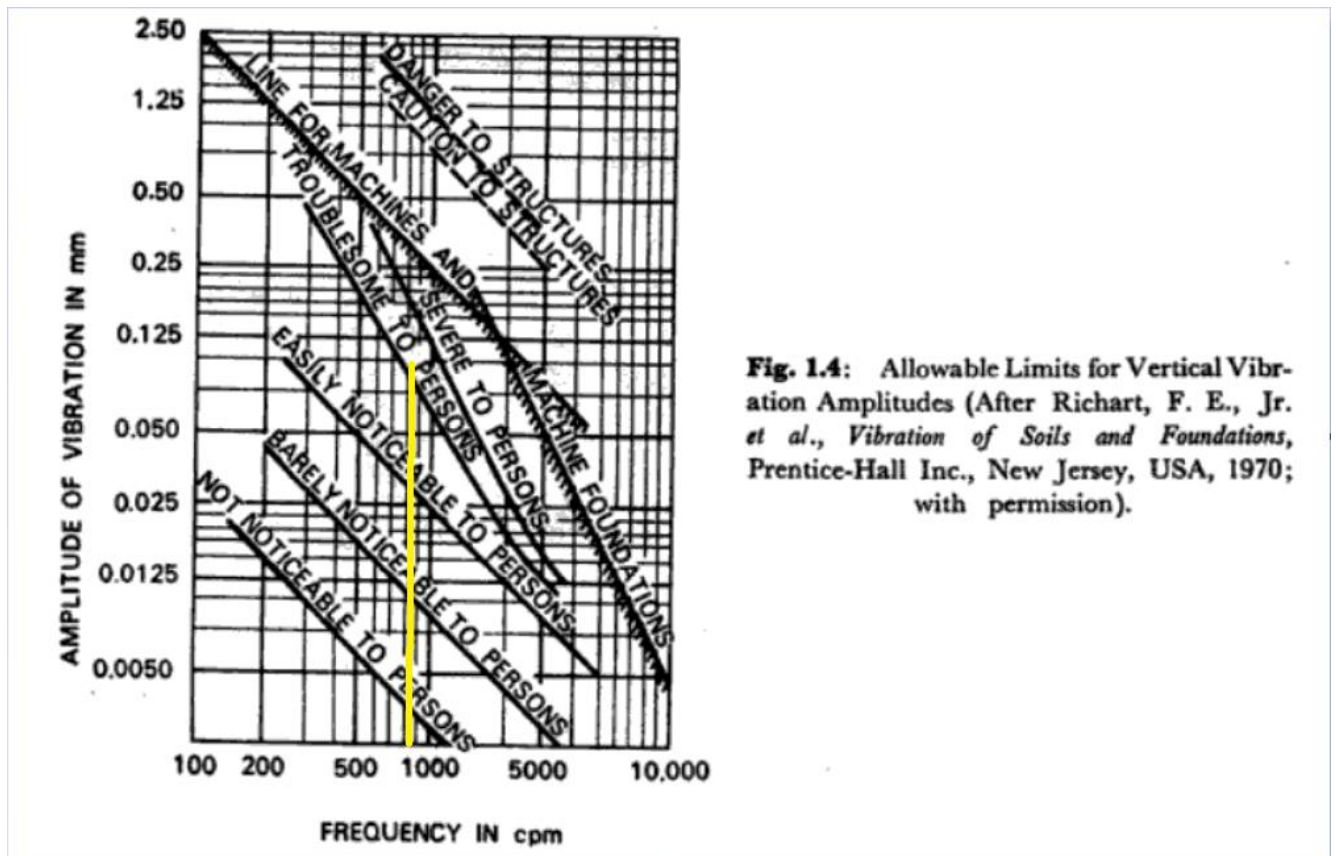
**Fig. 1.4:** Allowable Limits for Vertical Vibration Amplitudes (After Richart, F. E., Jr. *et al.*, *Vibration of Soils and Foundations*, Prentice-Hall Inc., New Jersey, USA, 1970; with permission).

Based on the vibration analysis carried out the structure is undergoing more vibrations than permissible limit of vibrations. (Frequency observed is 876 cpm and maximum amplitude observed during the test time of complete 3hrs is 0.0968 mm)
