## Third Party Audit of ROB's and FOB's Of SCR

**INSPECTION OF ROB NO. 561A AT CHITTOOR RAILWAY STATION**

**Final Report**  
**SEPTEMBER | 2020**

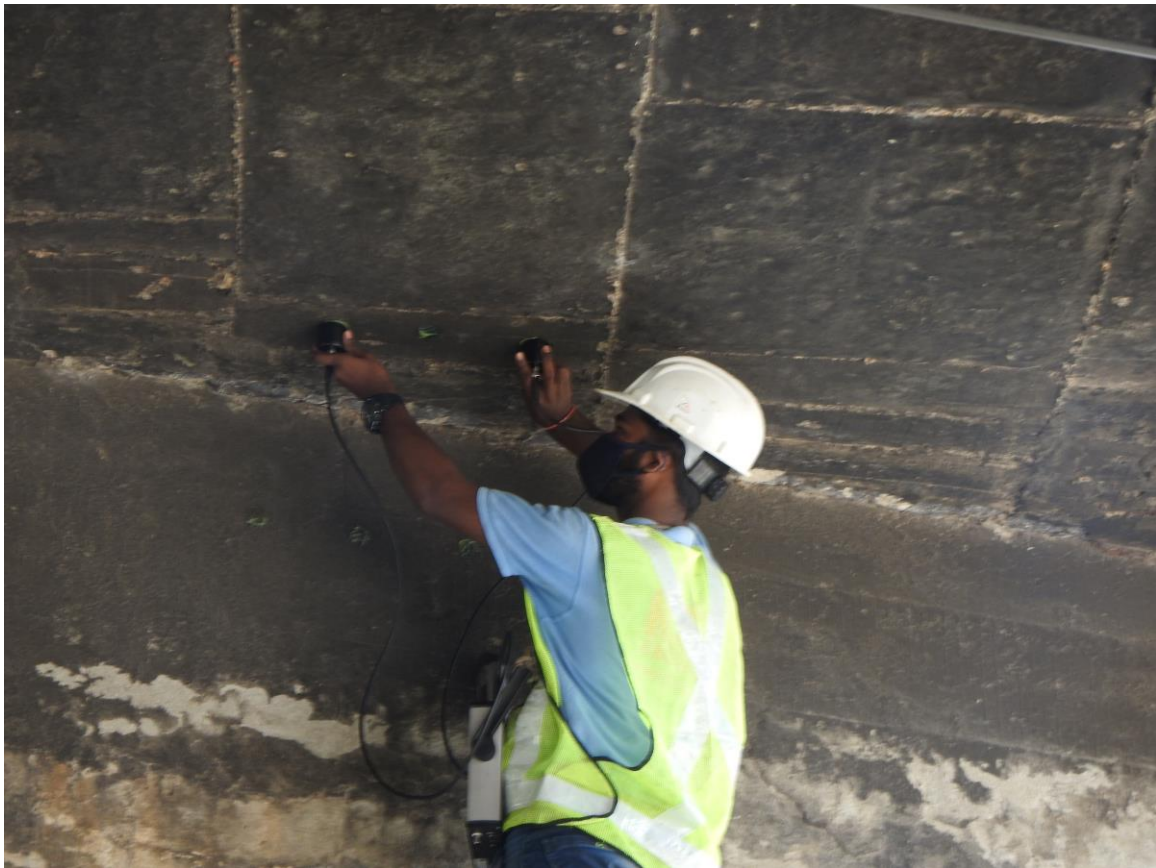
Fig 15: UPV test at site

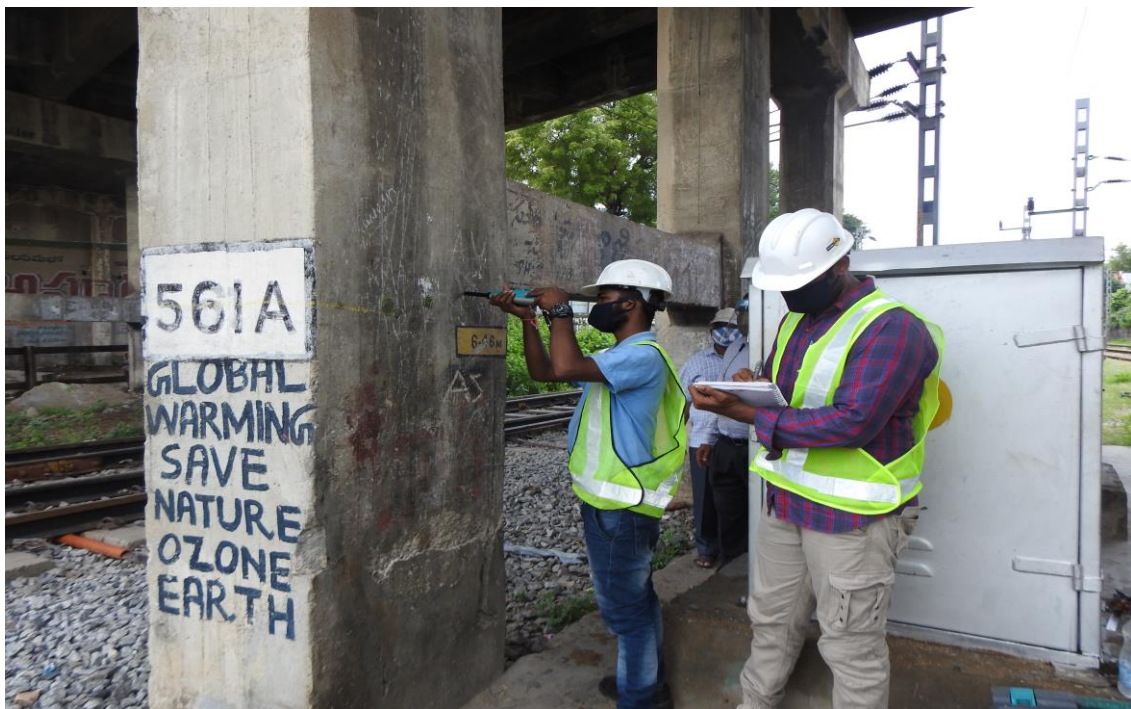
Fig 16: Rebound hammer test at site

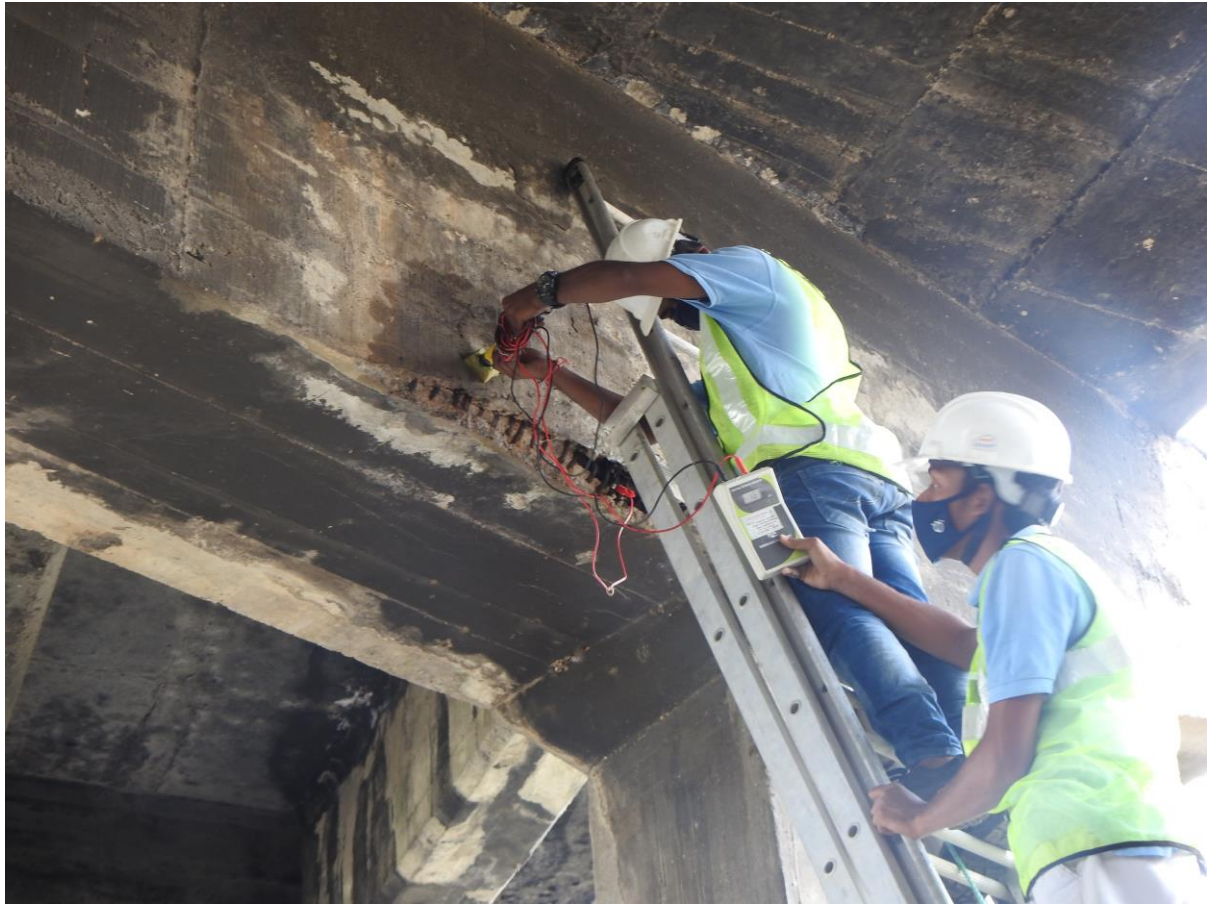
- Estimated strength as per rebound hammer test indicated that concrete strength is >26MPa.
- Ultrasonic Pulse Velocity test indicates that the quality of concrete varies from Poor to Excellent.
- Half-cell potential test shows that the Rebar is in Intermediate risk of Corrosion.
- Crack width test shows that the observed cracks at Pier columns are major structural cracks (>0.3mm)

**Fig 17:** Half-cell potential test at site
