# Third Party Audit of ROB's and FOB's Of SCR

INSPECTION OF ROB NO.295A NEAR KOMMALAPUDI RAILWAY STATION

**Final Report**  
SEPTEMBER | 2020

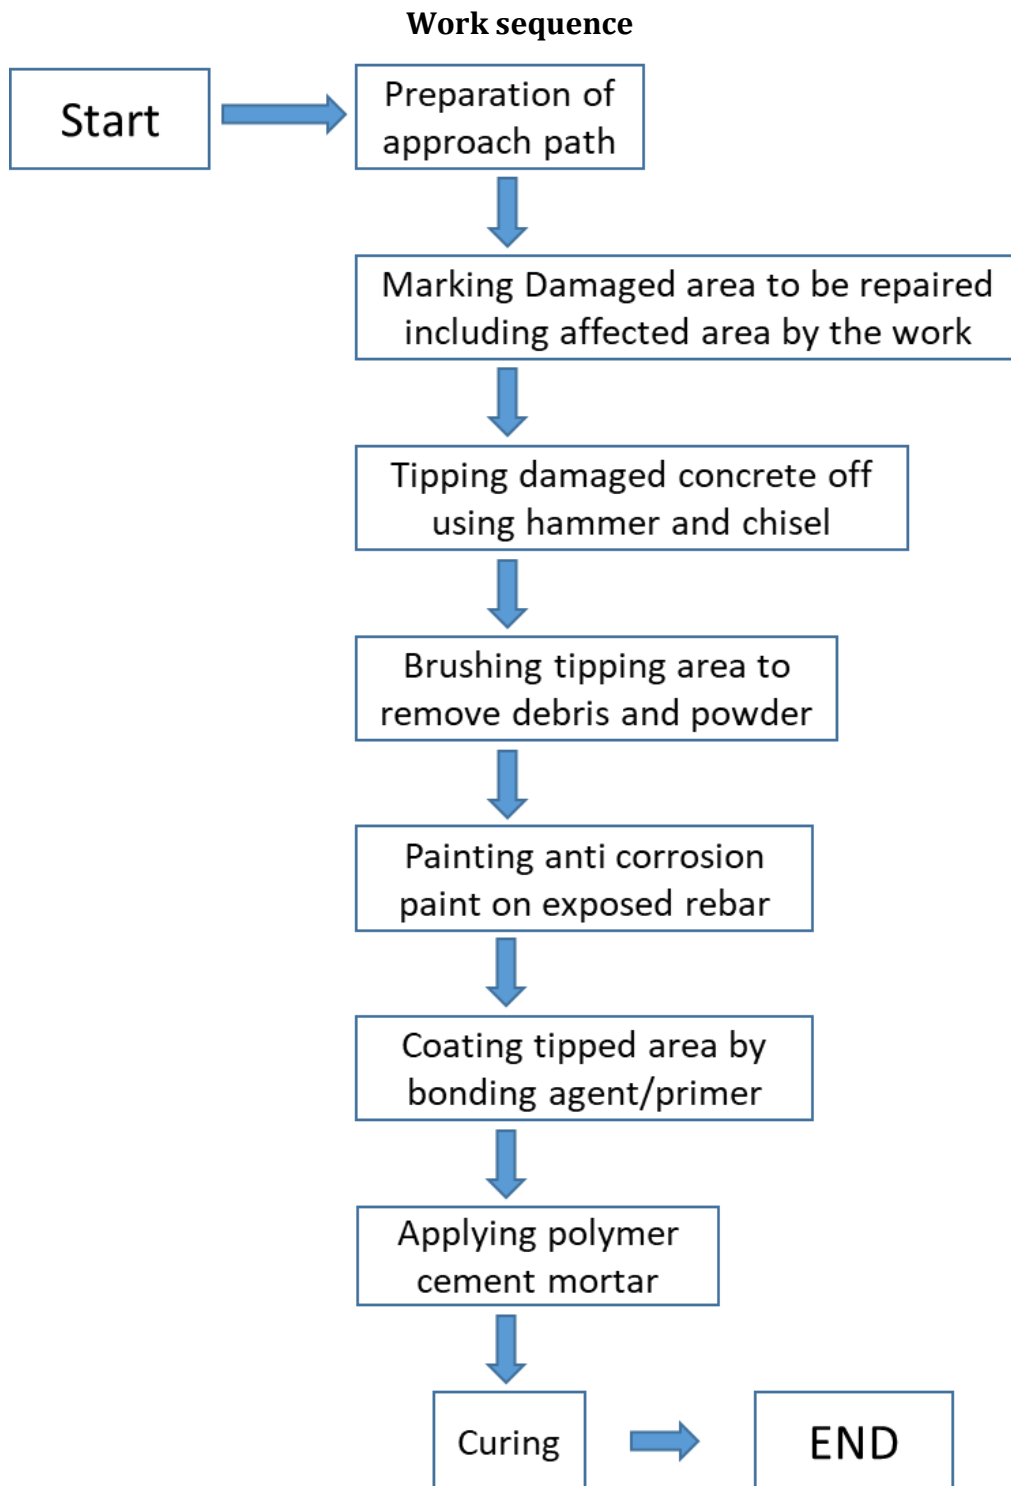
**Figure: 1.2** Work sequence of Epoxy Coating

| Defects/Deficiency | Spalling, Honeycomb |

| Remedial Measures | Patching |

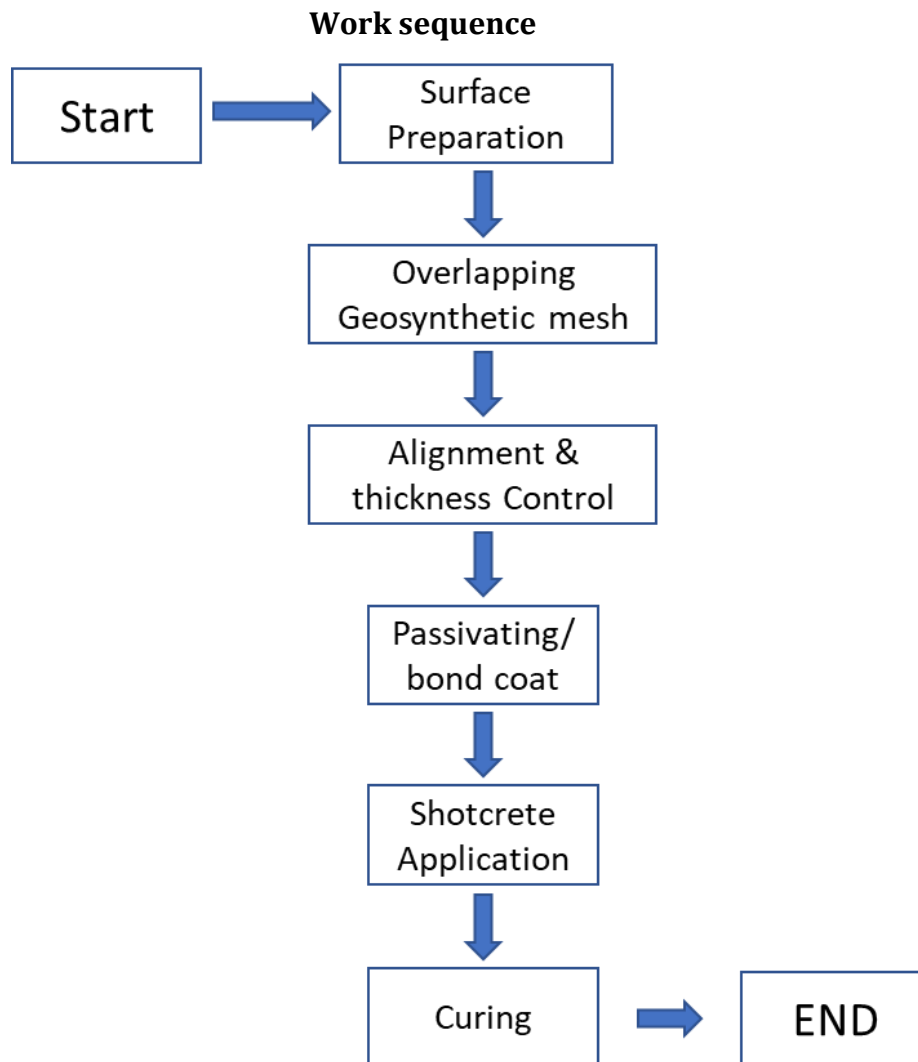
**Figure: 1.4** Work sequence of Shotcrete

| Defects/Deficiency | Reinforcement Exposure, Spalling and Cracking |

| Remedial Measures | Shotcrete |
