# Third Party Audit of ROB's and FOB's Of SCR

INSPECTION OF ROB NO.251 NEAR GODAVARI RAILWAY STATION

**Final Report**  
SEPTEMBER | 2020

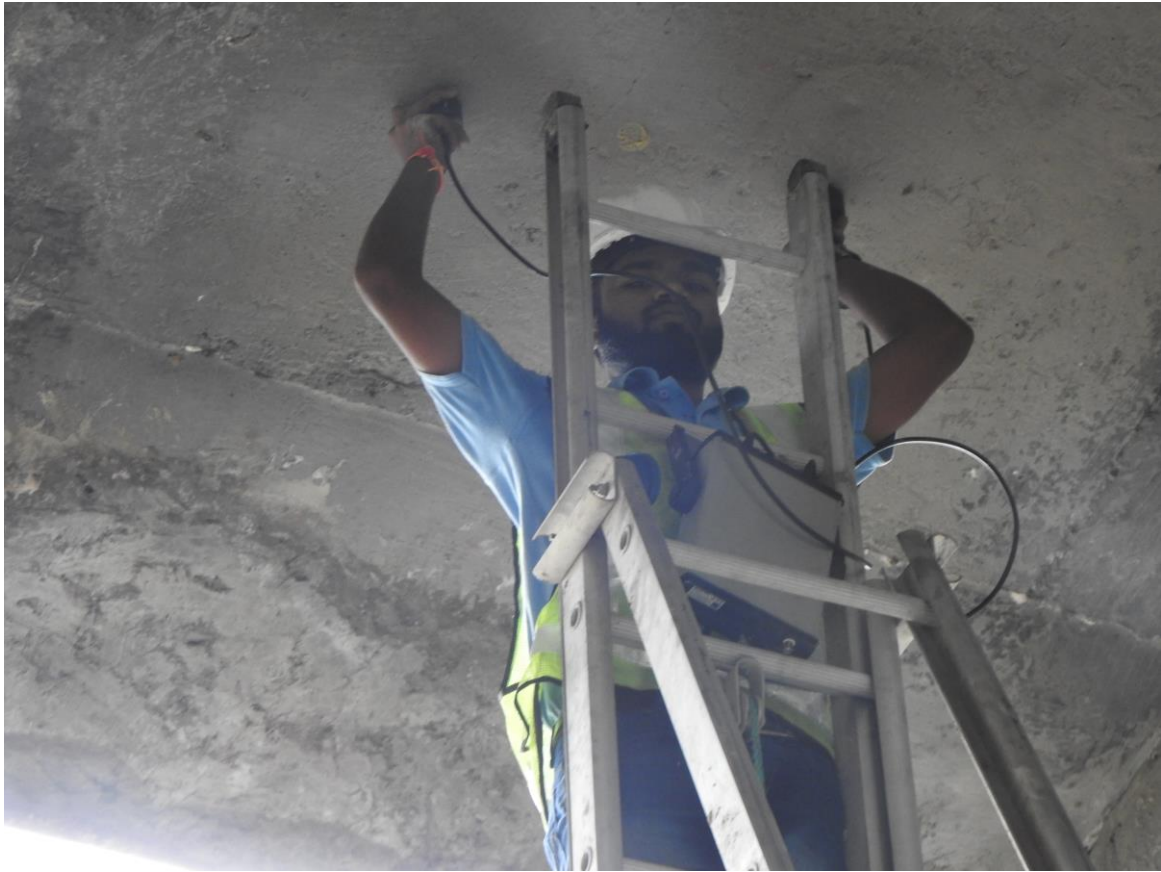
- a) Estimated strength as per rebound hammer test indicated that concrete strength is >39MPa.
- b) Ultrasonic Pulse Velocity test indicates that the quality of concrete for Pier wall and deck slab is poor.

**Fig 17:** UPV test at Kadiyam ROB

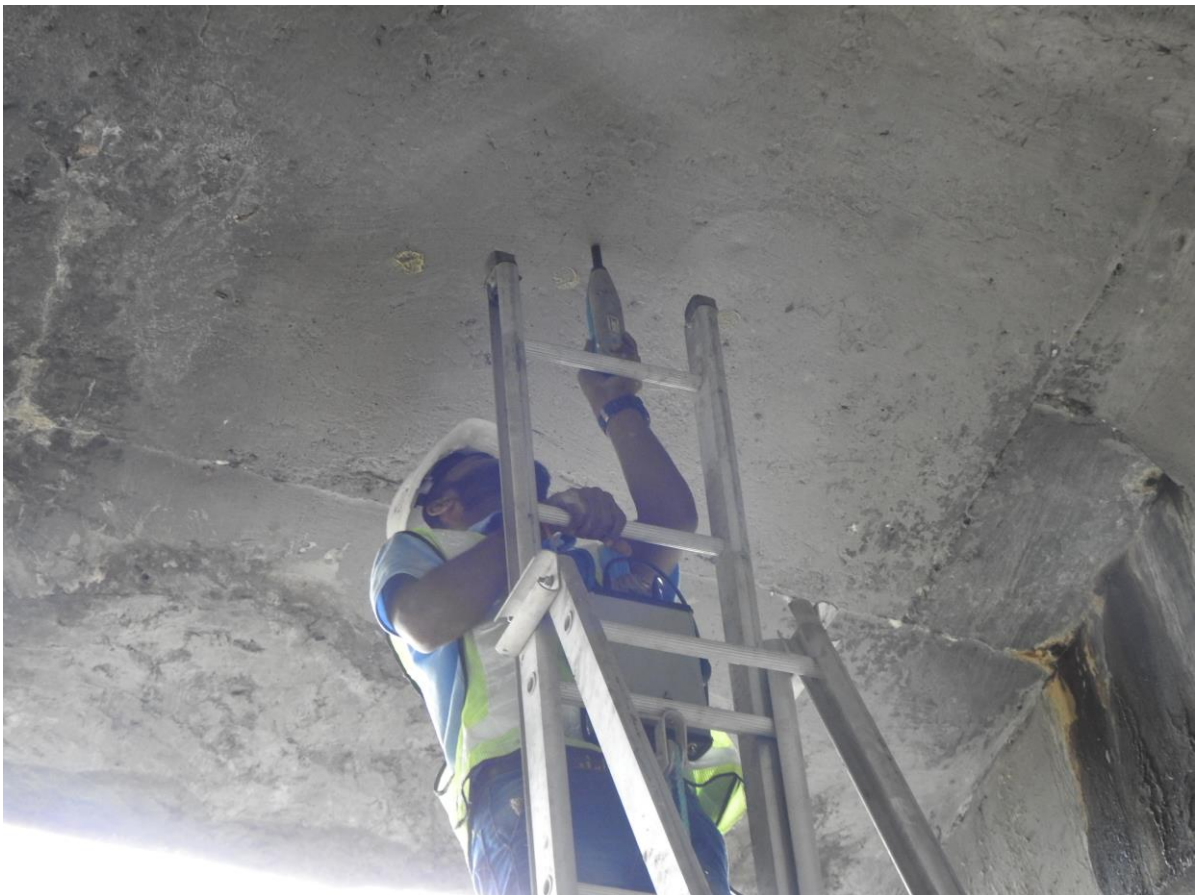
**Fig 18:** Rebound hammer test at site
