CHAPTER 2

SHELL

201 DESCRIPTION

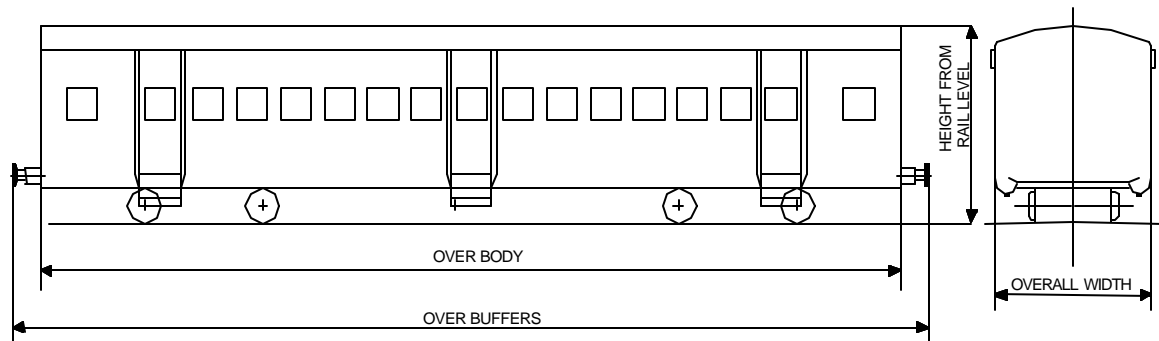
Figure 2.1

Leading dimensions of ICF, BEML and IRS are (see figure 2.1):

COACH SHELL

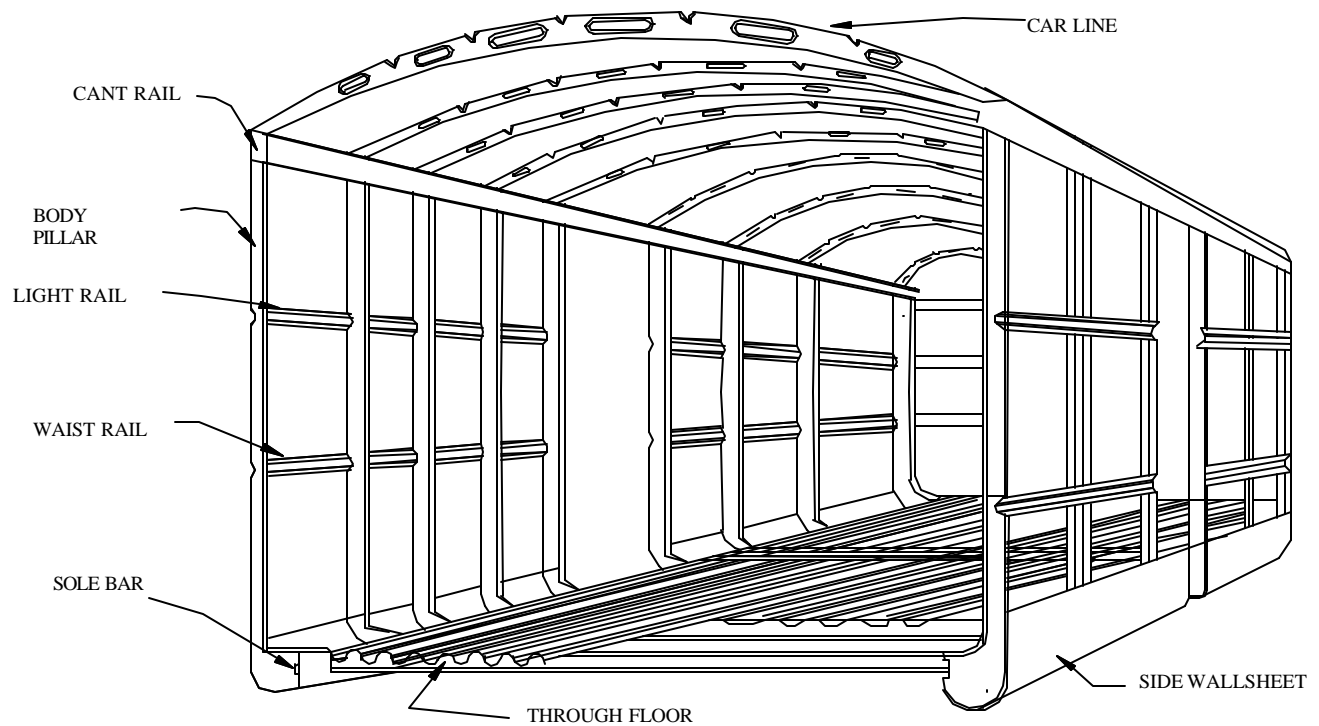
Figure 2.2

201a The integral shell is made of a framework of series of hoops, consisting of floor crossbeams, body side pillars and roof carlines located transversely at regular intervals, to suit door and window openings (see figure 2.2). These hoops are connected together by sole bars, waist rails, light rails, cant rails and carlines longitudinally. This frame work is sheathed all over by **2 mm thick** corten steel (IRS-M-41) on the side walls and **1.6 mm thick corten steel** on the roof. At the bottom **2-mm thick corten steel** corrugated trough floor is provided between the sole-bars and running over

the length between the head stocks of underframe. The whole forms a tubular shell of integral construction in which the sides and roof panels also share the load. The corrugated trough floor with its corrugations running longitudinally from one head stock to the other takes up the buffing loads. Below lavatory the tubular constructions are provided in place of trough floor to avoid corrosion due to seepage of water (See figure 2.2). In coaches with stainless steel trough floor, no tubular structure is used.

SHELL FOR ICF COACHES (CROSS SECTIONAL VIEW)

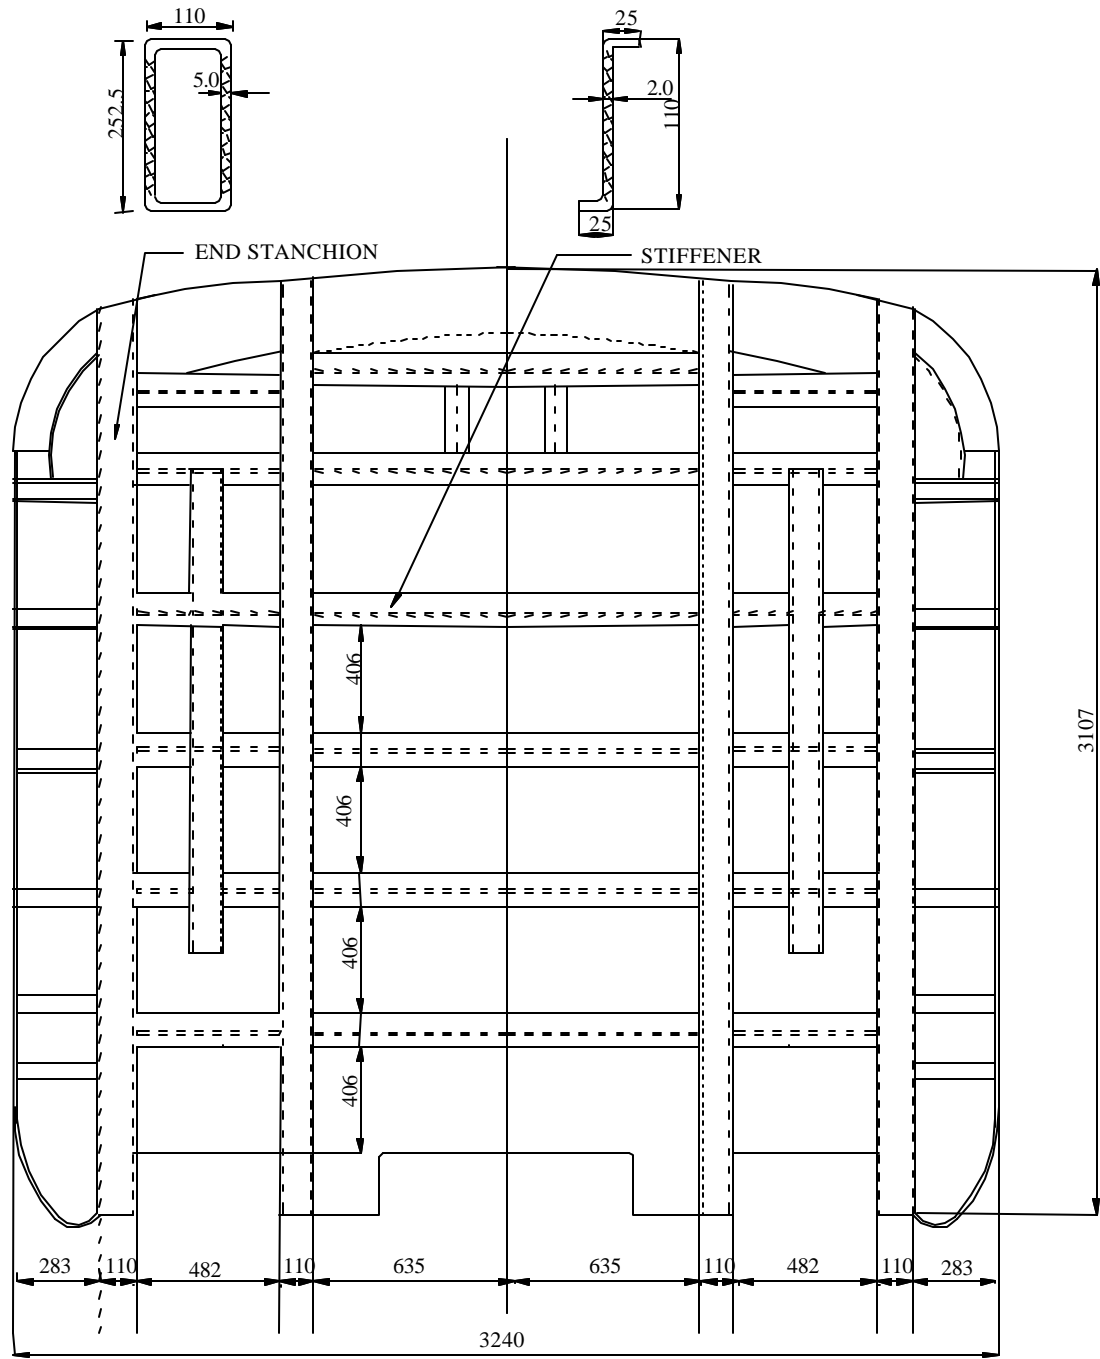
Figure 2.3

- 201b End wall consists of four vertical pillars of box section connected transversely by 'Z' sections and are welded to the head stock at the bottom and to the roof at the top. (See figure 2.3)

**END CONSTRUCTION OF BROAD GAUGE
ALL METAL LIGHT WEIGHT COACH ICF**

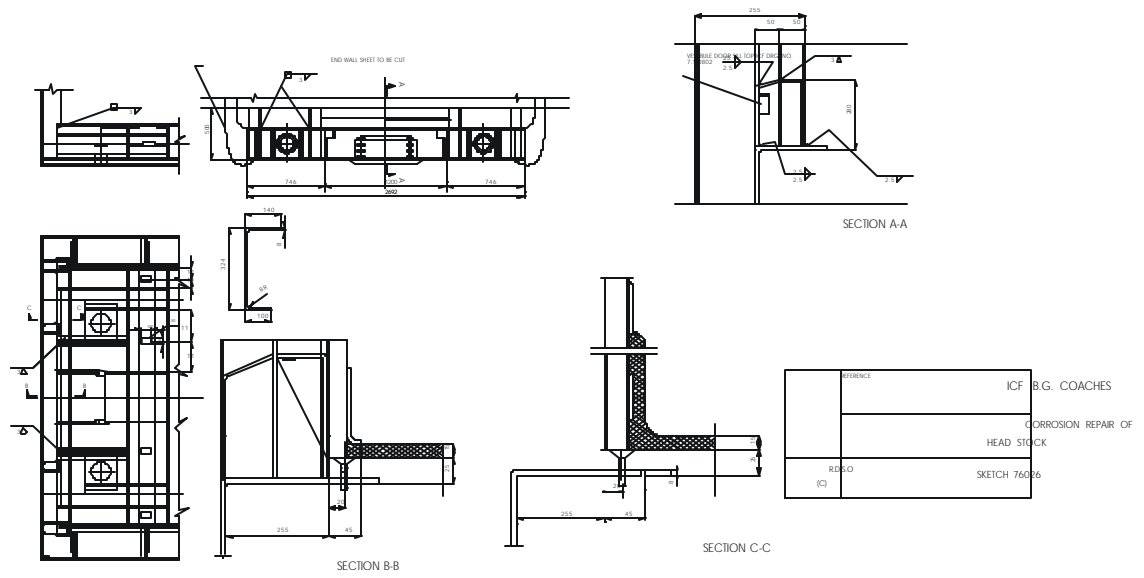
FIGURE 2.4

1. Head stock (refer figure 2.4)
