## Third Party Audit of ROB's and FOB's of SCR

### INSPECTION OF FOB AT KHAMMAM RAILWAY STATION

**Final Report**  
SEPTEMBER | 2020

| <b>Name of the Project</b> | <b>:</b> | VISUAL INSPECTION OF FOB/ PF-1 - PF-2 AT KHAMMAM RAILWAY STATION |

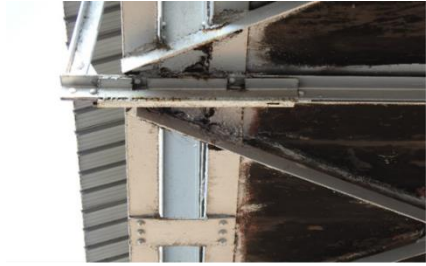
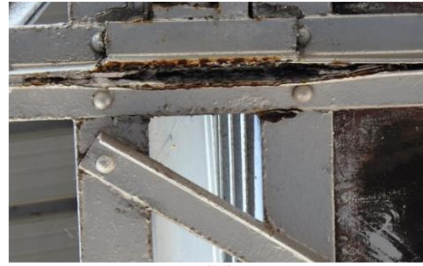
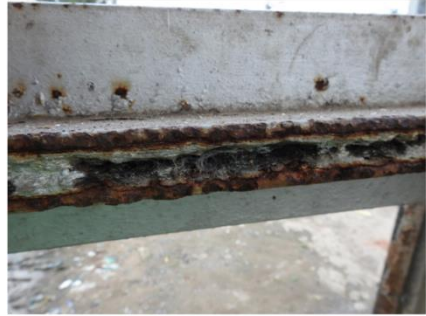
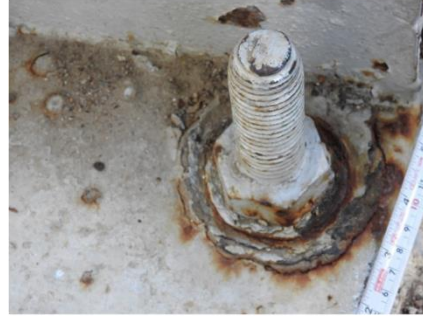
- ✓ Heavy corrosion is observed at bottom slab joint (Gusset plate, Angle sections)

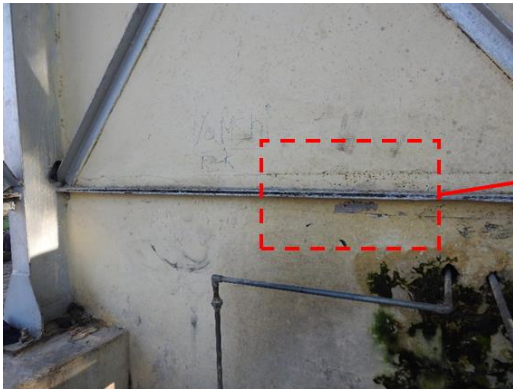
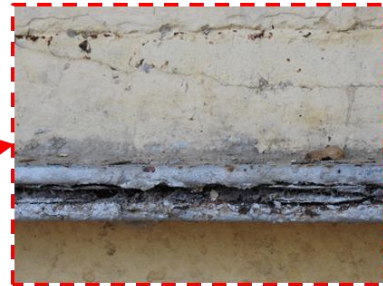
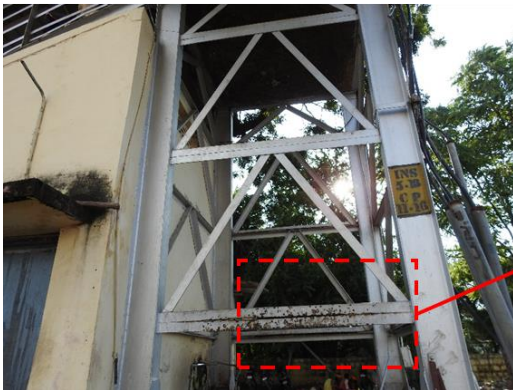
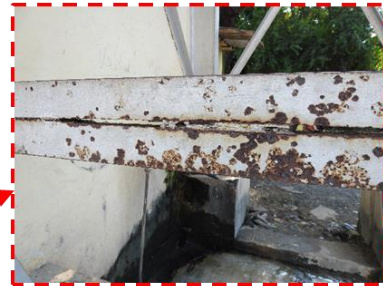
- ✓ Heavy corrosion is observed at Column bracings

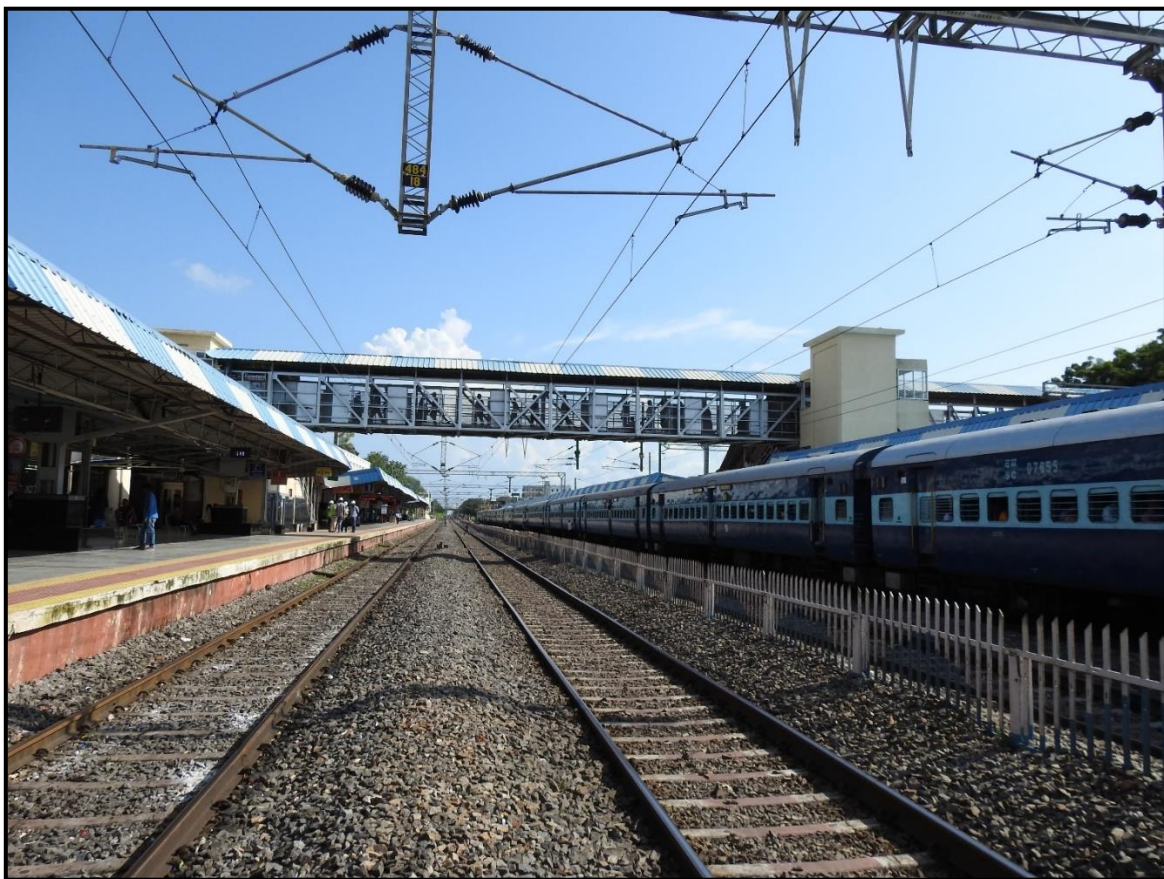
**Fig 1.1:** Front view of FOB span 1 towards Madira

| | Boundary Condition | Ridged connection | b) ISMB 175 are used as Vertical and inclined bracing Members<br>c) 10 mm thick, gusset plate used for welded joint. (Refer <b>fig: 1.1</b> )<br><b>Span 2:</b><br>a) Main Chord members 100 x 100 x 12 mm Double Angle section<br>b) 75 x 75 x 8 mm angles are used as Vertical and inclined bracing Members<br>c) 10 mm thick, gusset plate used for welded joint. (Refer <b>fig: 1.2</b> ) |

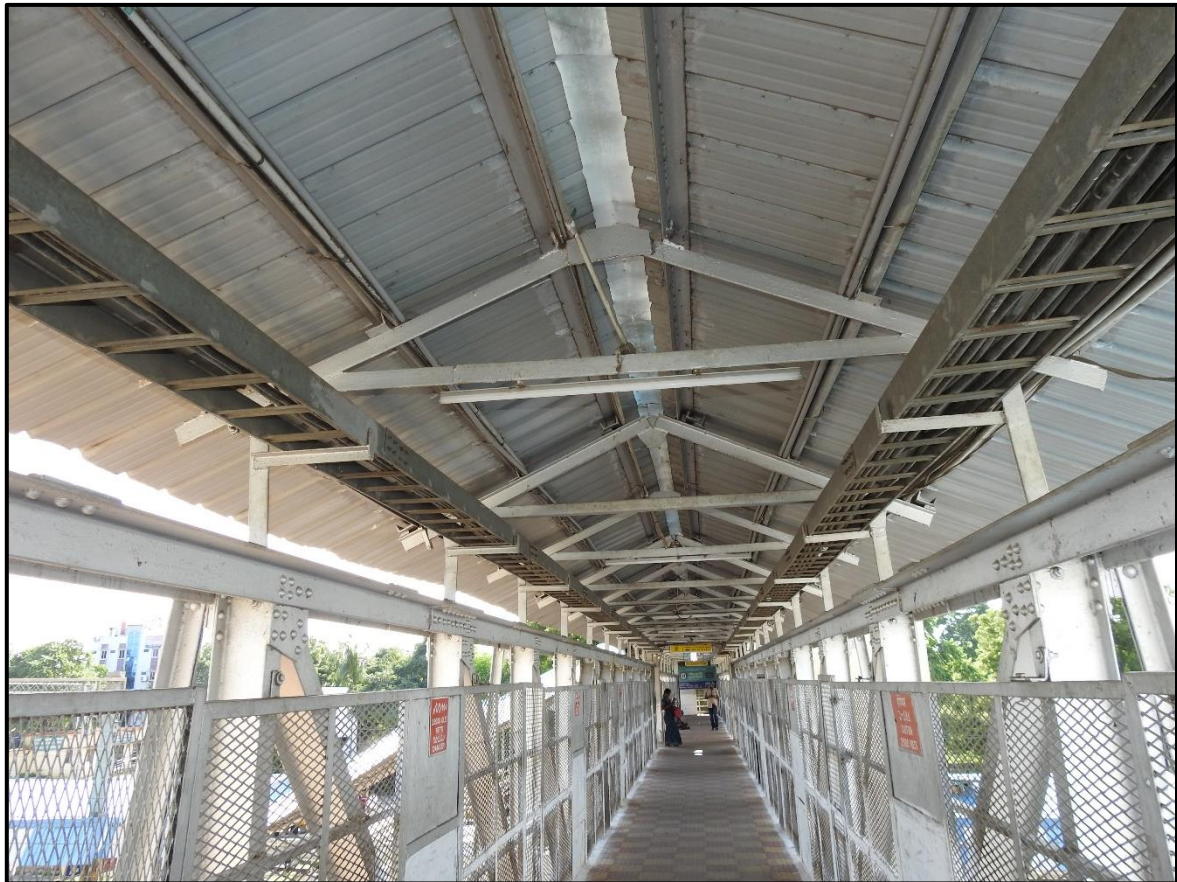
**Fig 1.3:** FOB span 1 pathway

| PART 2 IDENTIFICATION OF LOADS ON BRIDGE | | | |
|---|---|---|---|
| | b) Cables | Yes | Set of Cables running on the both sides along the length of FOB. (Refer <b>fig :1.3,1.4</b> ) |
| | c) Roof Truss | Yes | 65 x 65 x 8 mm Angles are used (Refer <b>fig :1.3,1.4</b> ) |
| | d) Roof Sheet | Yes | Steel Metal Sheet is used for Roof (Refer <b>fig: 1.3,1.4</b> ) |
| | a) Additional wearing coat on Floor | No | Only Chequered tiles used for Flooring (Refer <b>fig :1.3,1.4</b> ) |
| | b) Provision of protective screen for passengers | Yes | Fence made of galvanized wire of 2 mm gauge and 2 mm galvanized sheet is used above OHE Line on both side of pathway is used for passengers Protection. (Refer <b>fig :1.3,1.4</b> ) |

| PART 3 STRUCTURAL SYSTEM OF THE BRIDGE | | | |
|---|---|---|---|
| | Element of roof truss section | King post Angle | 65 x 65 x 8 mm King post Angle sections are used for roof truss supported on 125 x 125 x 14 mm, Top Chord Members using welded joints. (Refer <b>fig: 1.3,1.4</b> ) |

| | Material of Slab | Pre-cast slab panels | Pre-cast Reinforced Concrete Slab panels are used for pathway.<br>In span 1 Pre-cast RCC slab panels are resting on Angle chord members supported on Floor beams and Bracings from bottom.<br>In span 2 Pre-cast RCC slab panels are resting on Floor beams and supported on Angle chord members, Bracings from bottom.<br>Chequered tile (25 mm thick) flooring is laid on the top of the Pre-cast slab panels. (Refer <b>fig: 1.3,1.4</b> ) |

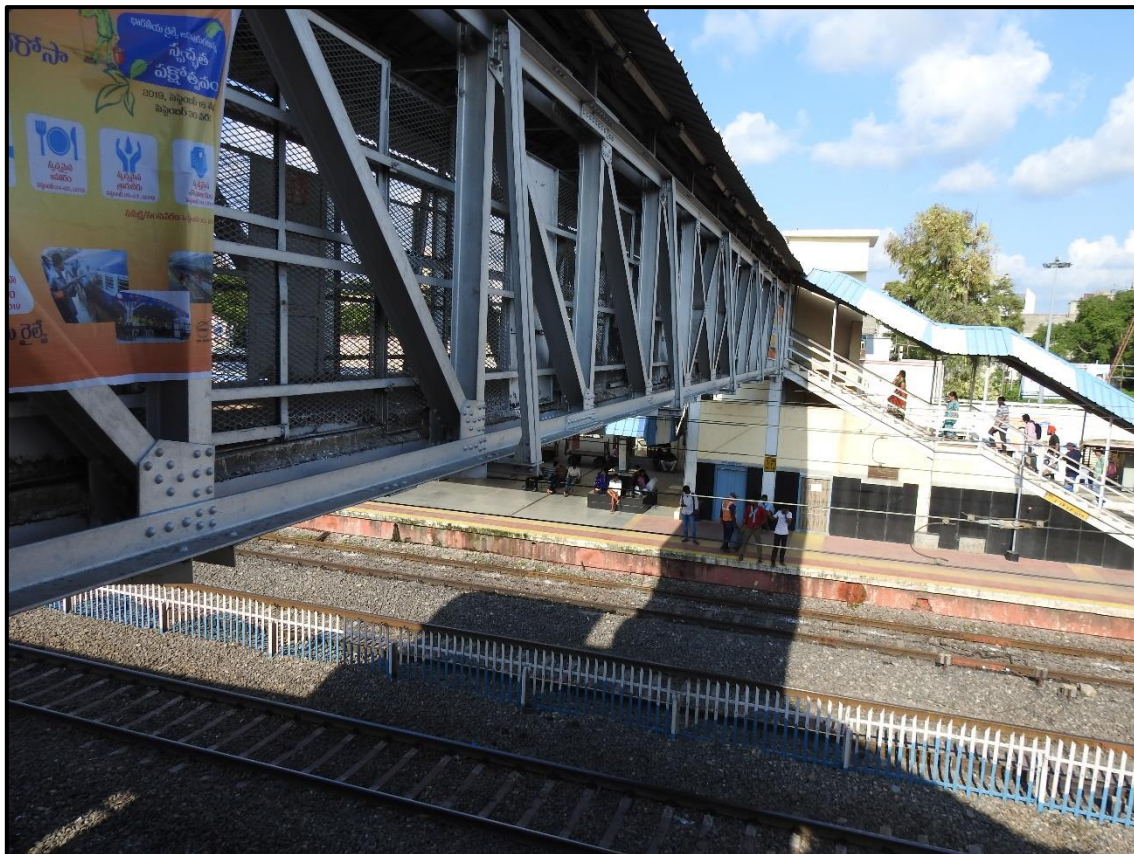
**Fig 1.5:** FOB span 2 pathway

| | Number of Staircase | 3 No's | Staircase steps are observed as Pre-cast RCC slab panels of size 300 x 100 are used. Steps are supported on ISMC 250 Channel using cleat Angles. Staircase Landing of 2 m wide is supported on Vertical and Horizontal Angle Members. (Refer <b>fig: 1.5,1.10</b> ) |

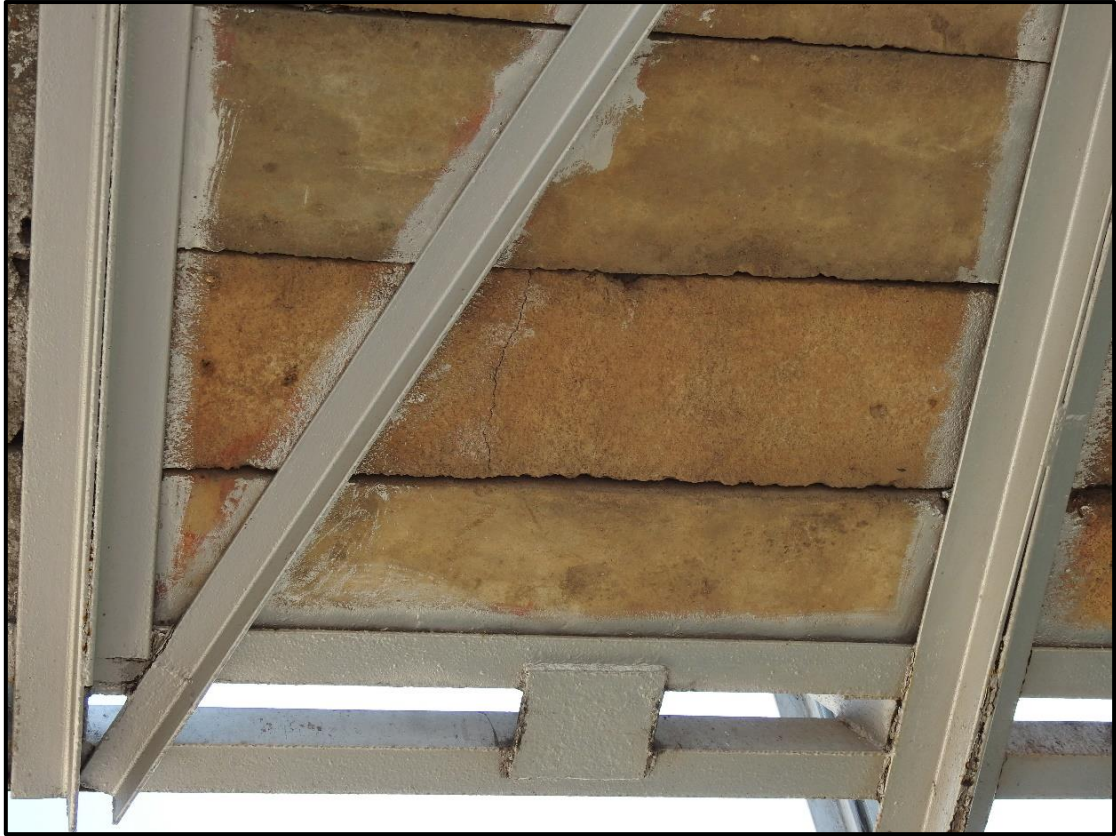
**Fig 1.6:** Cracks are observed in Pre-cast RCC slab panels (bottom view)

| PART 4 SURVEY OF SIGNS OF DISTRESS, DEFORMATION IN BRIDGES | | | |
|---|---|---|---|
| | Cracking in RCC components | Slab panels | Cracks are observed in Pre-cast RCC slab panels |

Reinforced cement concrete Slab at Deck level and some precast panels in staircase are observed with exposed rebar in many locations. (*Photographs of the same can be seen in fig 2.6*)

**Methodology for patching:** Hand applied Mortar (Patching) repair is performed to restore small areas where sound concrete is damaged by spalling, scaling and/or impact. This method of repair is generally applied using trowel and require minimum or formworks. The patch thickness is limited to a maximum of 100 mm depth of hollow surface. Hand applied Mortar repair is classified into two types considering defective area and surface. Hand applied Mortar

- a) **Type - A** is applicable to surfaces without exposed rebar is having defective widths of up to 300mm and depths of up to 50 mm.
- b) **Type - B** is for surfaces with exposed rebar, with defective widths between 300 mm and 600 mm, and up to 100 mm depths.

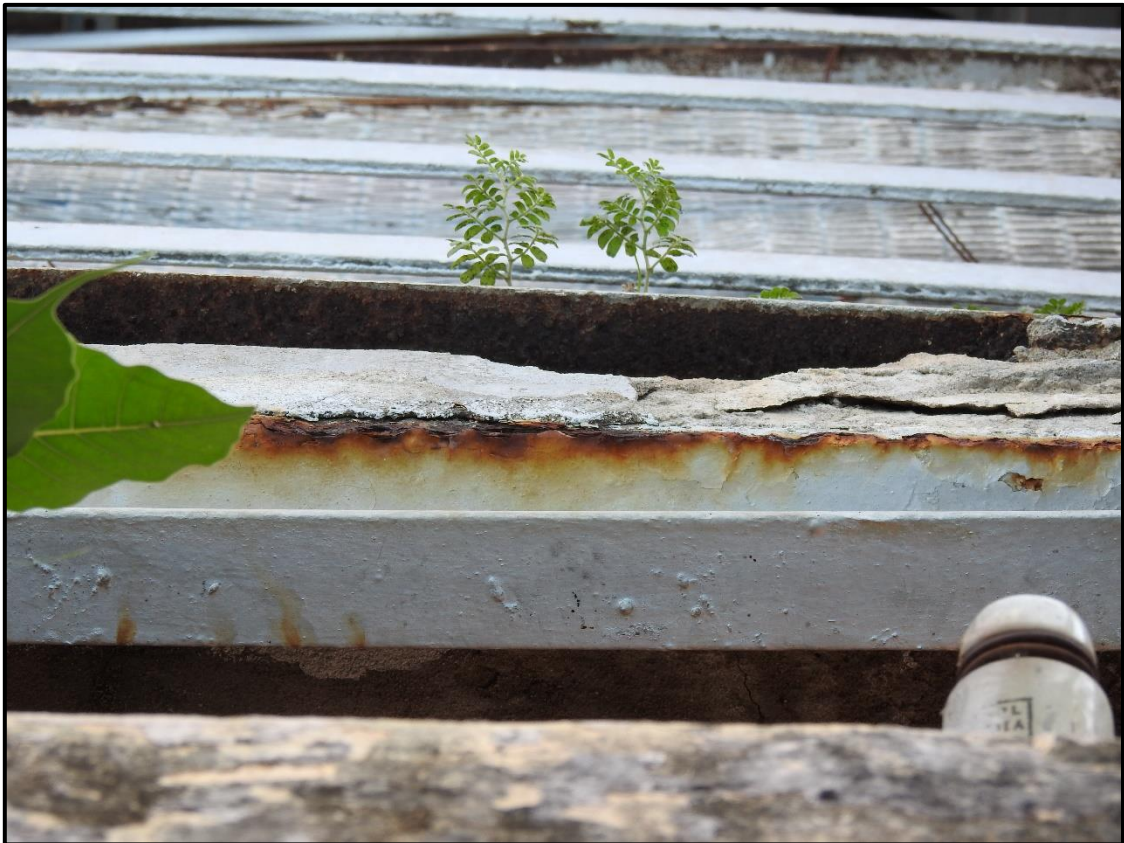
**Fig 1.7:** Vegetation is observed along the length of FOB

| PART 4 SURVEY OF SIGNS OF DISTRESS, DEFORMATION IN BRIDGES | | | |
|---|---|---|---|
| | Water seepage | | Vegetation is observed along the length of FOB |

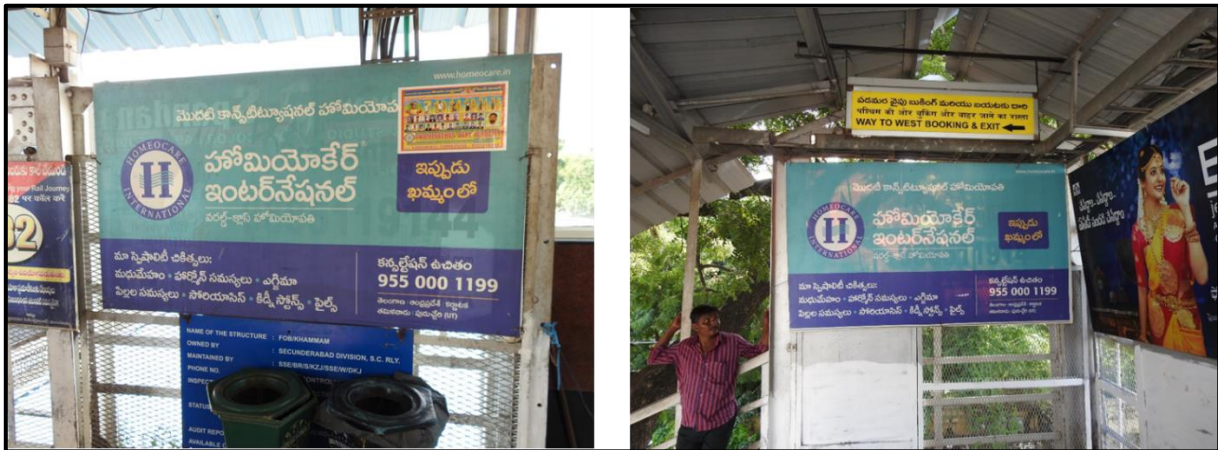
**Fig 1.9:** Advertisement boards are supported to passenger protection

| PART 2 IDENTIFICATION OF LOADS ON BRIDGE | | | |
|---|---|---|---|
| | e) load of advertising hoarding | Yes | Advertising boards are provided (Refer <b>fig: 9</b> ) |

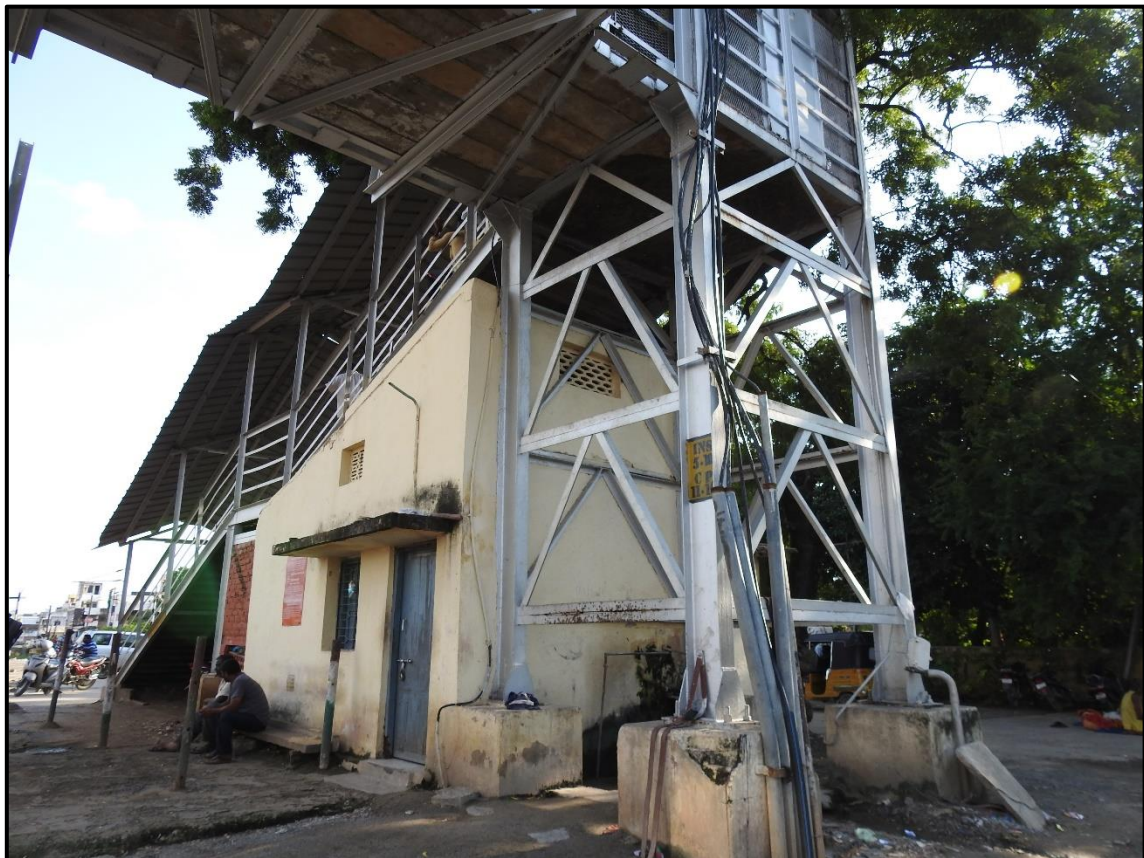
**Fig 1.10:** Trestles supporting staircase

| PART 3 STRUCTURAL SYSTEM OF THE BRIDGE | | | |
|---|---|---|---|
| | Type of Material | Concrete | Vertical columns are connected to Pedestal with Gusset plate, Cleat angle 150 x 100 mm, and 600 x 300 base plate (Refer <b>fig :1.10</b> )<br>** 'a' dimension of Concrete pedestal is observed in site below staircase 3. |

| | Shape of Column section | I – Section | FOB is Supported on Vertical Column of 4 - ISMB 400 with 75 x 75 x 8 mm Angle Lacing members connected using Gusset plates and bolts. (Refer <b>fig: 1.10</b> ) |

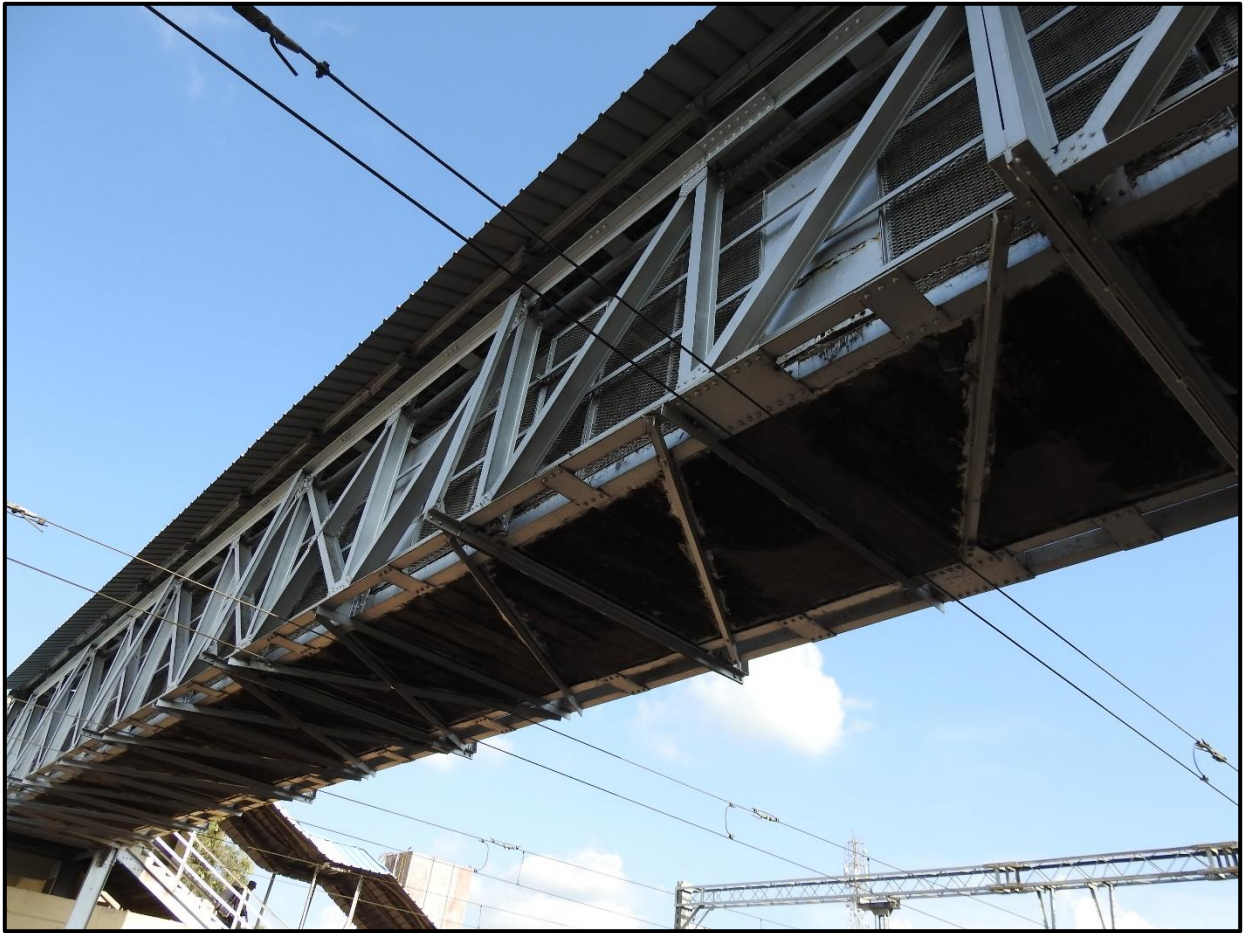
***Fig 1.11:*** Span 1 bottom view

| | Shape of Floor beam /Bracings | Double Channels angle section | 2/90 x 90 x 8 mm Double Angle Sections are used as Floor beams, supported with 65 x 65 x 8 mm inclined support to top Chord member. 65 x 65 x 8 mm angle sections are used for inclined bracings of pathway. Floor beams are connected to bottom chord Member using Bolts and Bracing are connected using welding. (Refer <b>fig: 1.11</b> ) |

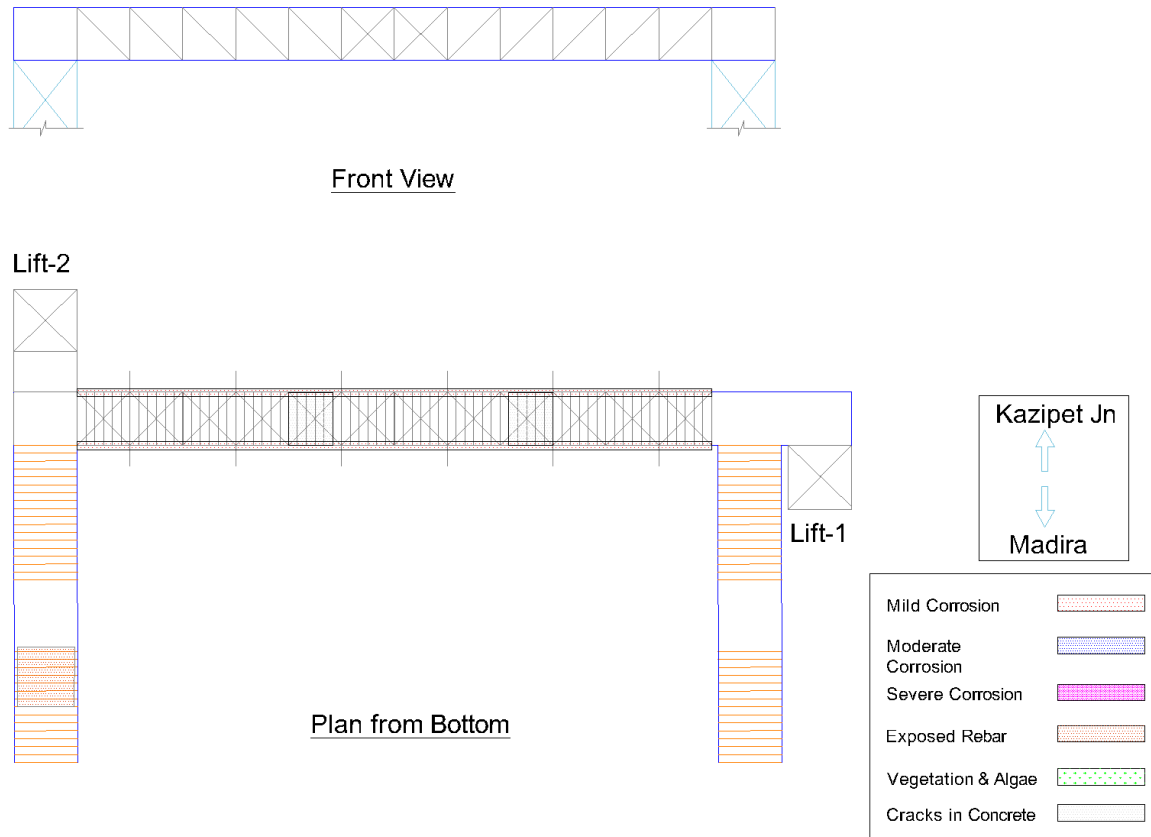
**Fig 2.1:** Locations of Deteriorations in span 1

Structural members are in fair condition, displaying mild corrosion for top chord members, verticals, diagonals, moderate corrosion for bottom chord members, and staircase stringer beam along steel concrete joint. Sacrificial plate and gusset plate is severely corroded from bottom at deck level.

- If the paint condition is identified as Grade-1, aluminum paint shall be applied with a similar shade.
- Where condition of paint is evaluated as Grade-2 special anticorrosion paint shall be applied to restrict corrosion from progressing further.

- When the condition of the member is observed to be in Grade – 3, which might have occurred due to environmental conditions or age of the structure. In such cases section loss is calculated by using caliper where it is accessible and UPV at one accessible location. The first step in dealing with corrosion is to measure the section loss in the member. The member may be measured using calipers or other appropriate methods for totally exposed sections.

- a. Section Loss < 15% - Clean the Surface and Apply the anticorrosion protective coat.
  - b. Section Loss 15% - 40% Repair the member as per design.

- c. Section Loss > 40% - Replace the member.

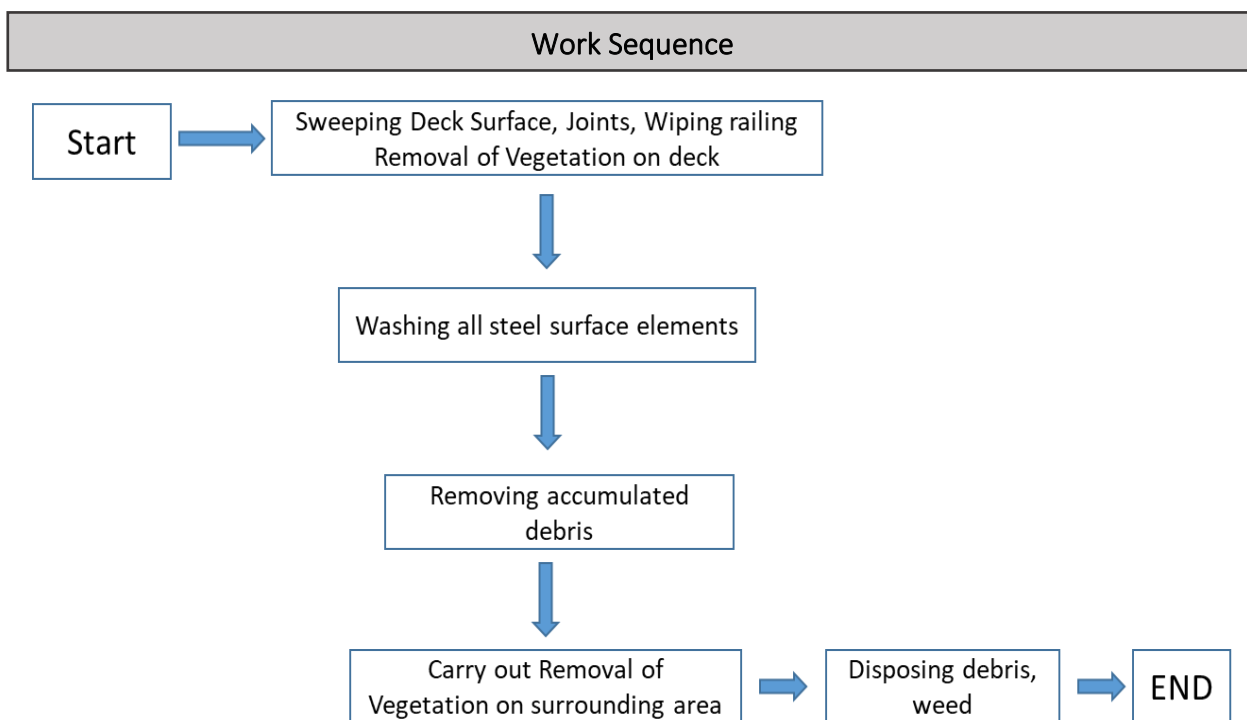
**Figure:1.1** Work sequence of removal of vegetation and accumulated debris

During the Bridge service life, several components of bridges get unclean due to deposition of foreign materials. Materials that collect on the deck surface flow with the rain water towards the drainage spouts which may choke the outlets and affect drainage. Also the materials that collect on the deck and carried by the rain water towards edges of the gangway and accumulate in the gaps or on the steel members. Such debris accumulation can cause acceleration of the corrosion in metal since debris tend to hold water. Also growth of vegetation such as grass, shrubs and other plants on the components of bridges is very common. But, they should be thoroughly cleaned of accumulated dust, debris and other foreign materials at regular intervals. This is to prevent deterioration of the bridge, which will therefore preserve the bridge components in their intended conditions resulting in increased service life of the bridge as well as provide safety and comfort to the users.

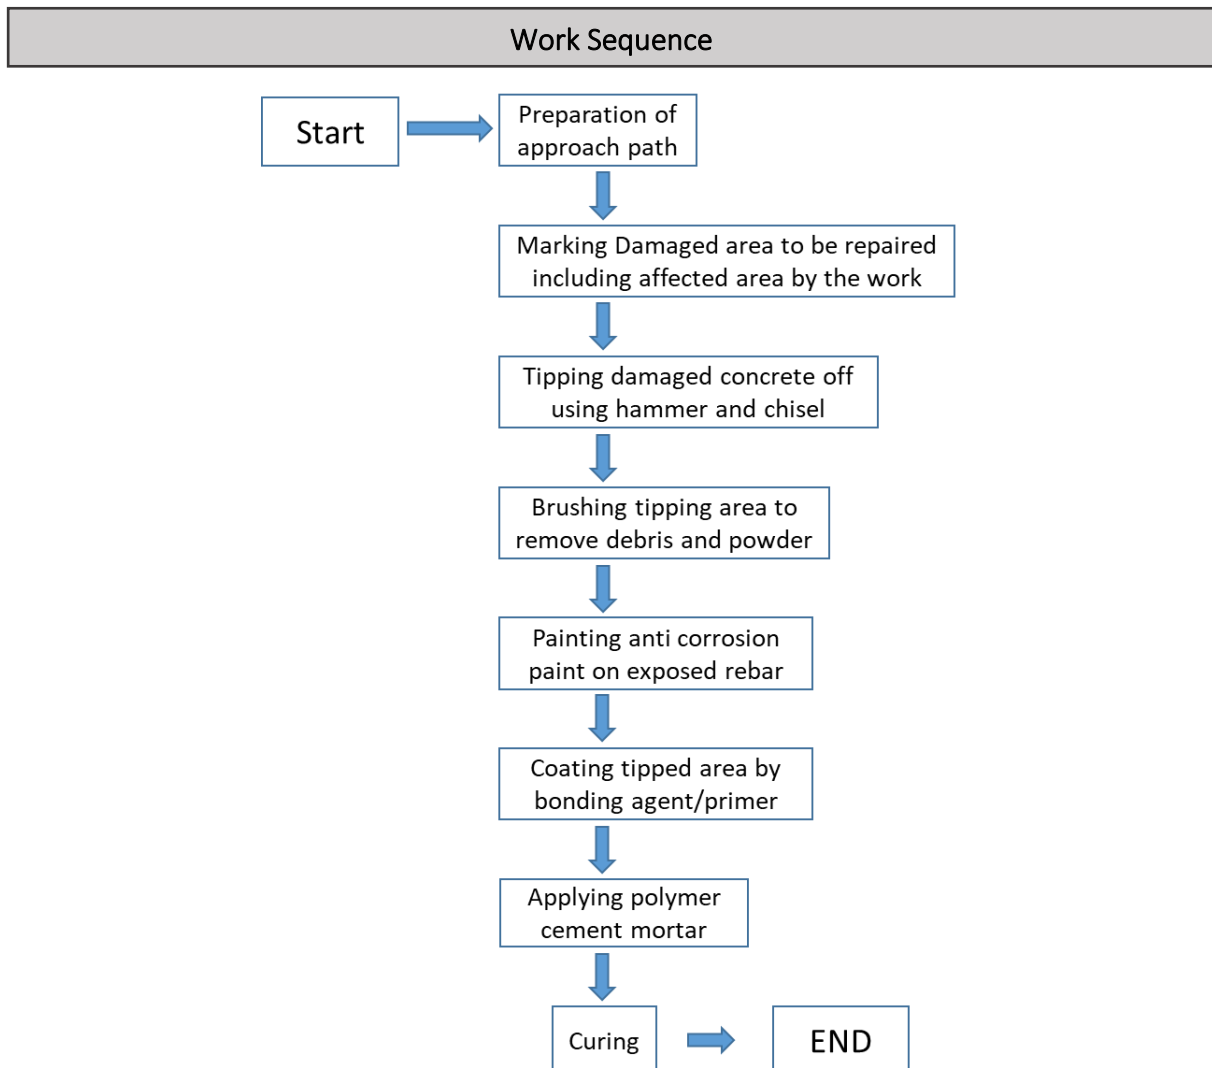
**Figure: 1.2** Work sequence of Epoxy Coating

Spalling of concrete requiring patching, which is usually caused by corrosion of steel reinforcement. Honeycomb is the effect of inadequate compaction of concrete while being cast. Patching is a temporary repair measure unless all the chloride-contaminated concrete is removed before the concrete deck or stair case is patched. If only the spalled and delaminated concrete is removed, the corrosion process continues and additional spalling can soon appear.

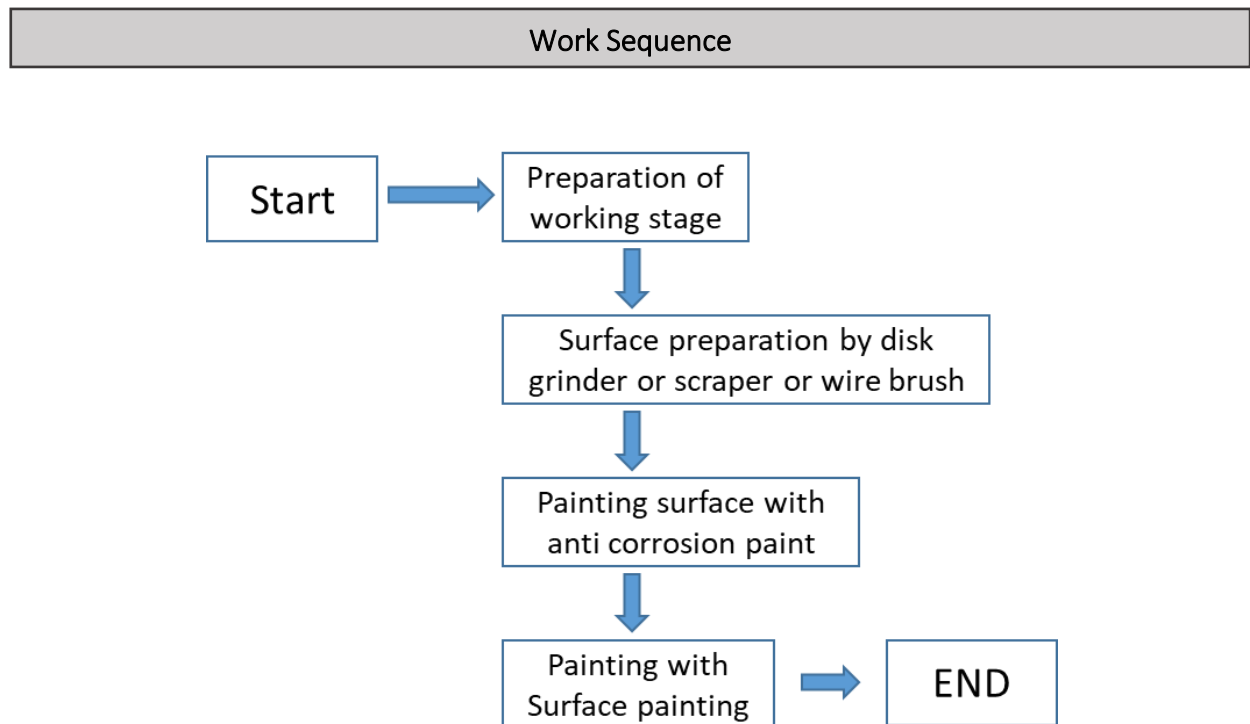
**Figure: 1.2** Work sequence of Painting with anti-corrosion paint

Due to thin paint coverage on steel surfaces or formation of pin-holes in paint, the steel surface may get exposed to atmosphere resulting in initiation of corrosion. Touch up painting at the early stages prevents progress of corrosion. Work included in this section comprises field touchup painting on steel members at localized areas including surface preparation and other associated works. This section covers only painting on relatively small affected areas which can be carried out with the use of small power tools / hand tools. Painting of larger areas requiring sand blast cleaning should be carried out in accordance with the specifications covered under major repairs.

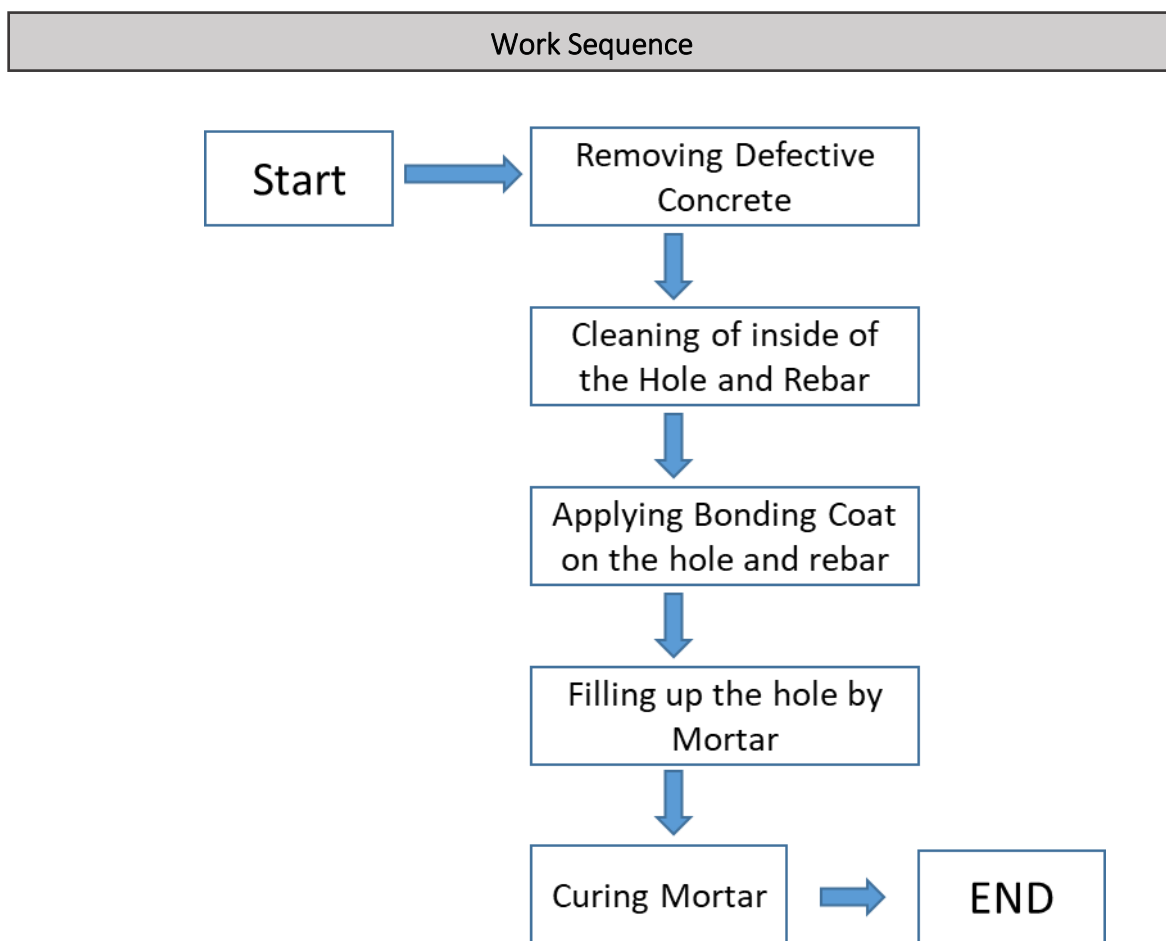
**Figure: 1.3** Work sequence of Hand applied mortar

Hand applied Mortar (Patching) repair is performed to restore small areas where sound concrete is damaged by spalling, scaling and/or impact. This method of repair is generally applied using trowel and require minimum or formworks. The patch thickness is limited to a maximum of 100 mm depth of hollow surface.

Hand applied Mortar repair is classified into two types considering defective area and surface. Hand applied Mortar (A) is for defects without exposed rebars while Hand applied Mortar (B) is applied to surfaces with exposed rebars. Hand applied Mortar repairs may be composed of Polymer cement mortars or non-shrinkage cement mortars depending on the type of patching, location and extent of damage.
