# **Third Party Audit of ROB's and FOB's Of SCR**

## **INSPECTION OF ROB NO. 268A NEAR MALLAPUR**

**Final Report**

**SEPTEMBER | 2020**

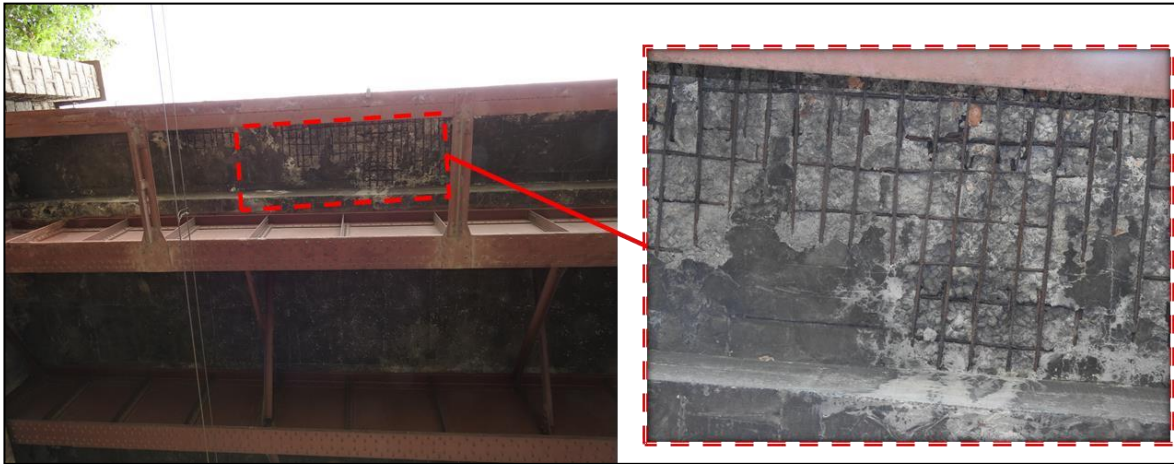
- a ✓ Spalling and Reinforcement exposure is observed at the bottom of slab.

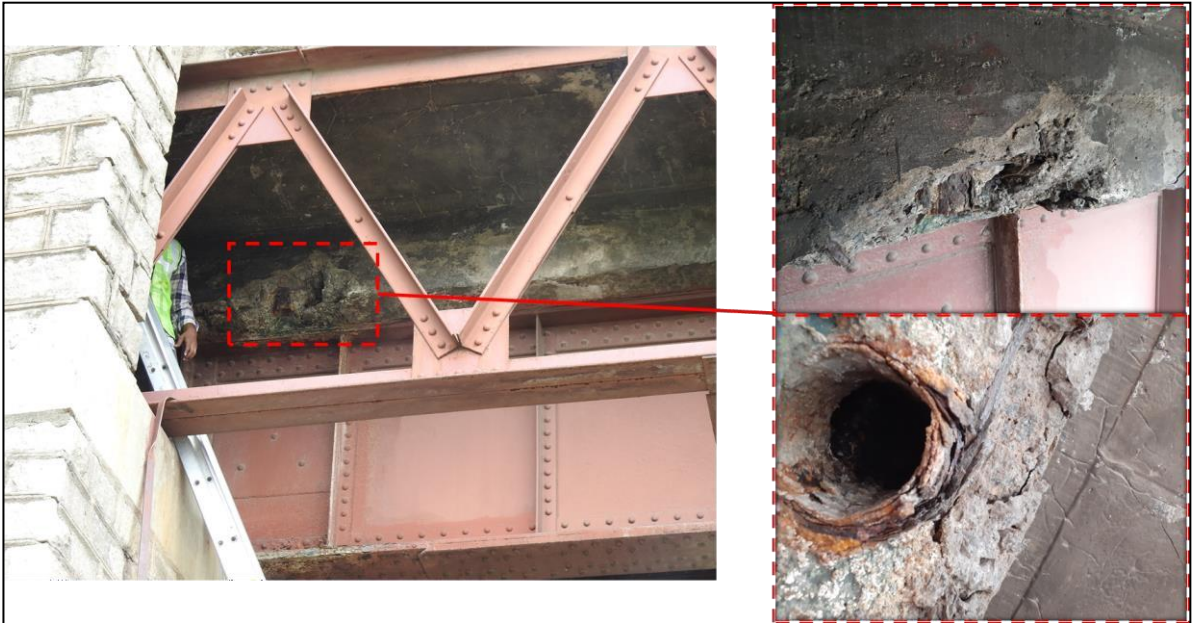
- b ✓ Corrosion and Spalling observed near Drainage Spout

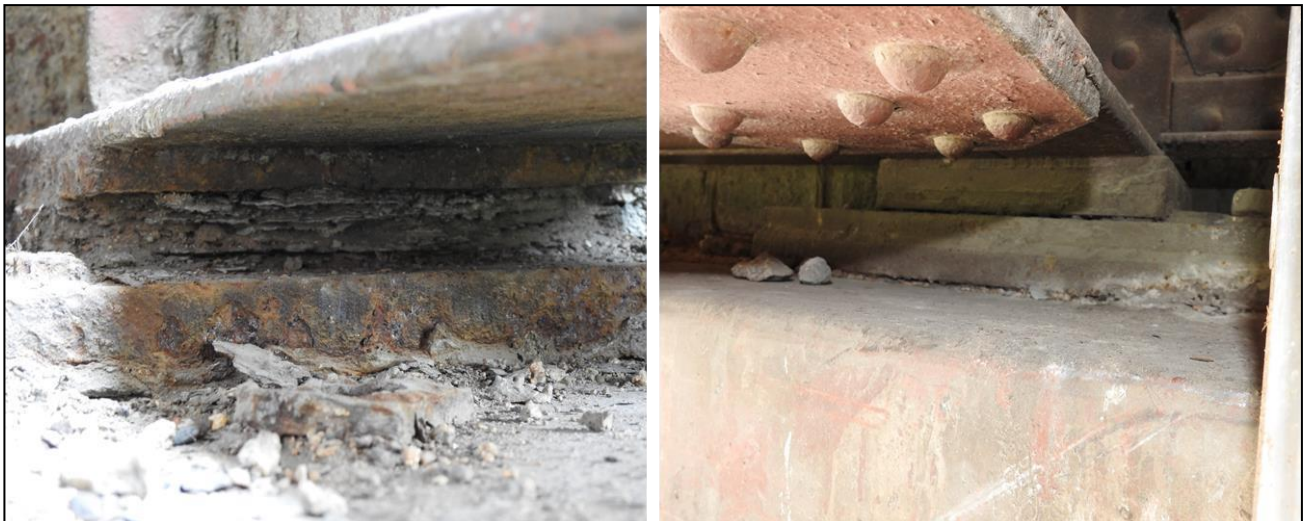
- c ✓ Distresses are found in the Elastomeric Pad bearings.

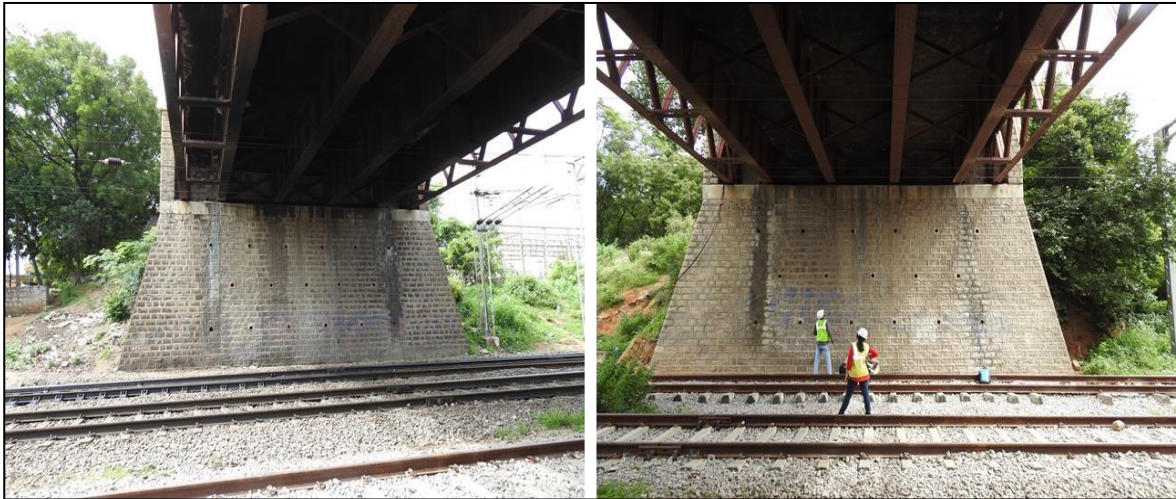
**Fig 1.1:** Stone masonry abutments

| PART 2 STRUCTURAL SYSTEM OF THE BRIDGE | | | |
|---|---|---|---|
| | Type | Stone masonry | Refer <b>fig :1.1</b> |

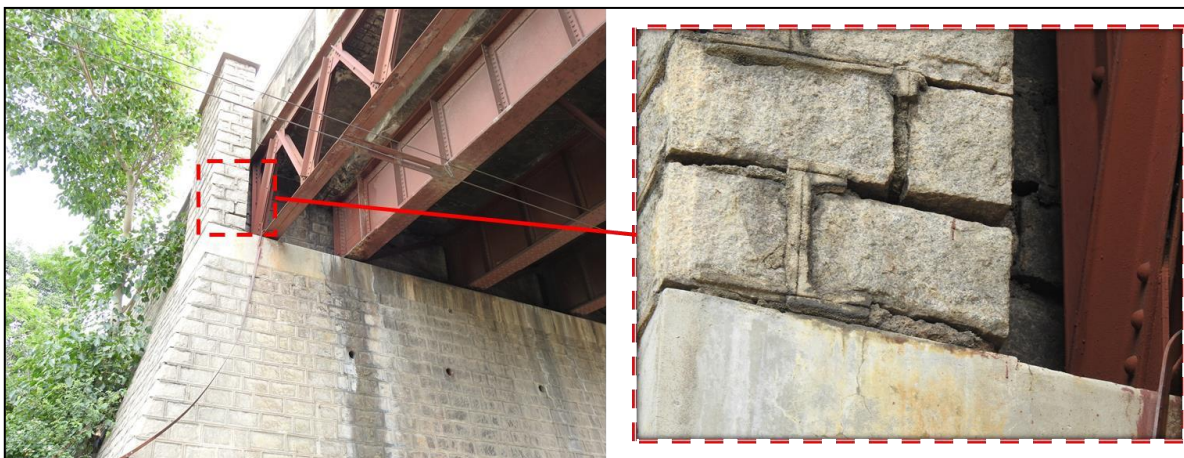
**Fig 1.2:** failure of pointing near abutments

| PART 2 STRUCTURAL SYSTEM OF THE BRIDGE | | | |
|---|---|---|---|
| | Condition (Crack, Settlement, Scour, Tilting, Steel Corrosion, Strains and other damages etc...) | Pointing has failed | Refer <b>fig:1.2</b> |

- It is recommended that 2 to 2-1/2 times the thickness of the mortar or a minimum of 3/4 inch be removed for repair. This will ensure the replacement mortar has adequate bond area.

- The mortar should be removed using hand tool or a small Pneumatic chisel. The use of power tools such as grinder is not recommended because it is difficult to control and can result in damage to adjacent masonry units. Square cuts at the limits of the removal are recommended.

- Any loose stones should be carefully removed, cleaned and re-set prior to repointing.
- Mortar used for repointing should be stiff, as stiff mortar will shrink less as it cures. Mortar should not be allowed to dry out during use and should be reworked at intervals prior to being placed in the joints.

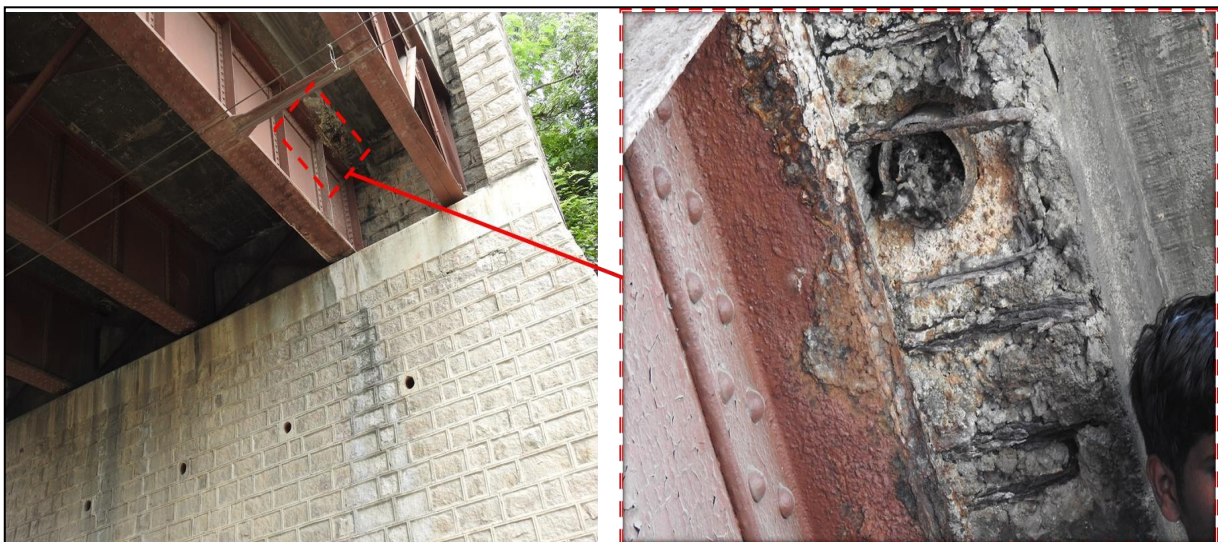
**Fig 1.3:** Reinforcement exposed and corrosion of main girder

| SIGNS OF DISTRESS, DEFORMATION IN BRIDGES | | | |
|---|---|---|---|
| | Steel girders | Main girders | Corrosion of girders near end supports ( <i>Refer fig :1.3 and 1.4</i> ) |

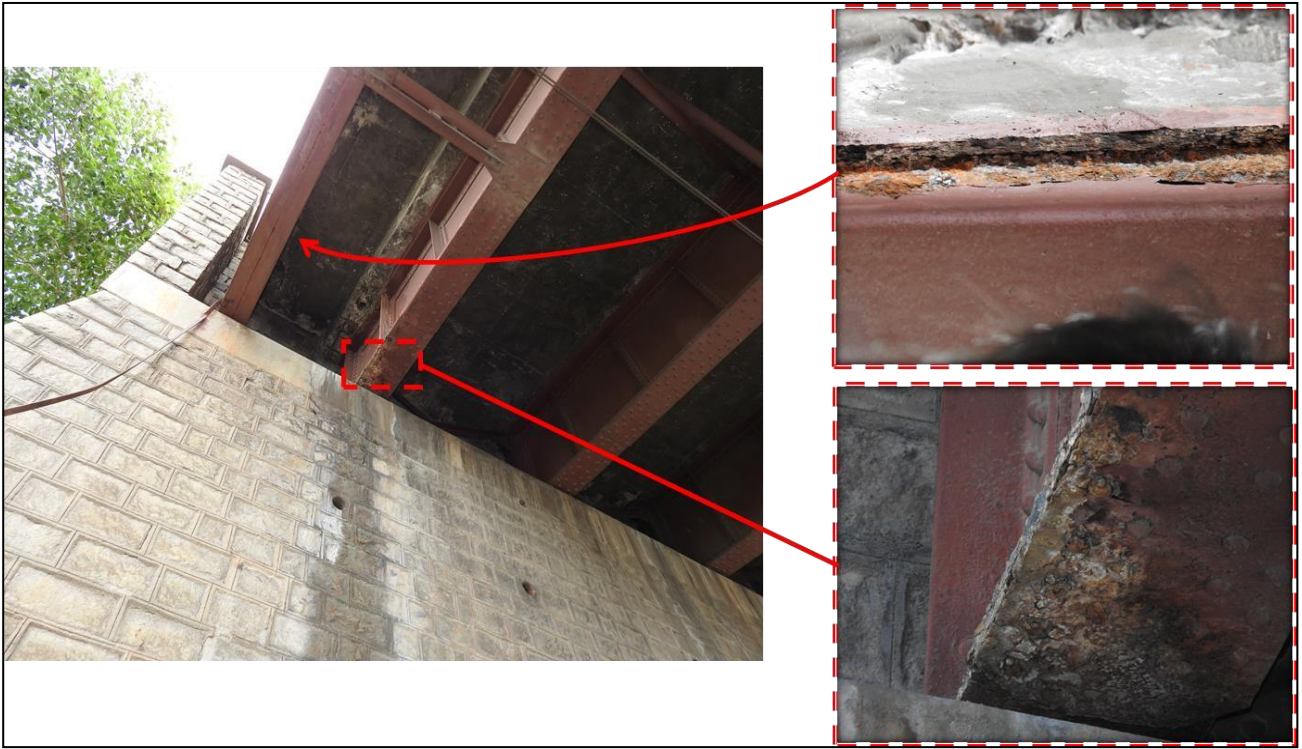
***Fig 1.4:*** Corrosion of main girder

| | Condition of Girder | | Corrosion is observed at top and bottom of girder near end supports |

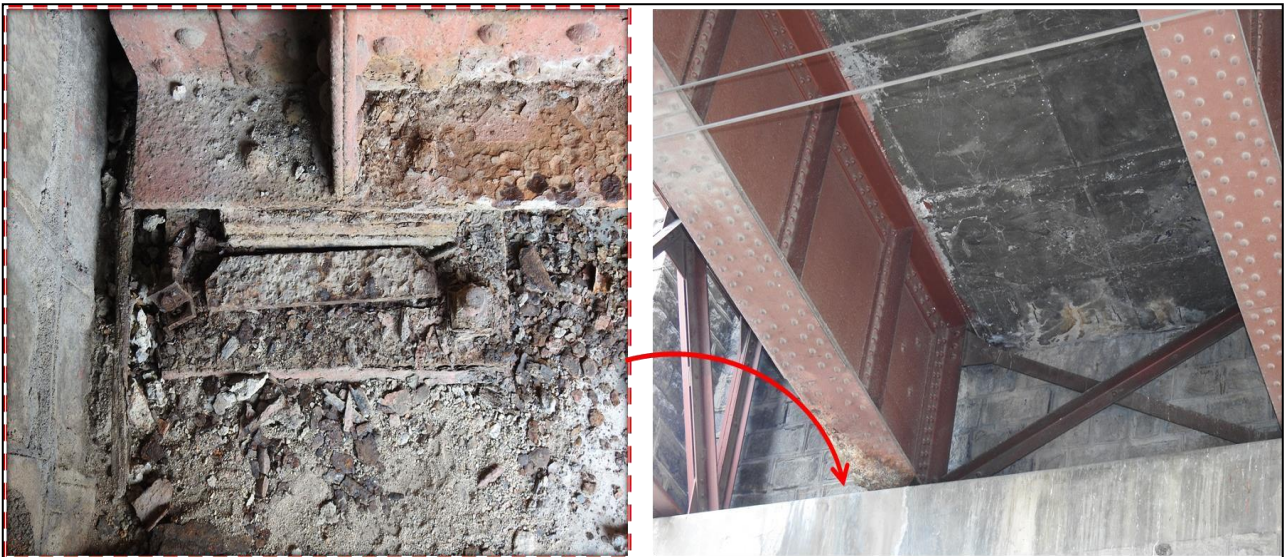
***Fig 1.5:*** Base plate corrosion

| | General condition (Check Corrosion, cleanliness, seizing of plates silting) | Corrosion | |

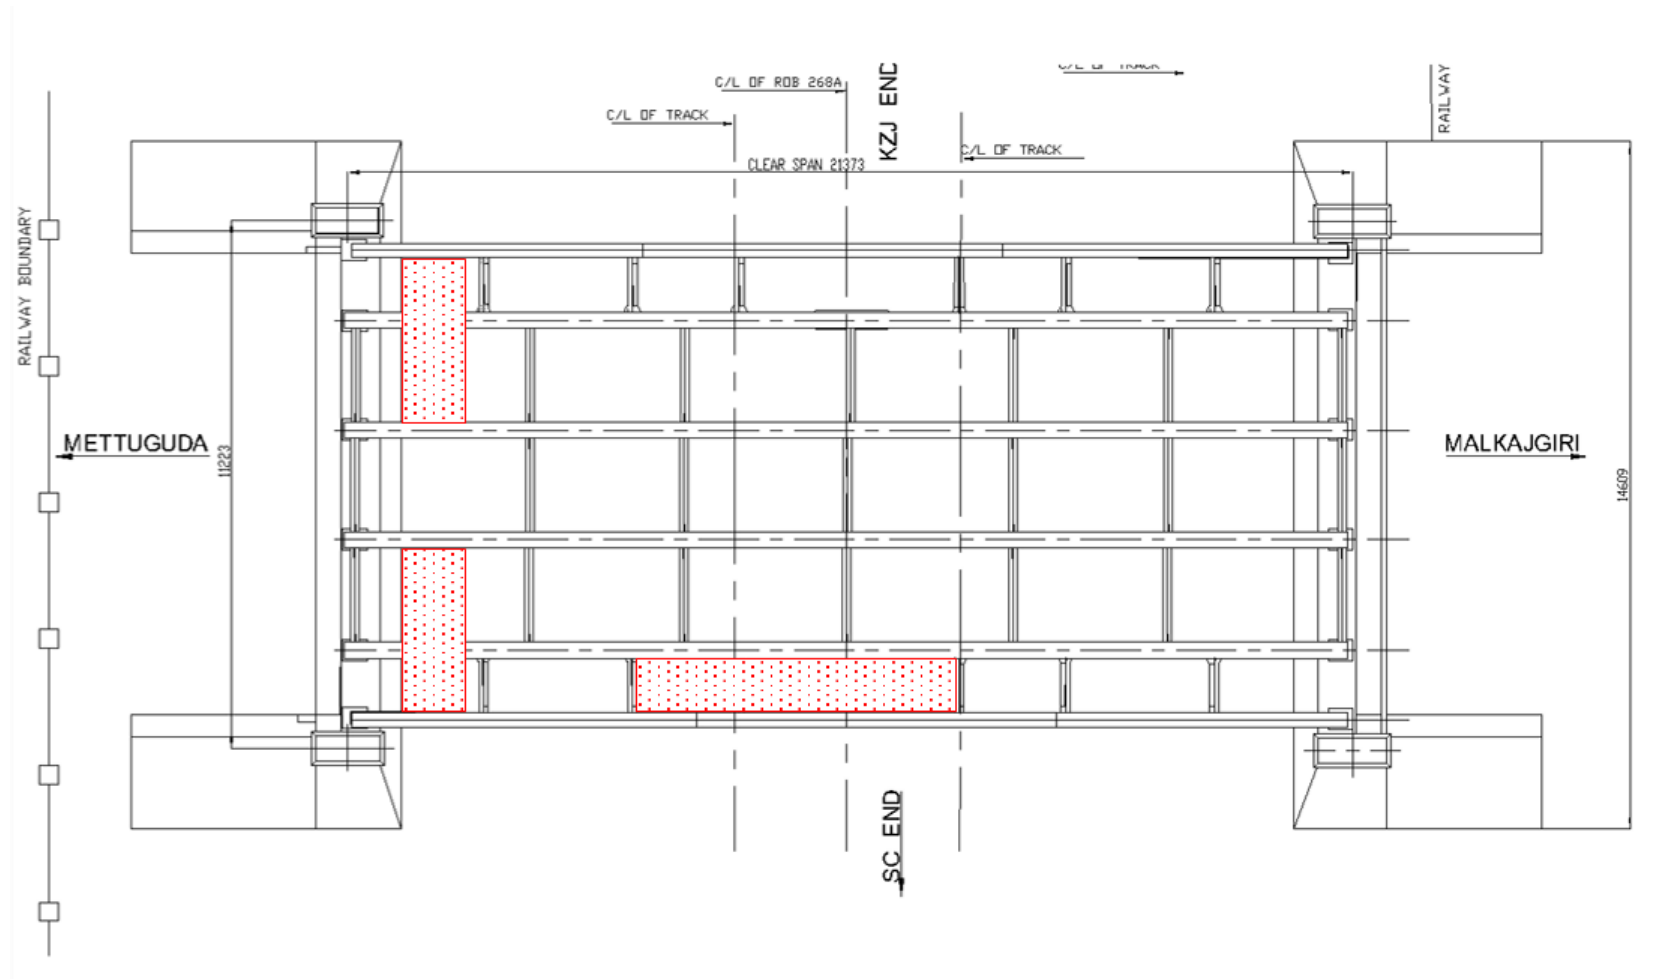
**Fig 2.1:** Bottom view of slab deck with reinforcement exposed (damaged) locations

During the detailed visual observation, is made of Deck slab on the above said locations and the following observations are made, excessive spalling was noticed in span majority of the deck slab is affected with dampness, rebar corrosion and cracks were noticed at the steel concrete joints.

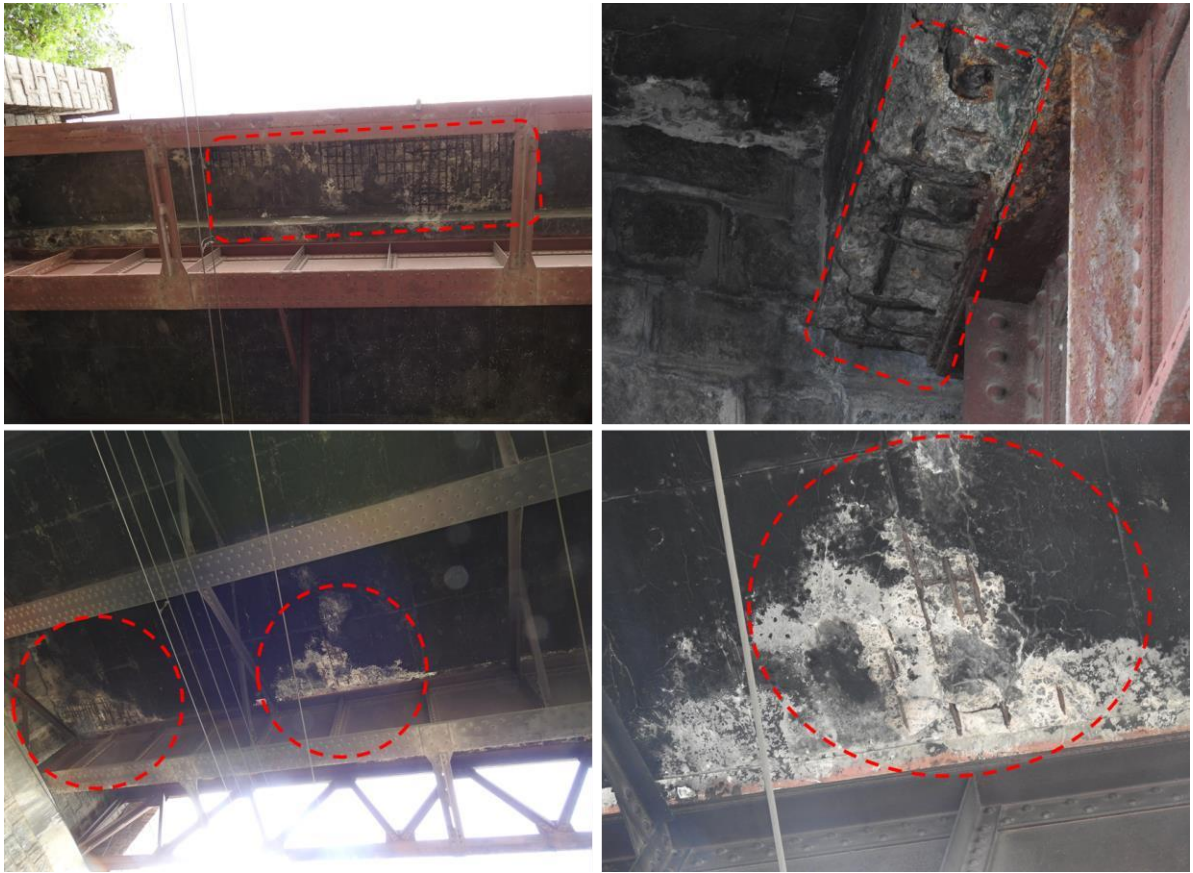
**Fig 2.2:** Damage locations identified in deck slab

- Spalling and Rebar exposure in deck slab

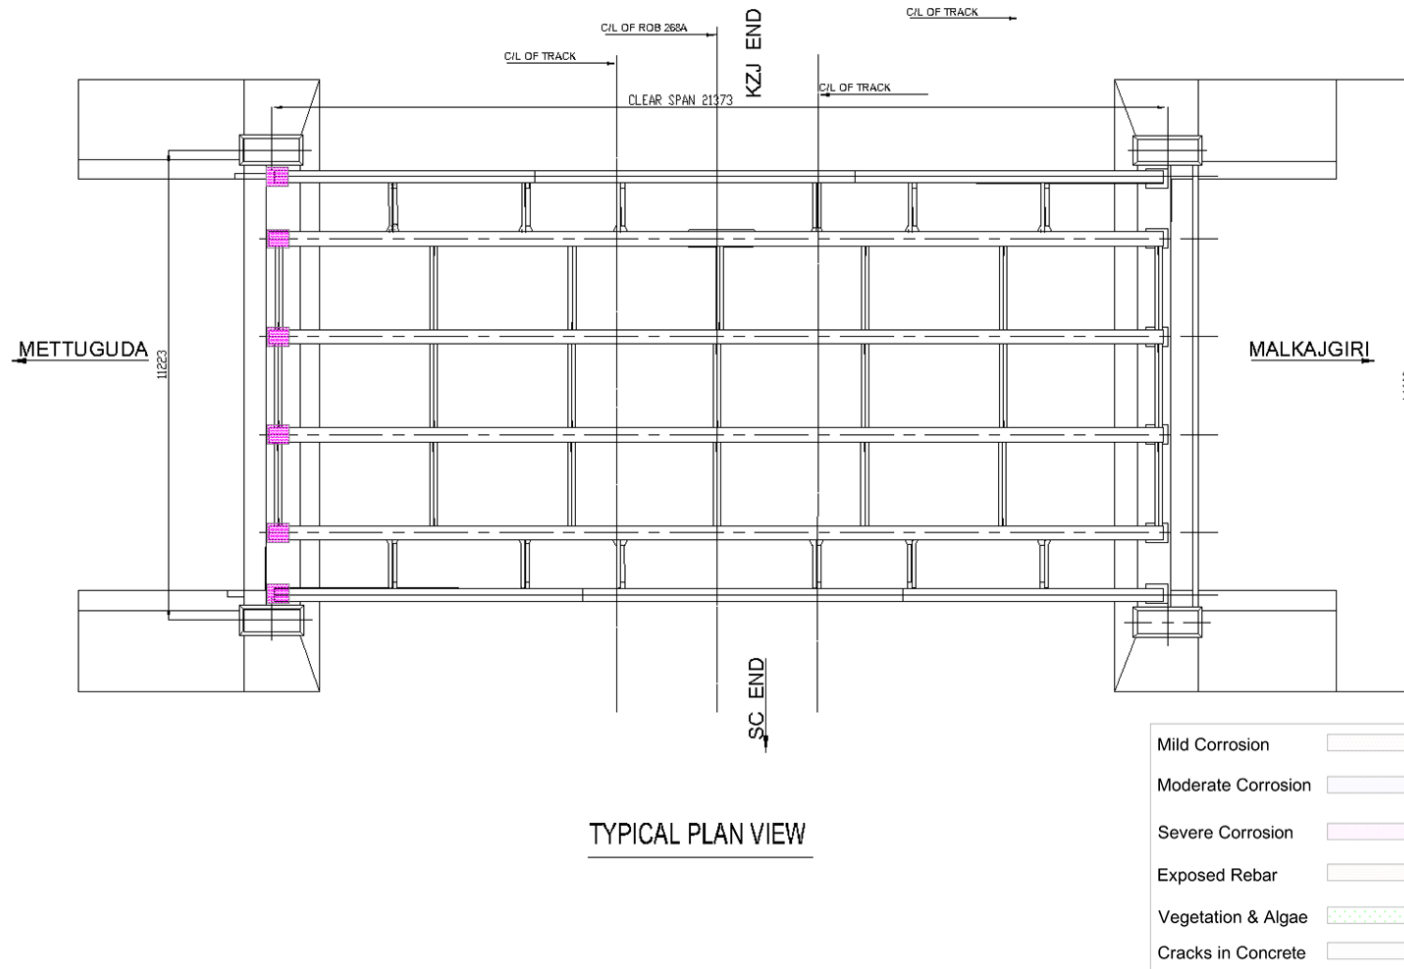
**Fig 2.3:** Bottom view of slab deck with Steel girder exposed (damaged) locations

A detailed visual observation is made on steel girders on the above said locations and the following observations are made, excessive corrosion and steel flaking was noticed in span near drain holes and bearings.

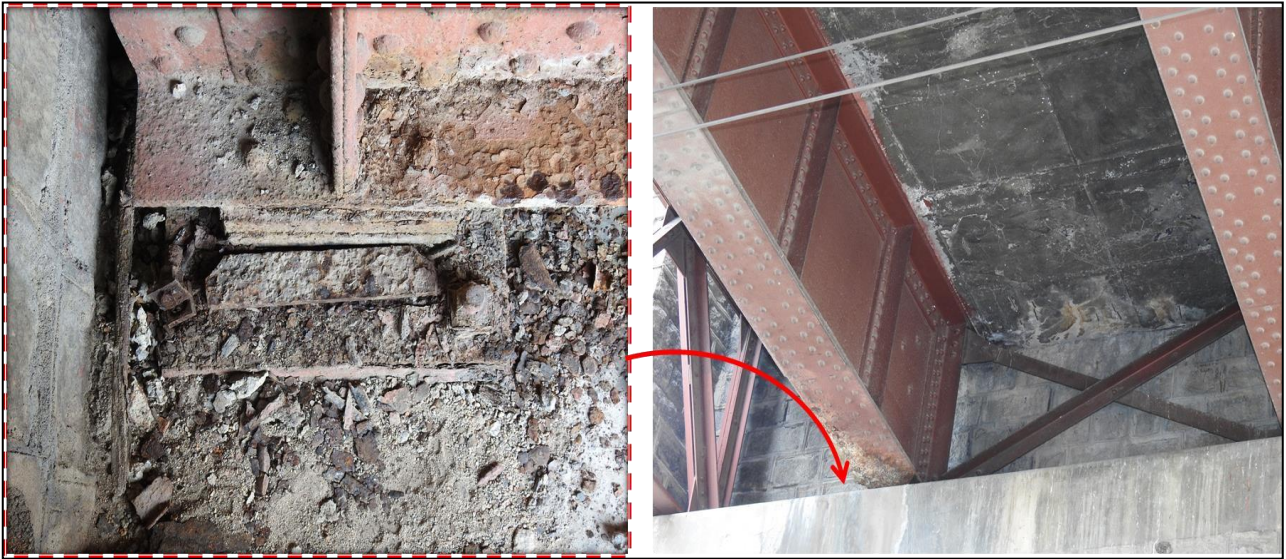
**Fig 2.4:** corrosion of bearing plate

Corrosion and steel flaking observed near support

Section Loss > 15% - Clean the Surface and Apply the protective  
coat. Section Loss 15% - 40% Repair the member with Suitable  
method Section Loss < 40% - Replace the member with Suitable  
method

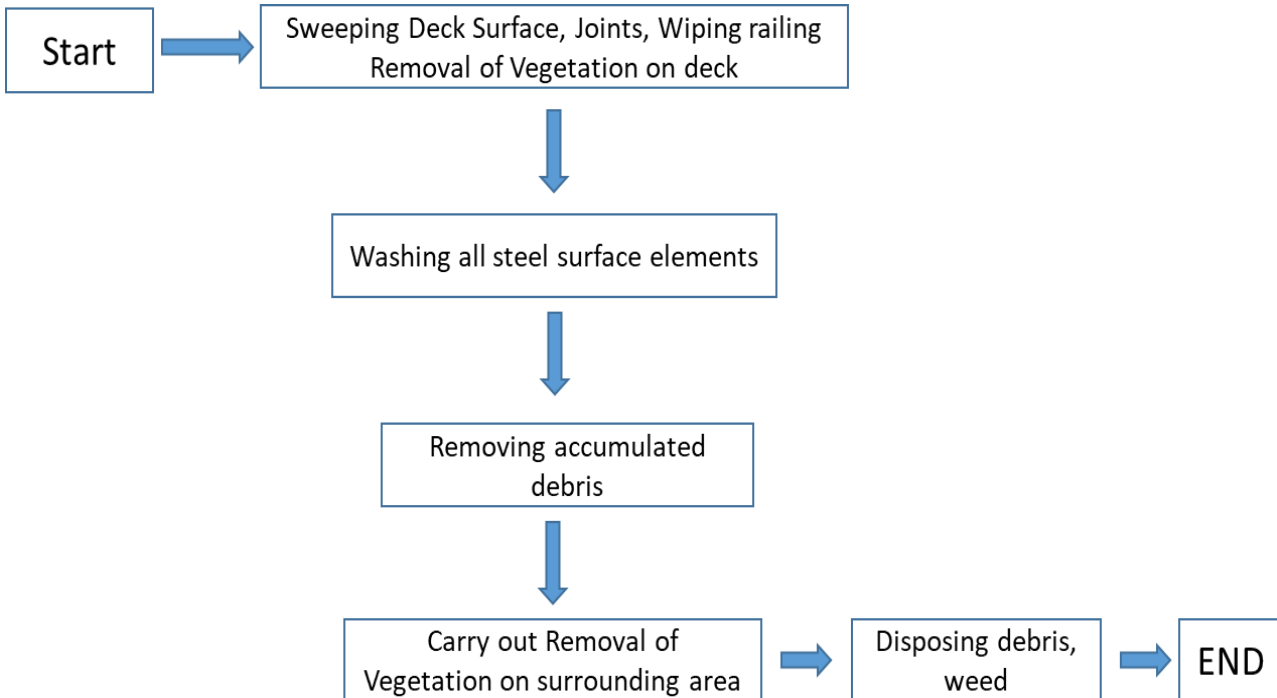
**Figure:1.1** Work sequence of removal of vegetation and accumulated debris

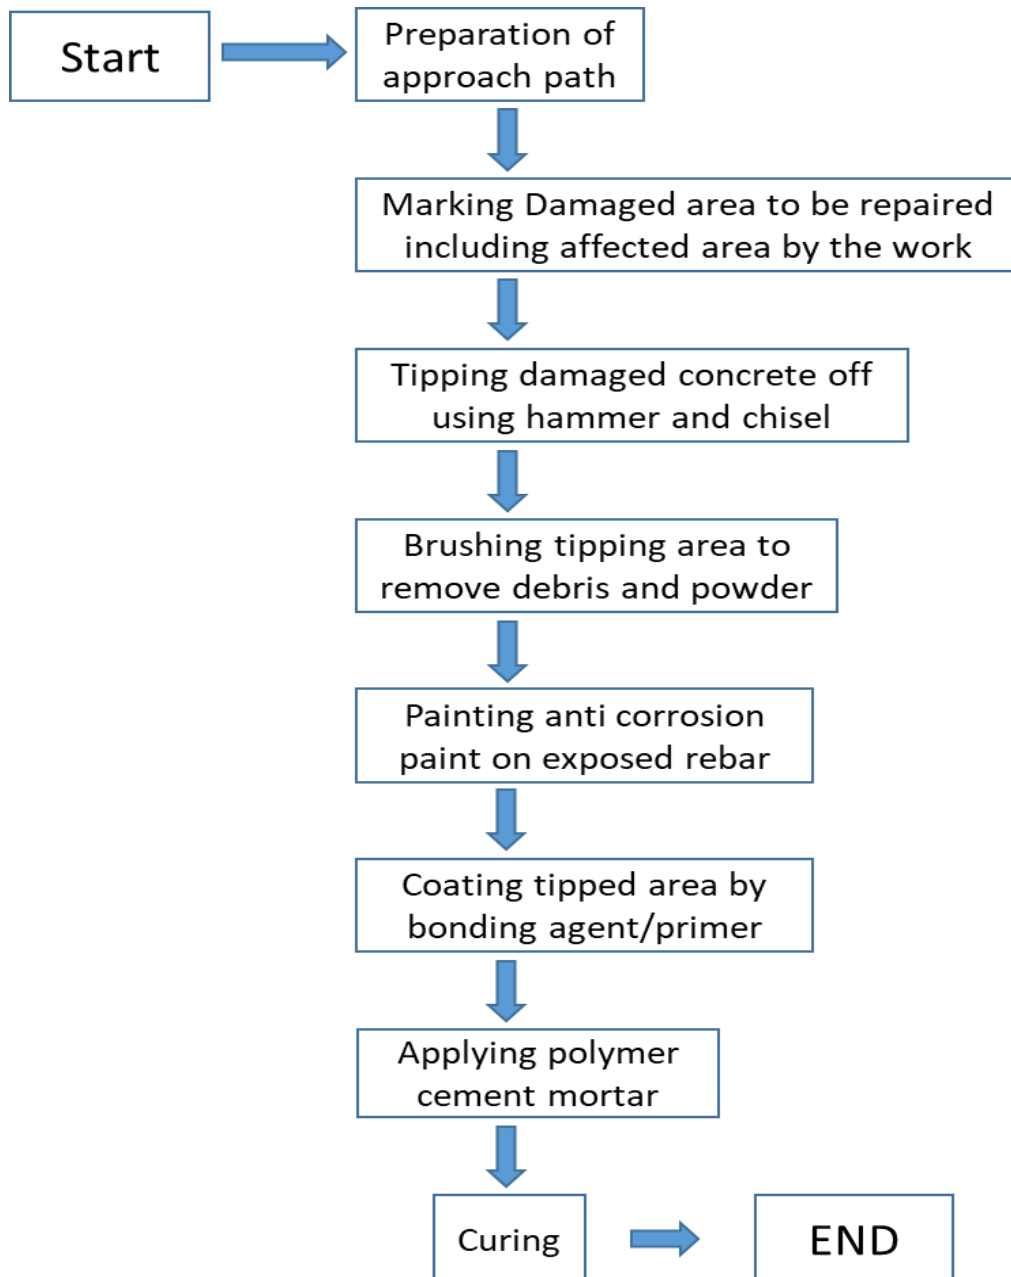
**Figure: 1.2** Work sequence of Epoxy Coating

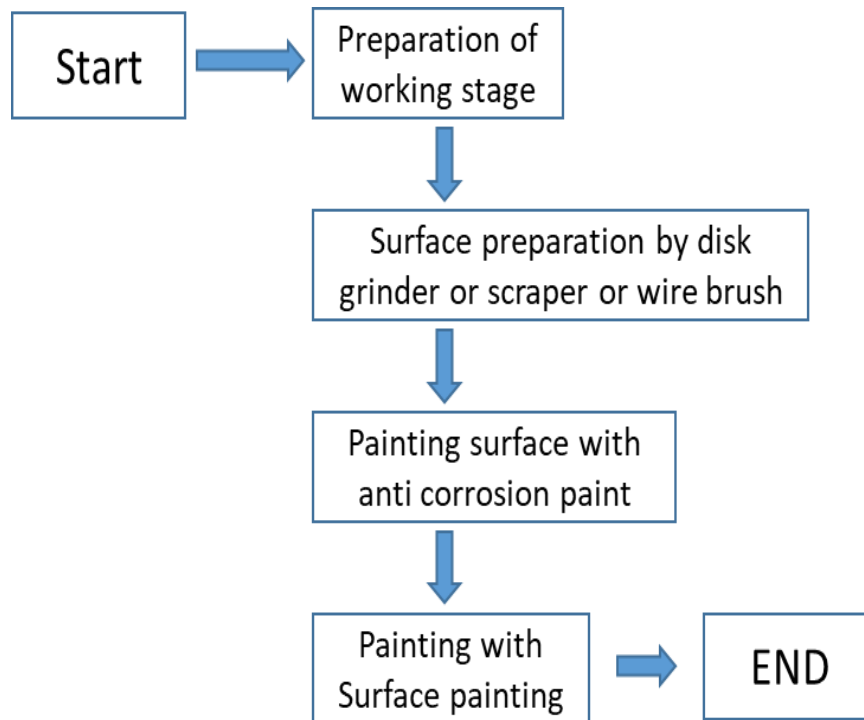
**Figure: 1.2** Work sequence of Painting with anti-corrosion paint

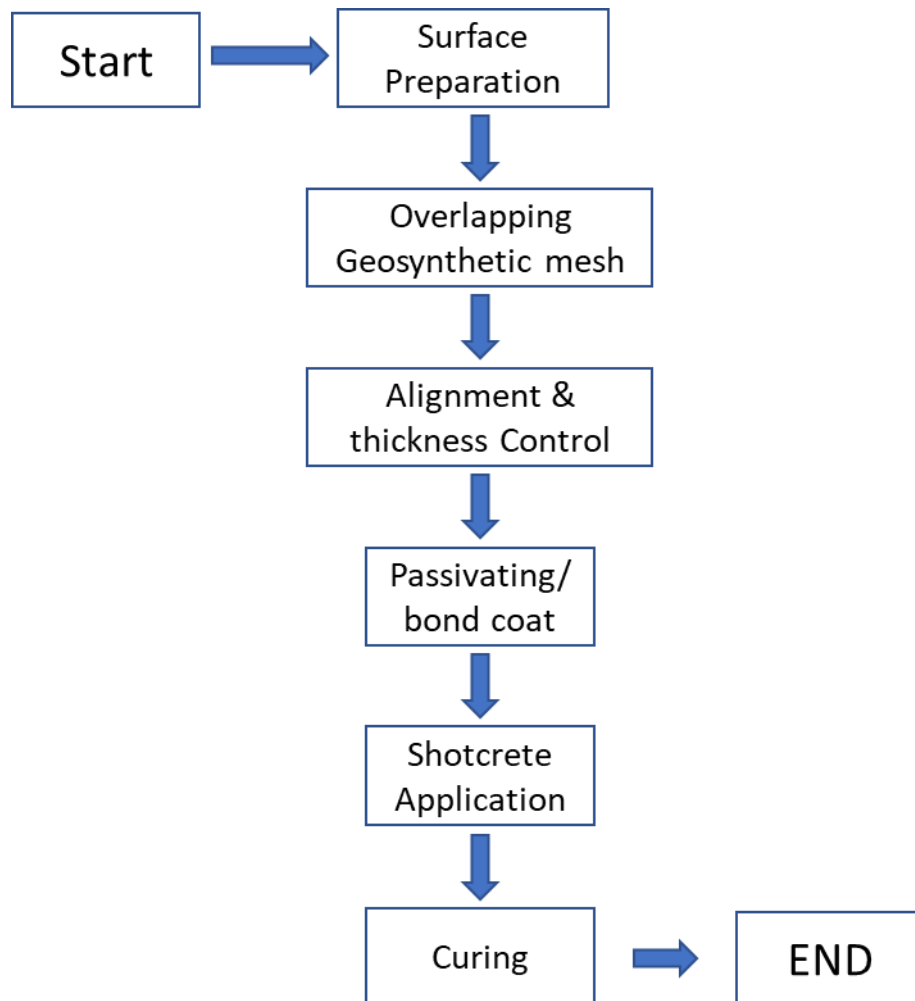
**Figure: 1.2** Work sequence of Shotcrete
